# Folkboat's Bulletproof Hull-to-Deck Joint Set It Apart

*Although not immune to the problems that plague older boat, the IF has stood up well to the test of time.*

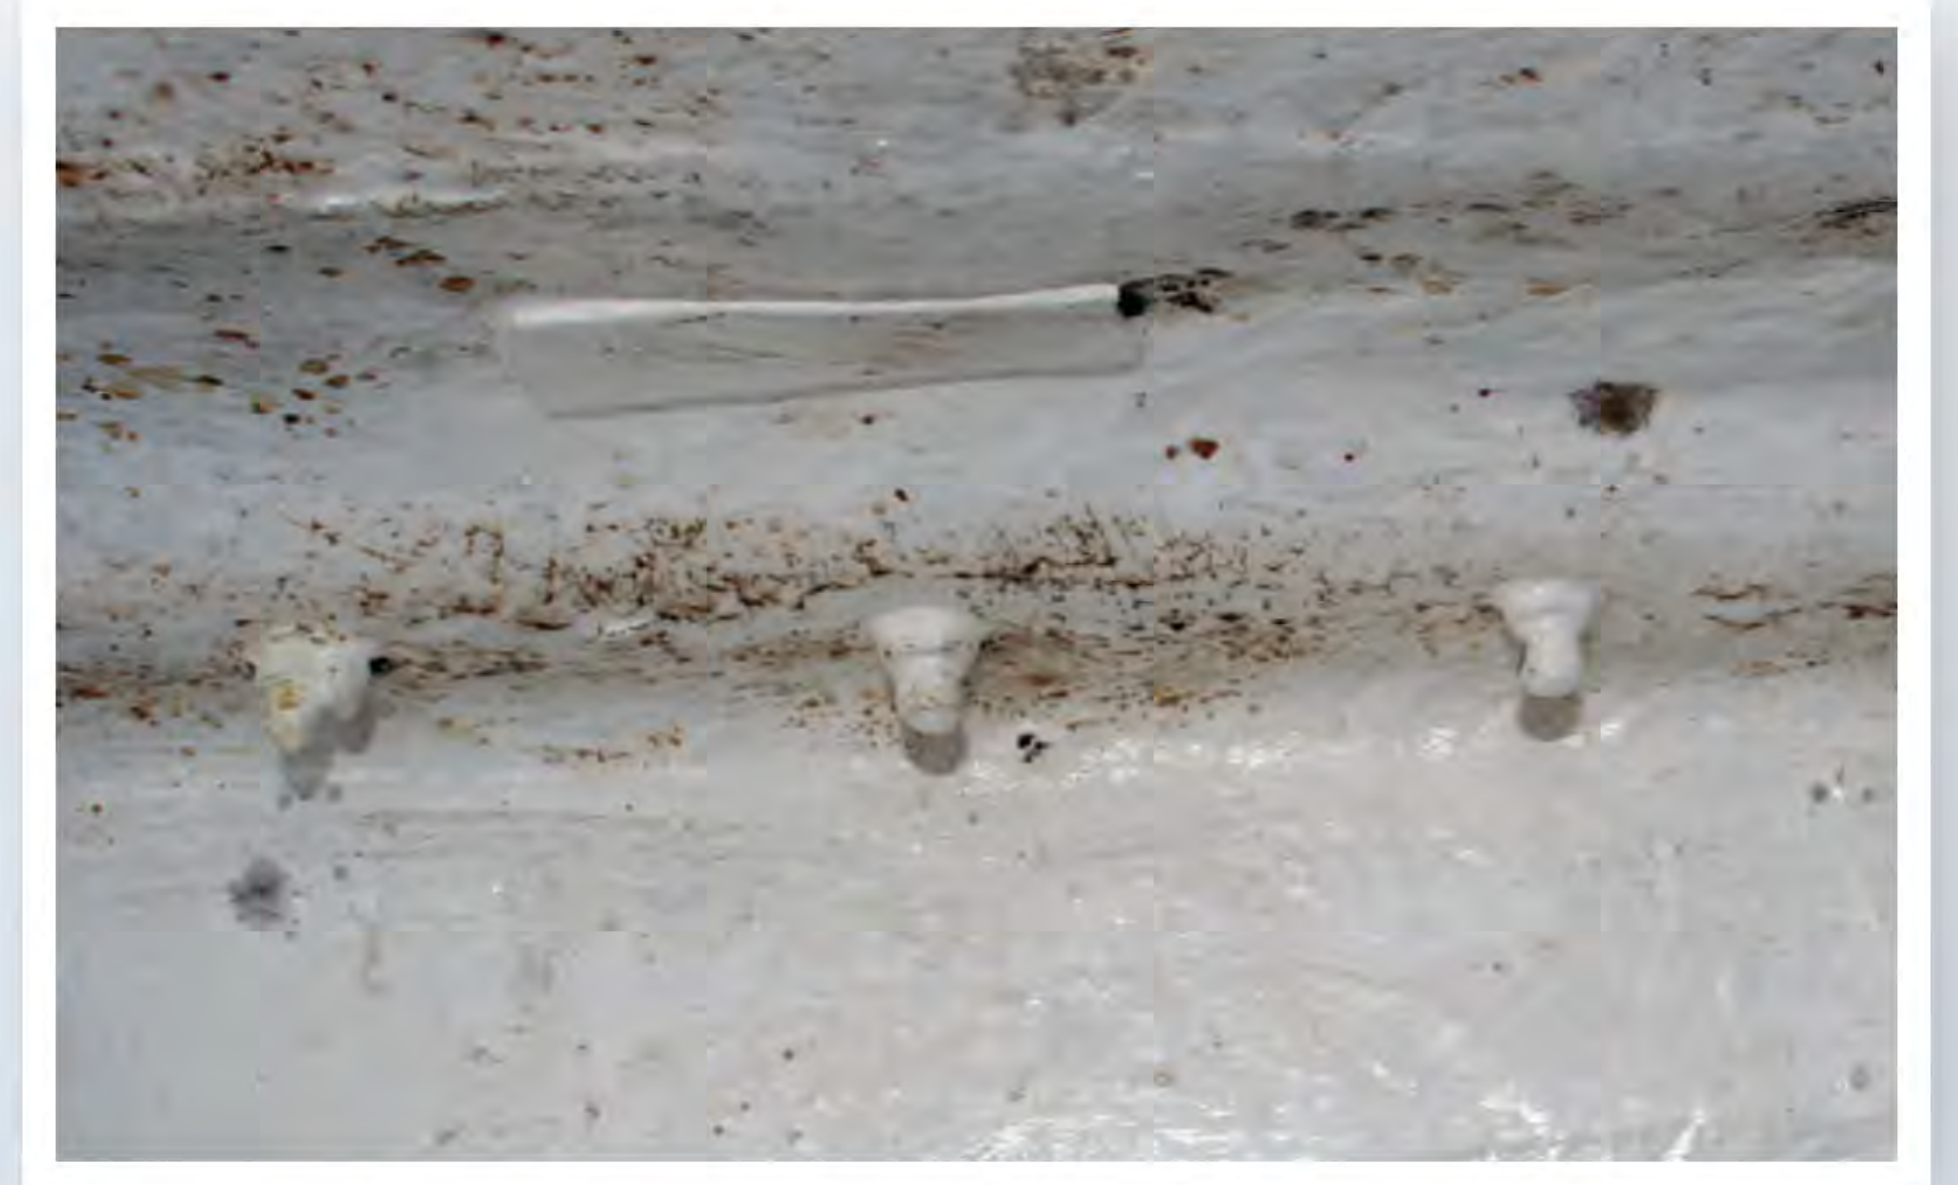
**Hull-to-deck joint:** The International Folkboat's deck is bonded to the inward-turning flange in the hull with bedding compound sealant, mechanically fastened, and then fiberglassed together from the inside, forming a strong monocoque hull. This time-consuming process makes for bulletproof, watertight bond.

*The hull-deck joint is glassed from the inside. Genoa track bolts, also shown here, will need inspecting.*

boats. Both are grooved for boltropes or round slugs. Although the sheaves for internal halyards were designed for wire, they are easily converted for all-rope halyards. Suspicious chainplate eyes should be pulled and inspected for corrosion, as should at least one or two through-bolts for the genoa track.
