SPECIAL REPORT

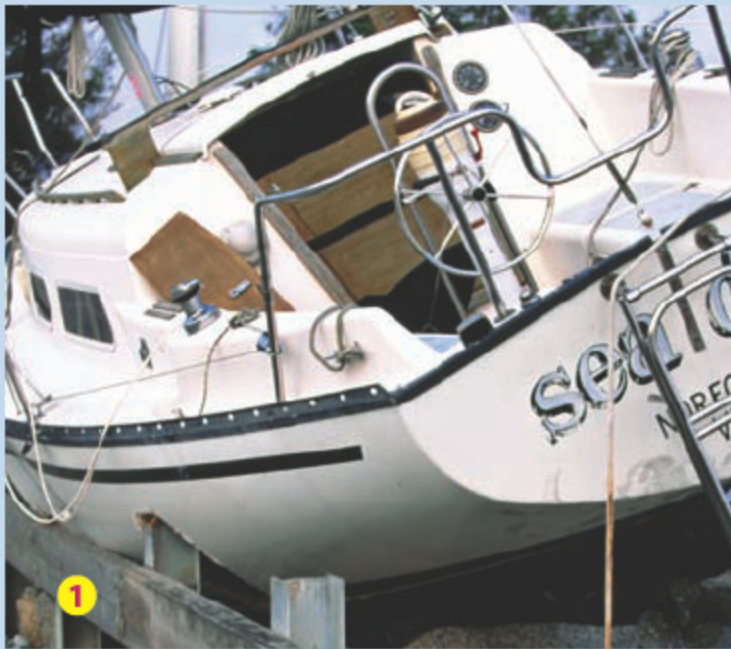
1. The point loading of a roadside guardrail doomed this boat, whose anchor rodes had parted during Tropical Storm Isabel in Annapolis, Md.

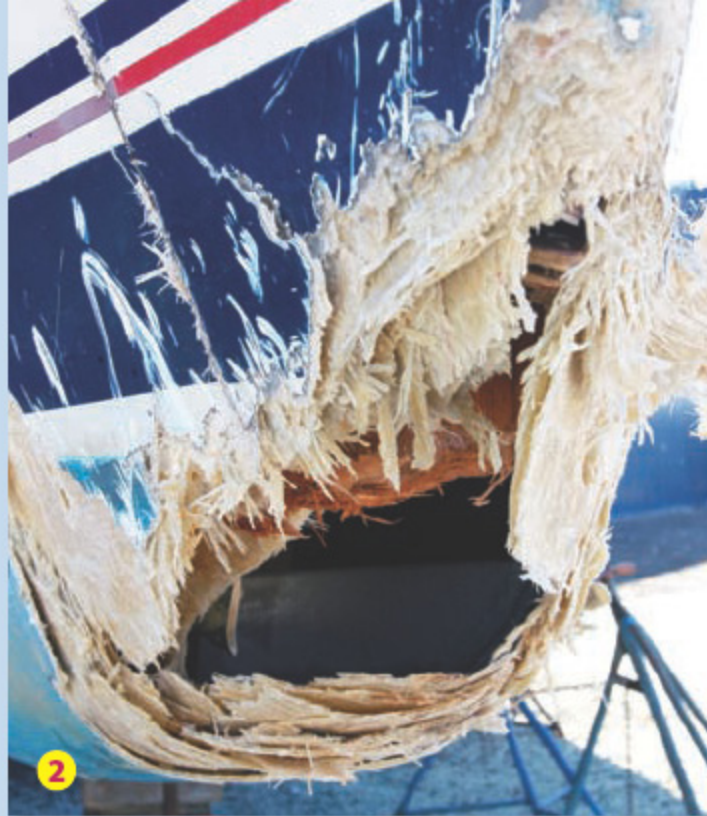
2. Although this Beneteau 44's solid FRP stem is capable of handling sailing loads, there was little question as to whether the rock or the fiberglass would win the tussle that left a gaping hole in its hull.

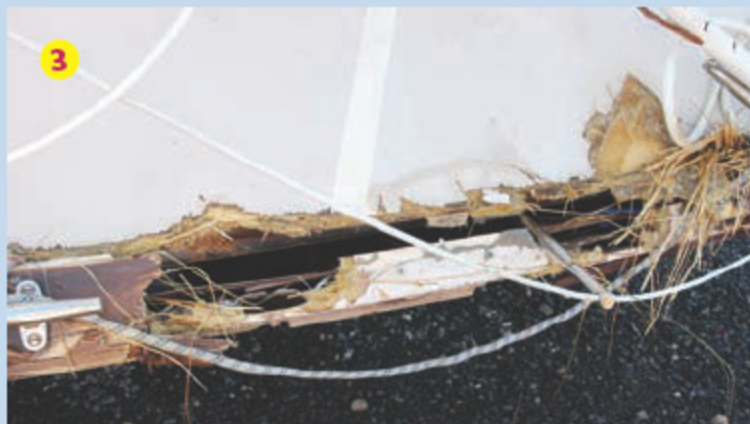
3. A hole is all that is left of FRP-bonded stainless steel chainplates on this Island Packet 44, which was found dismasted and driven onto rocks beneath a low bridge near Stamford, Conn.
