Overboard on a Volvo 70

ABN 2's heroic efforts go in vain, as extreme sailing lives up to its name.

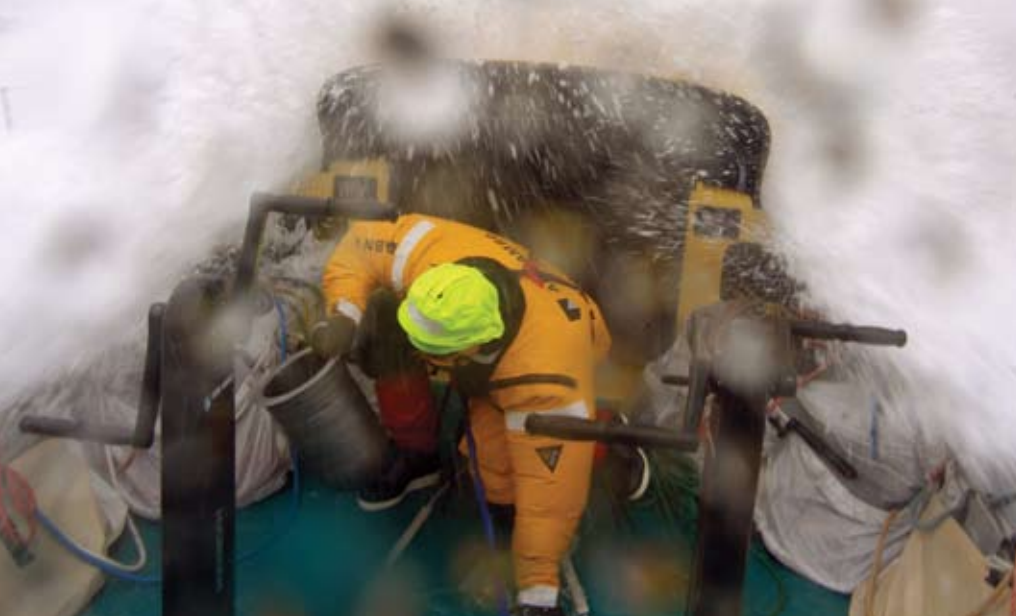
The hatch dodger on ABN Amro Two slides forward for spinnaker take-downs, but locks in place aft at other times. The hatch board arrangement folds up inside the dodger, always remaining ready for instant use.

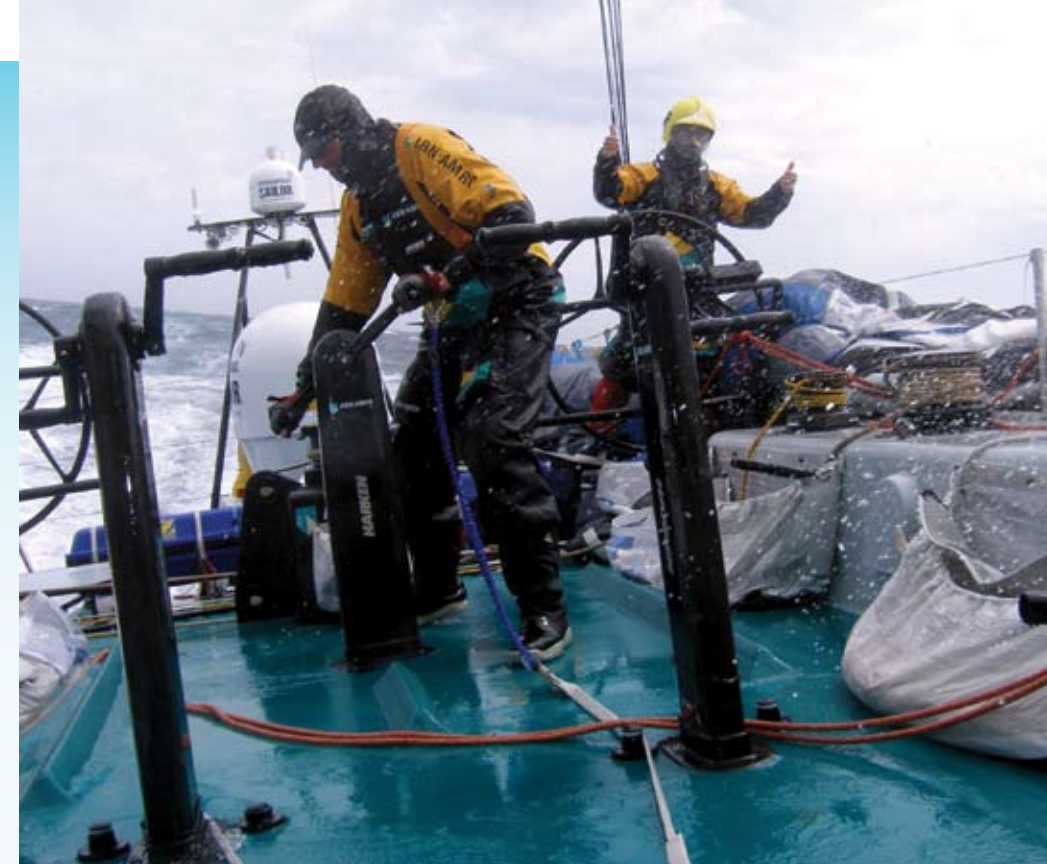
ABN One skipper Mike Sanderson, right, inspects his office. A short tether enables him to hook to a soft padeye in the hub of the wheel, preventing him from losing his grip on the wheel when water rushes aft.

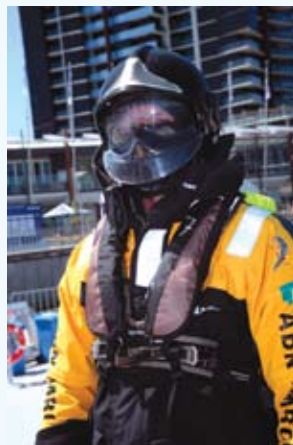
An ABN crewman models the safety gear racers wear offshore.
