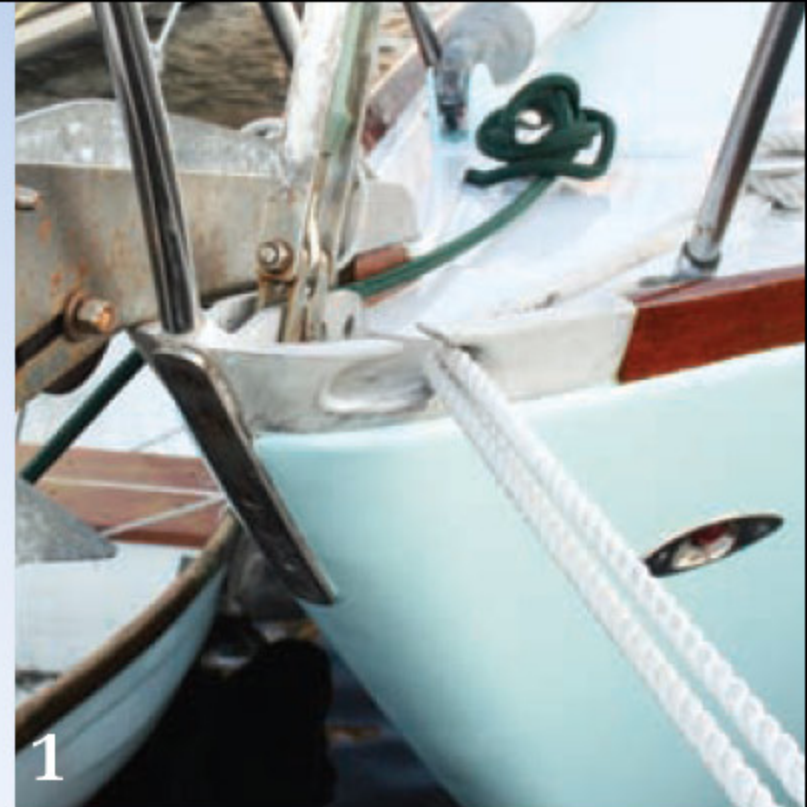
1. A cast aluminum-alloy stemhead fitting and the stylish but nearly invisible port running light;

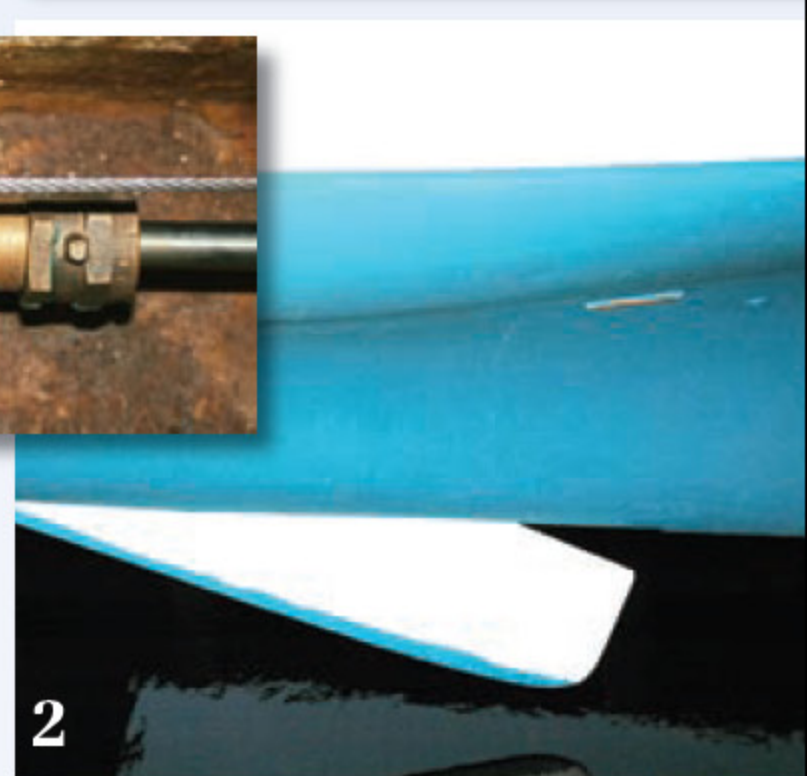
The centerboard is a different story. The lifting setup employs two sheaves (one of which is attached to a mild steel plate beneath the mast), two cables (one of which is continually immersed in water and notoriously prone to corrosion), and a stainless steel shaft (which passes aft through shaft log that is prone to leaking). Morgan 41 owners have come upon perfectly good solutions—one of which involves the simple substitution of Spectra SK75 for the immersed wire rope—but the improvements require the assistance of a professional. Access to the problem sheave is usually delayed until the mast is replaced, so the mast step of any boats which still have the original rig merit close inspection.

2. Centerboard partially lowered with an inset photo of an improved shaft and cable lifting system;

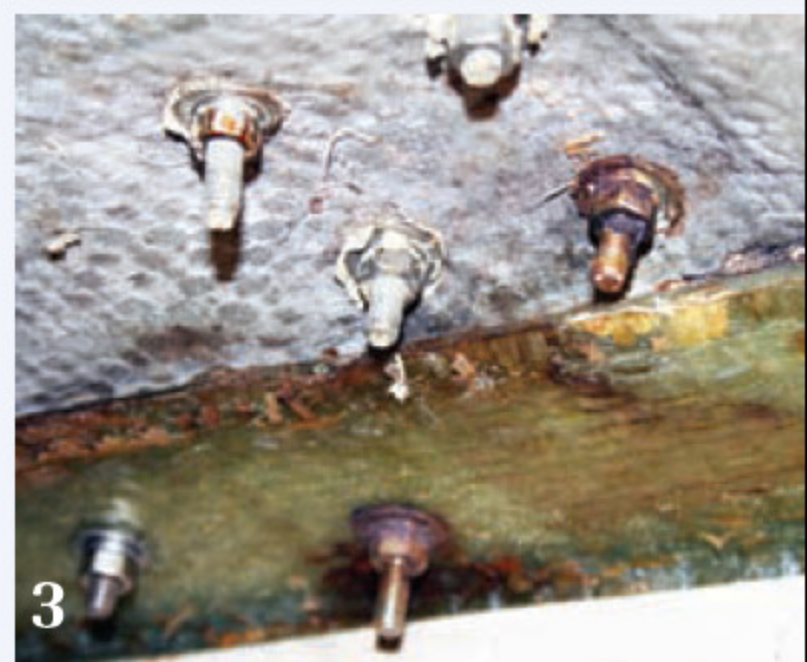
The hull-deck joint is an inward-turning flange with the deck through-bolted at 10-inch centers and bedded in a poly-

urethane sealant. The joint is capped with a teak toe rail, which is screwed in place with self-tapping screws. On the boat we inspected (Hull No. 83), some of the through-bolts showed signs of leaking, but in general, the hull-deck joint appeared in very good shape for a boat of this age. The joint was such a nuisance on one heavily raced boat that it was fiberglassed from the inside—a bear of a job.

3. Hull-deck joint and stanchion fasteners (which could use a backing block) from belowdeck.
