What Does *Doomsday* Say?

Fuzz, neck, and pull tests tell us what to expect from a cleat after a season or so of use.

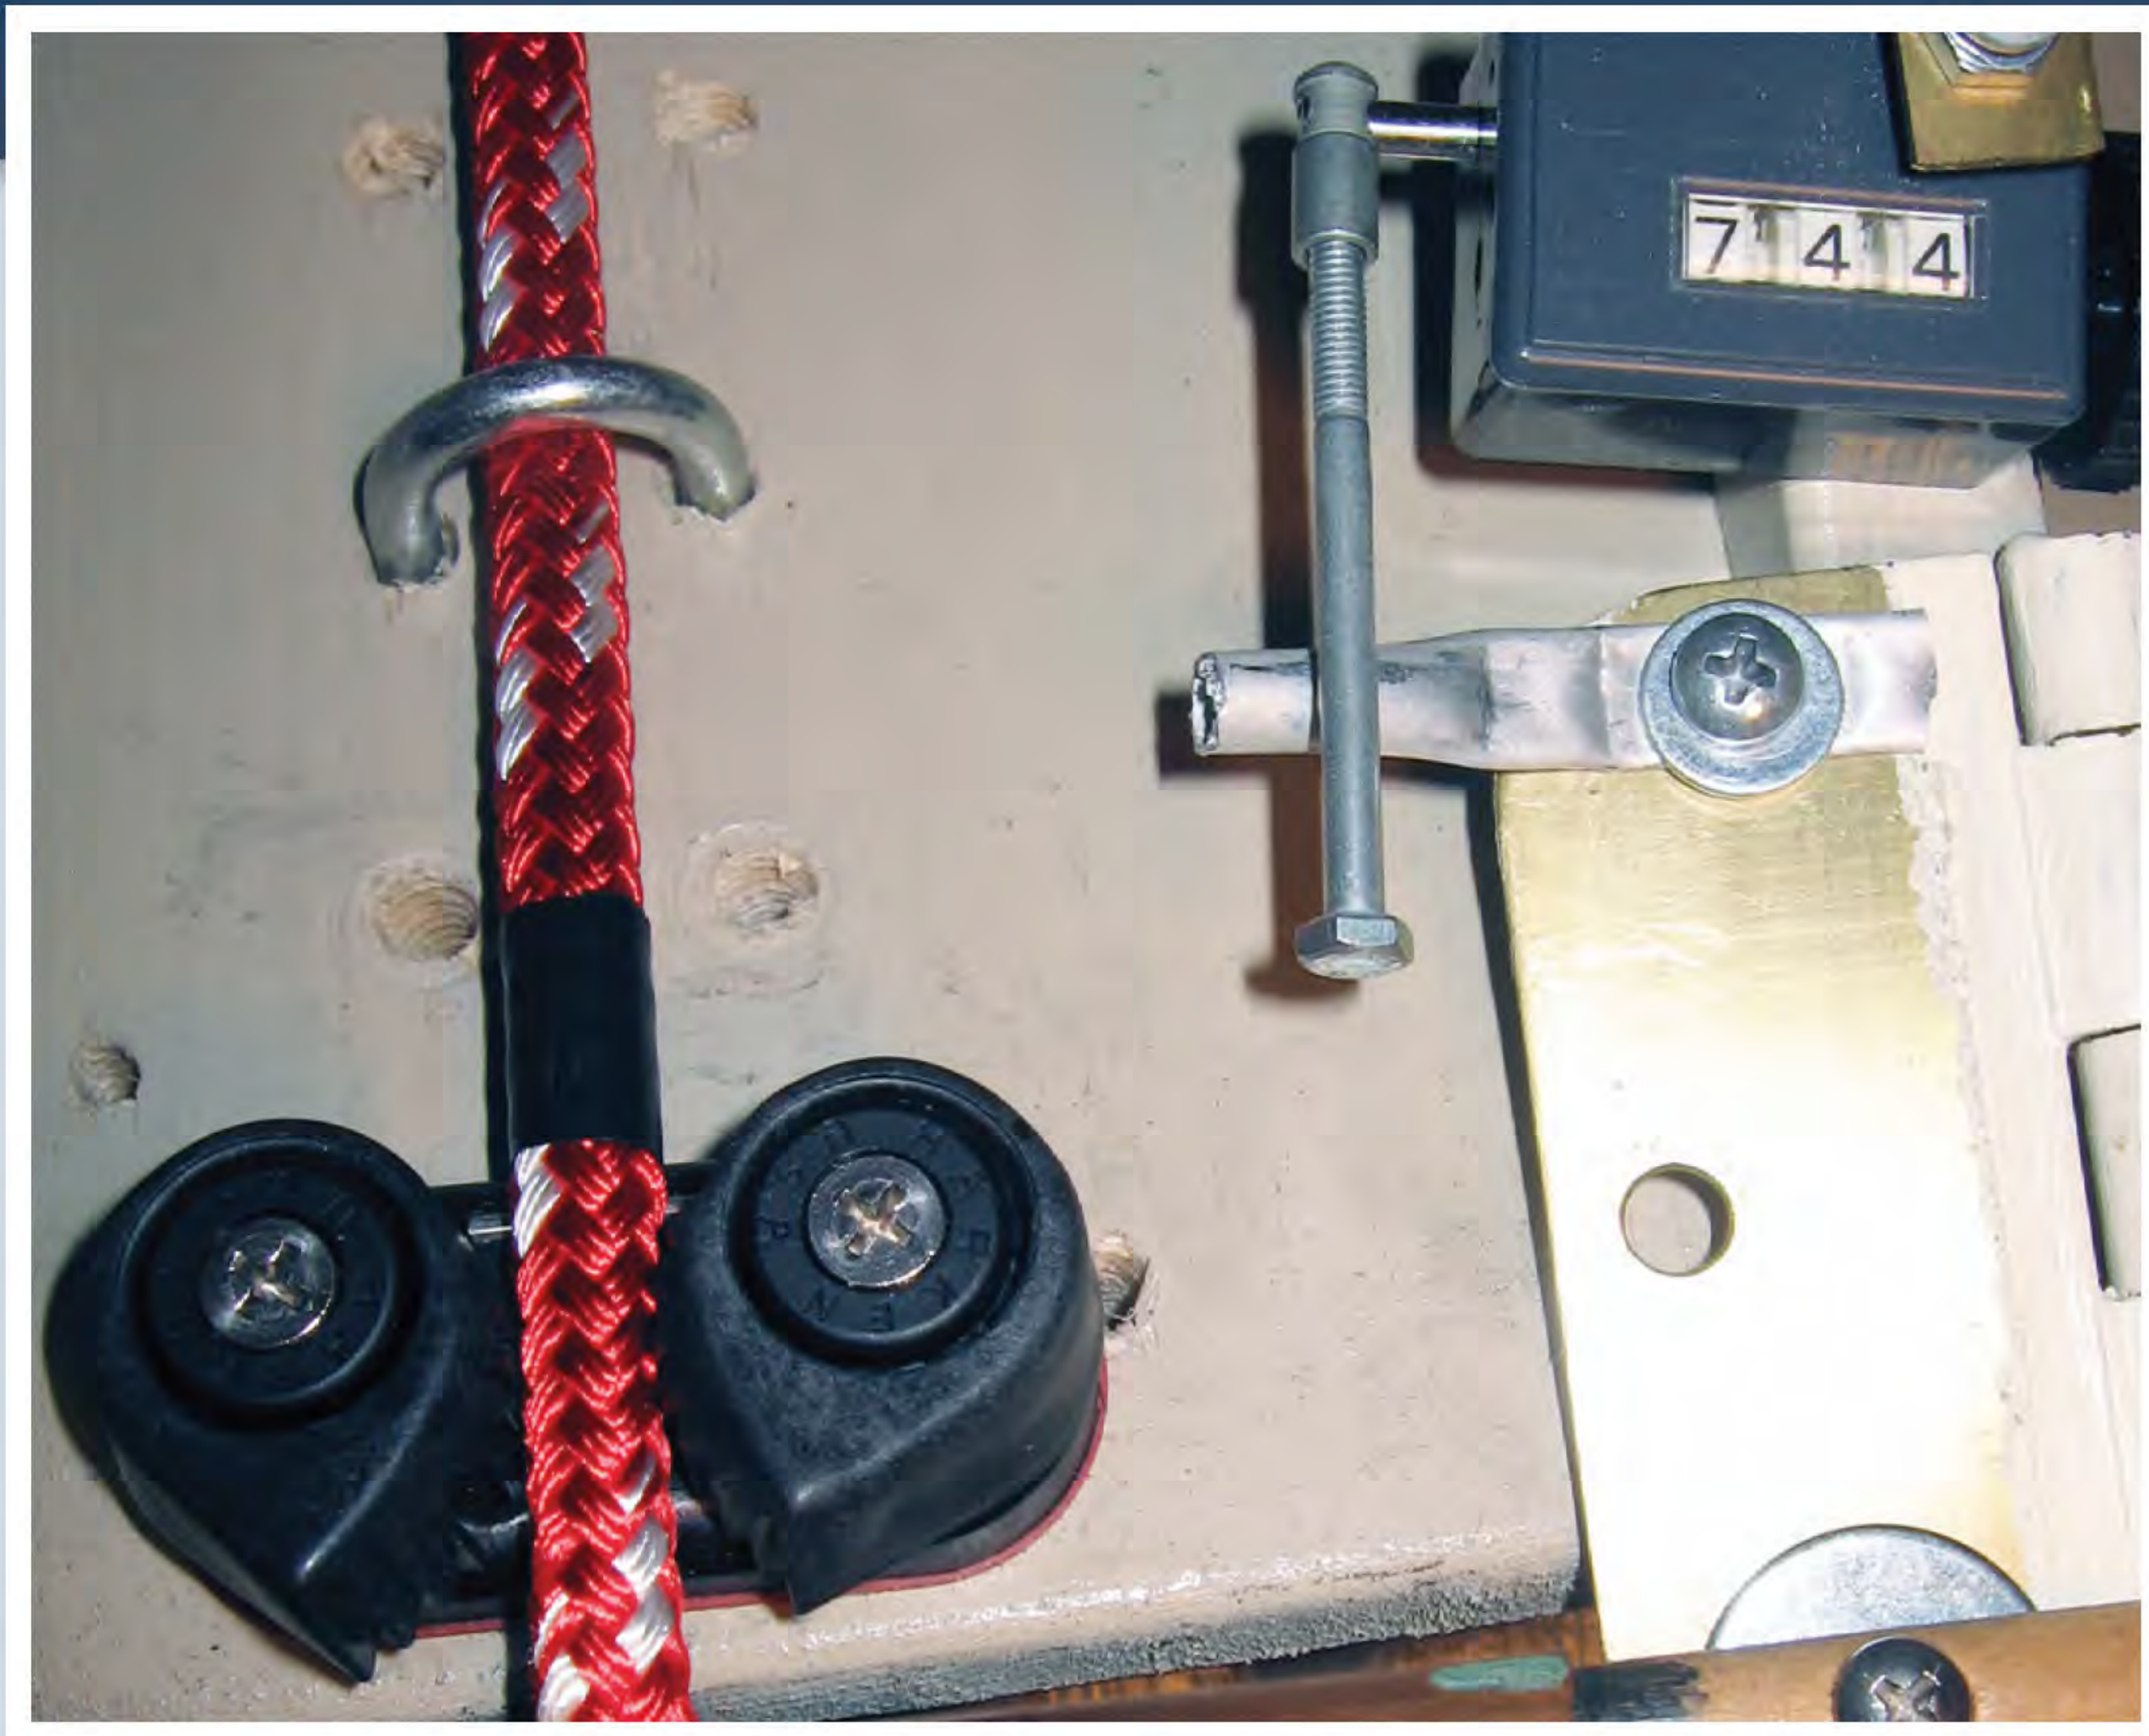
Testers ran each cam cleat through 1,000 cycles of loading and pulling with 3/8-inch Sta-set from New England Ropes.
.....

Essentially, the machine pulls the line over the cam cleat and, as the wheel rotates, pulls it down into the cleat and a short way through it. (See photo page 16.) A bungee provides the load for the machine to pull against. After a brief pause while the bungee attempts to pull the line back, the machine trips the line out of the cleat. This is where the machine's geometry failed us a little: The line then drags back over the top of the cleat until the cycle starts again. However, the part of the line we were interested in—the length that pulls through the cams and

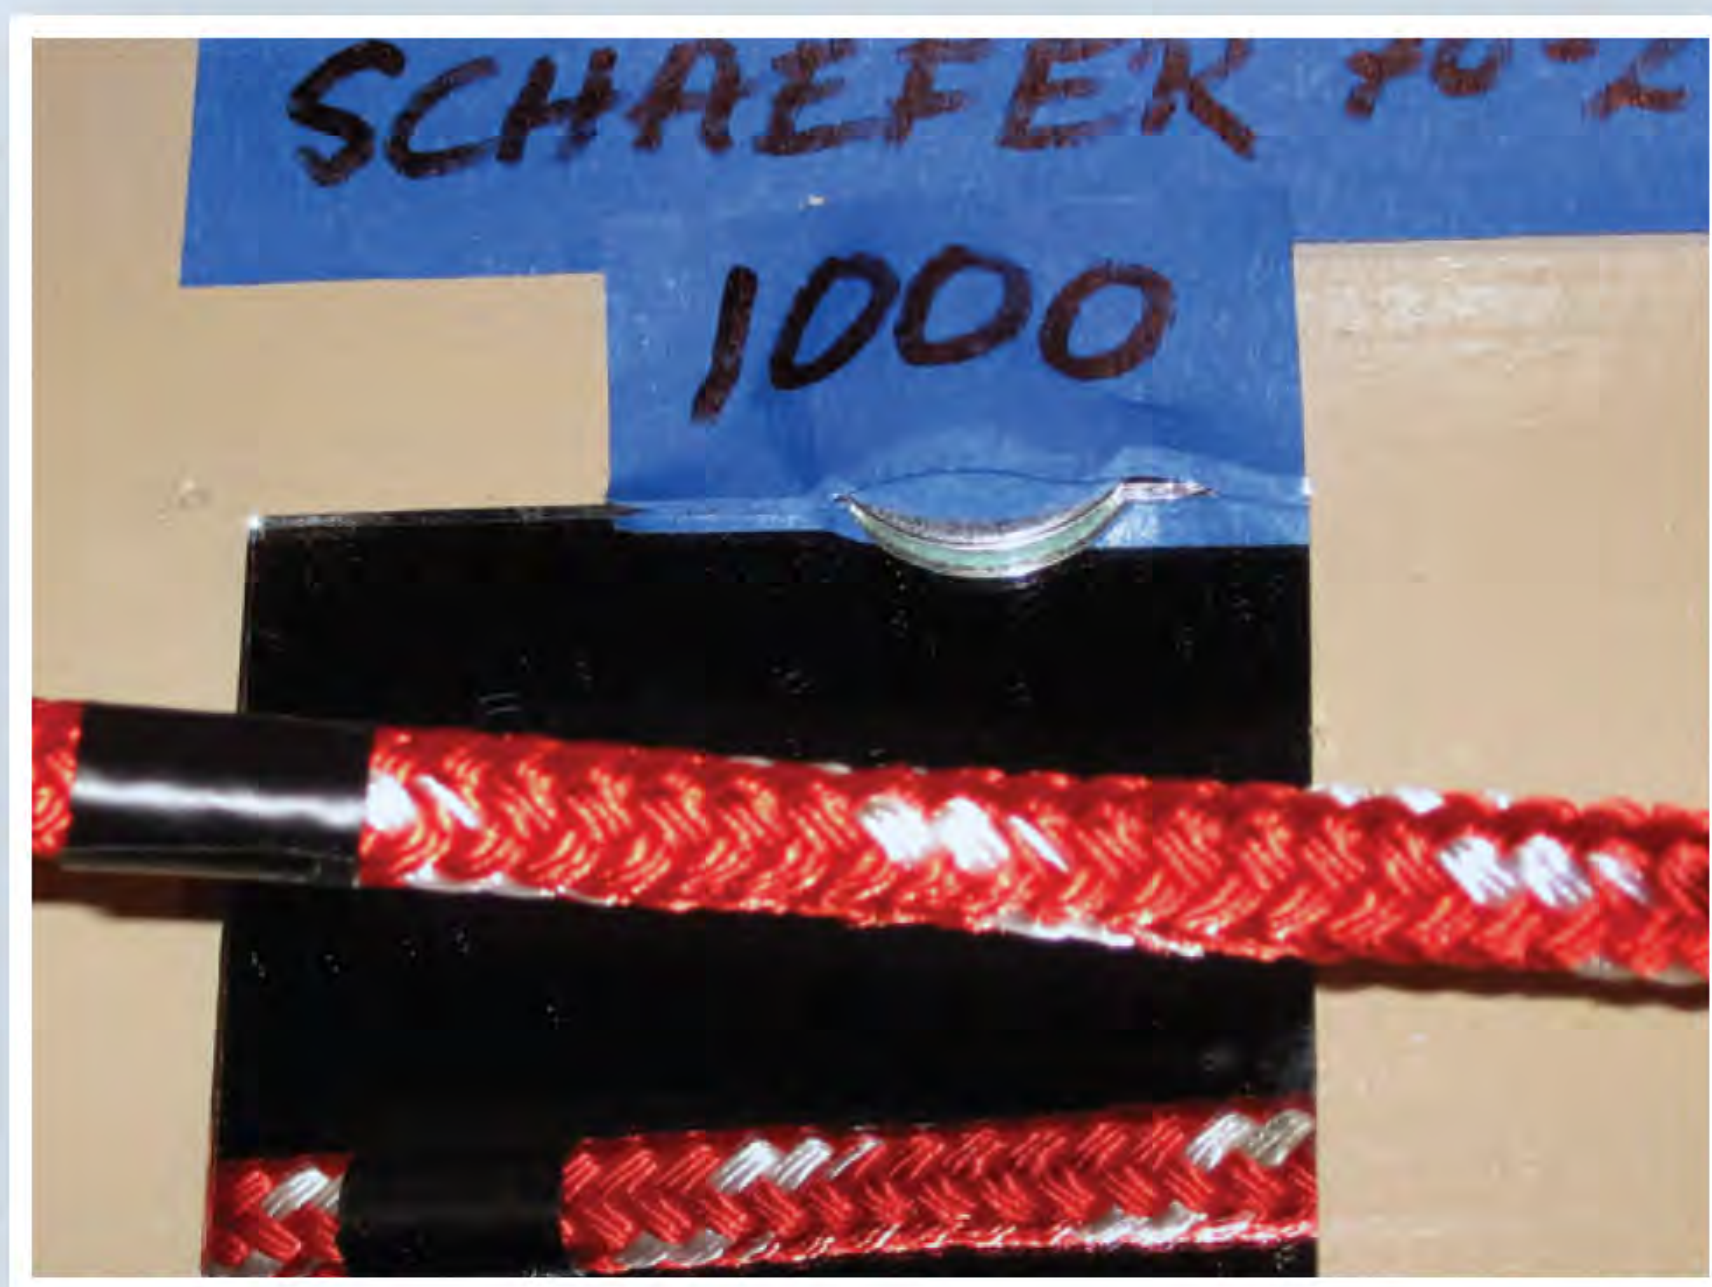
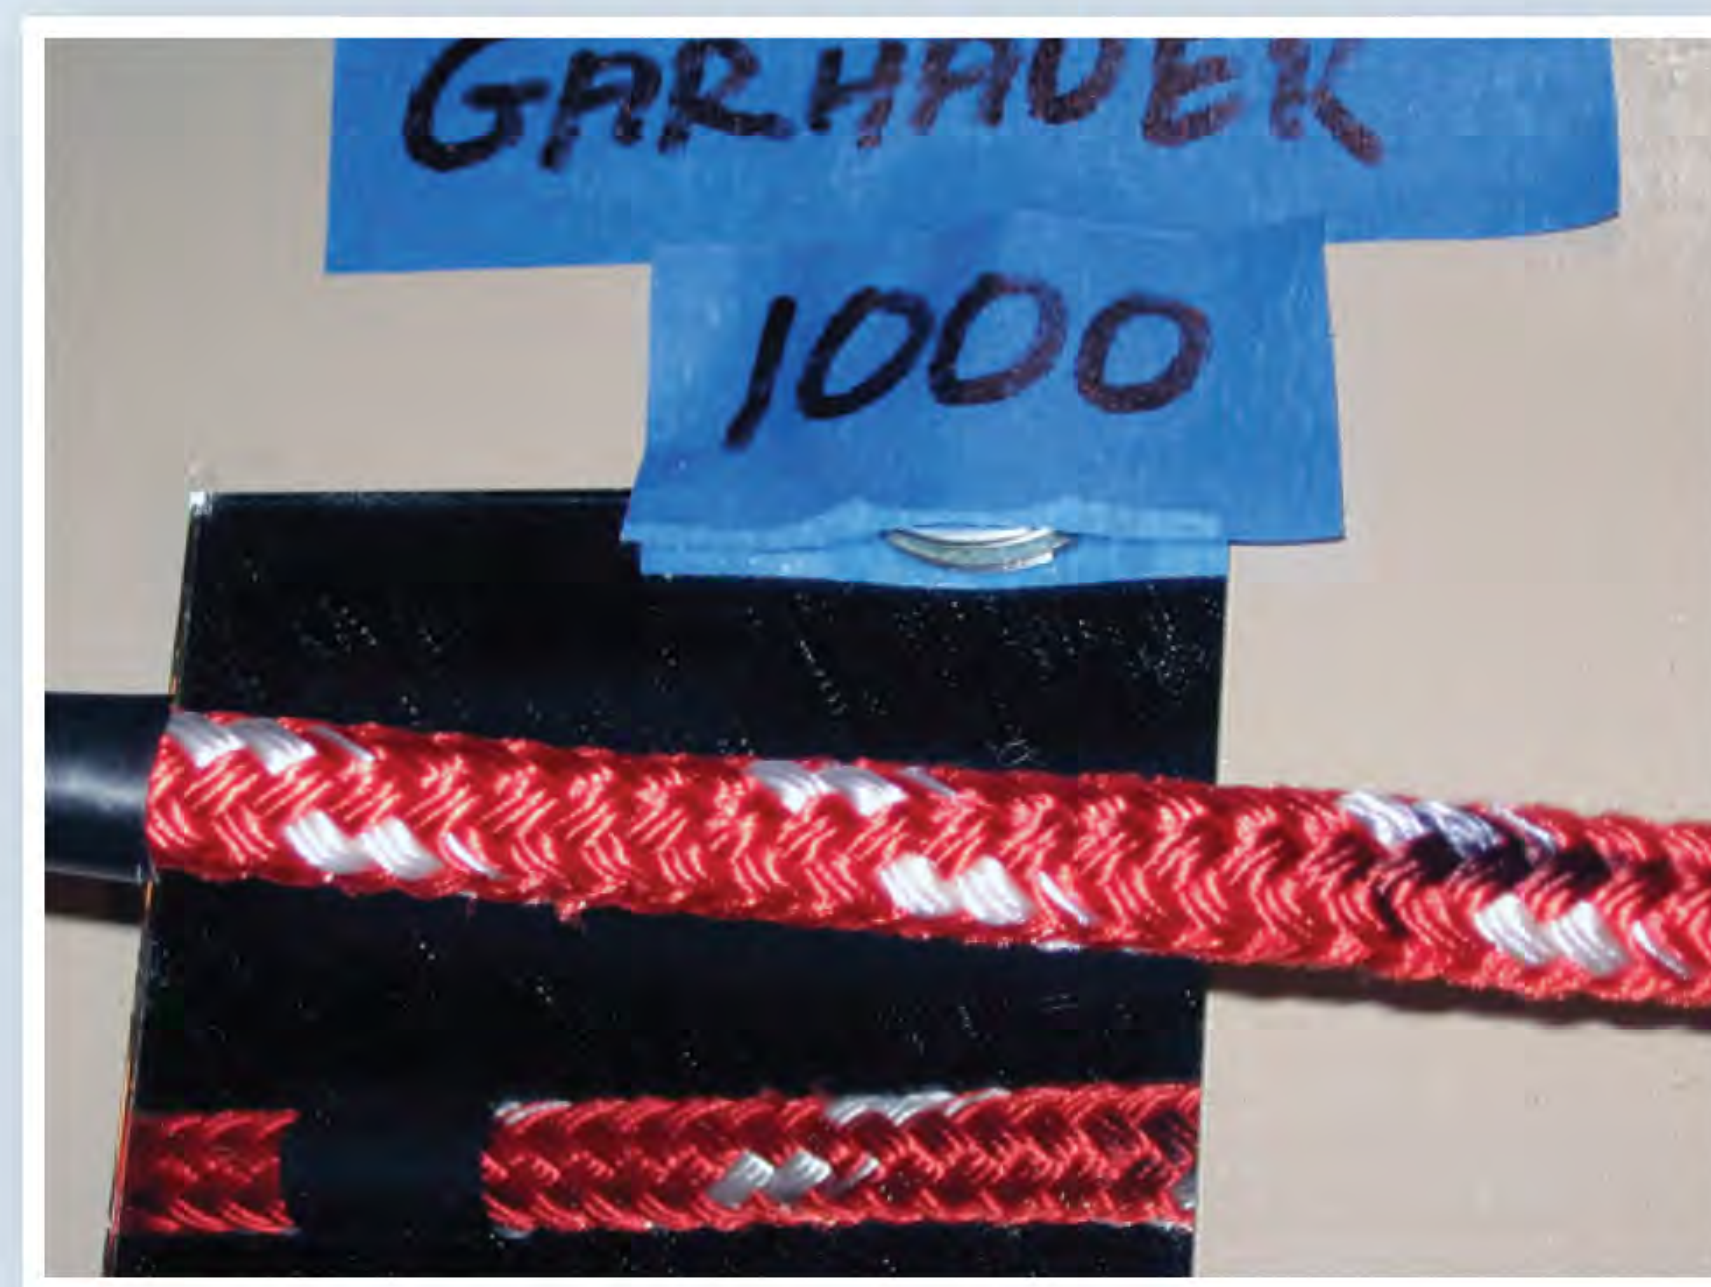
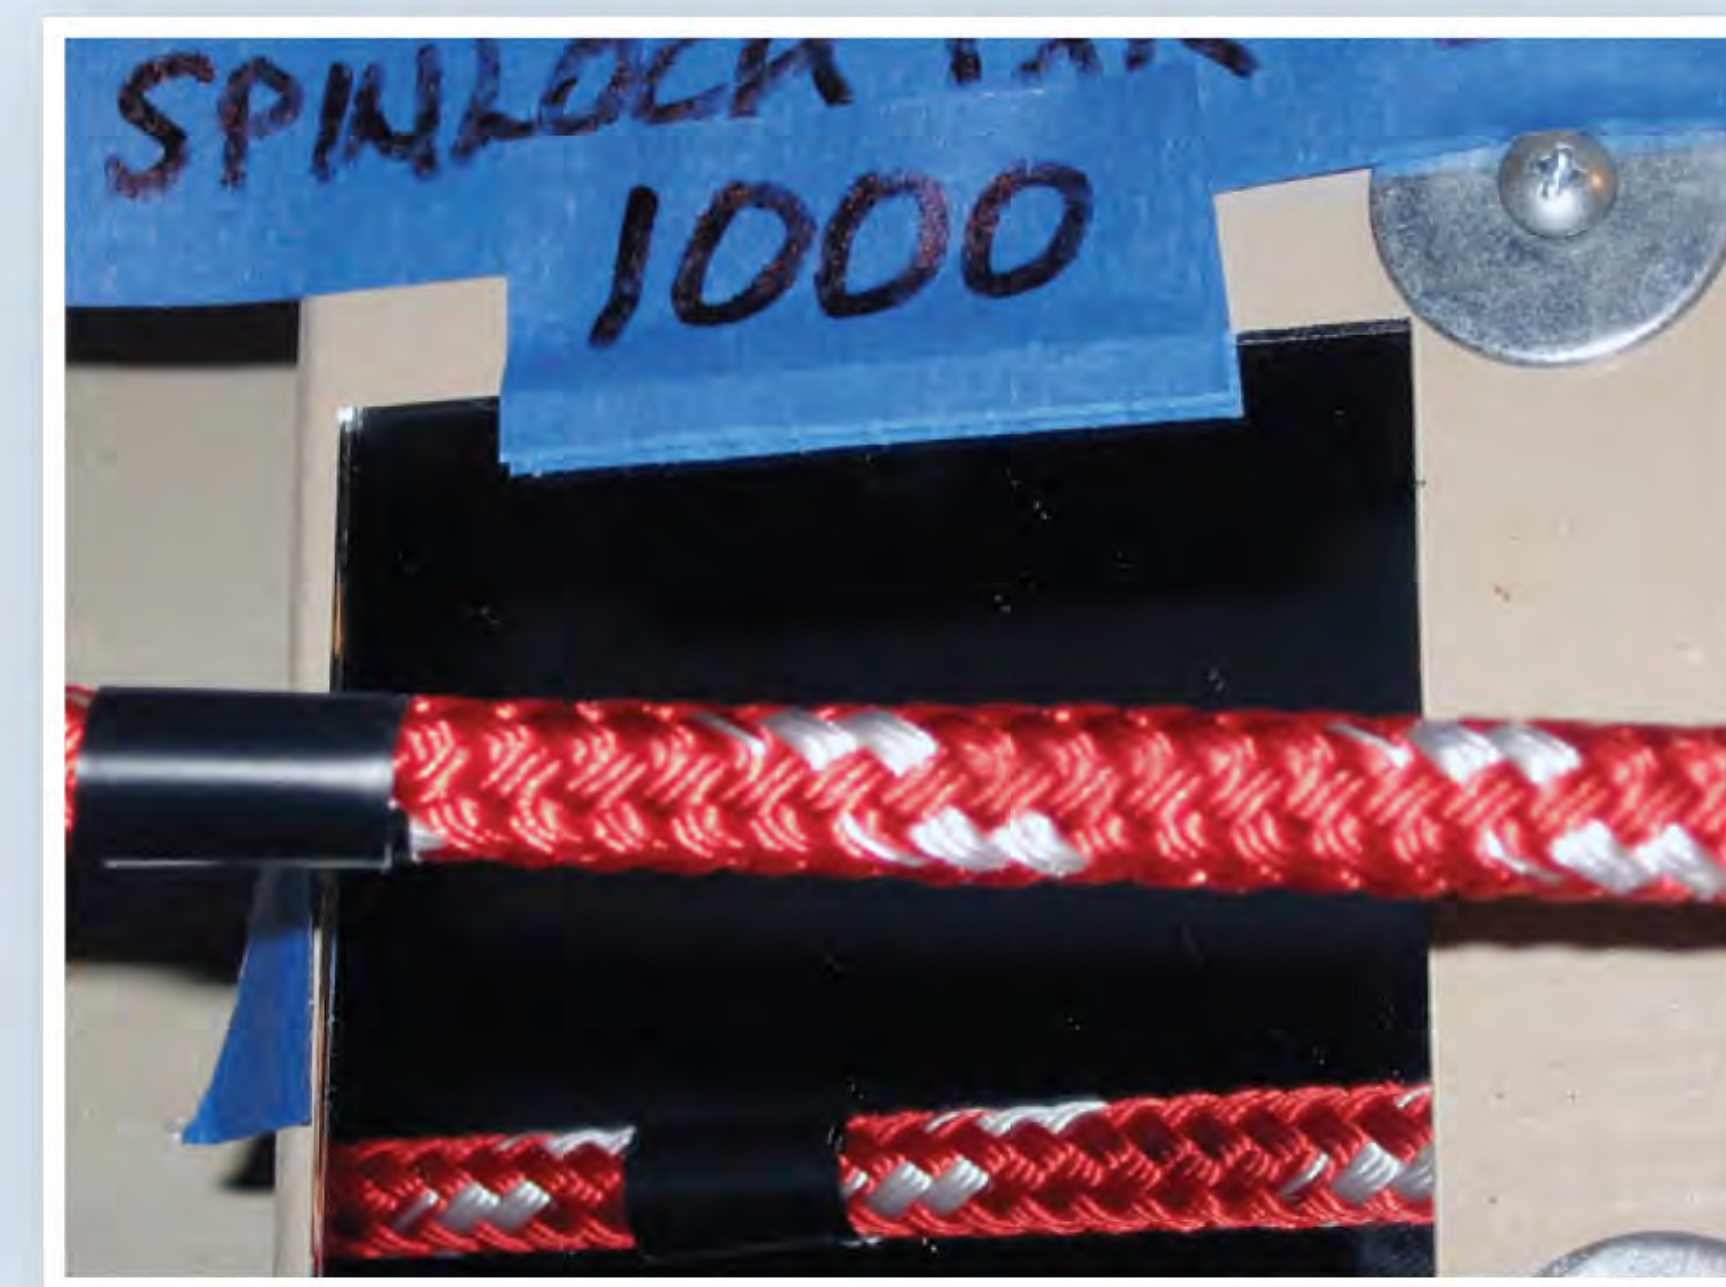
The neck is just ahead of the tape, and the fuzz is an inch or so ahead of the neck. The dark color on the underside of the line is in most cases from the trip bar. The dark mark on the top of the line is the point where the line pulls down into the cams.

Some testers suspected that the neck might be a result of the radius of curvature of the cams, but results didn't bear that out. In real life, it's unlikely you'd have the cam cleat repeatedly gripping the same exact spot in the line anyway. Testers found a correlation between a pronounced neck and pronounced fuzz with only two of the test products, the Seldén 201 (composite) and the Garhauer (aluminum).

The fuzz we were interested in appeared on the sides of the line just ahead of the neck, in the region where the line was pulled down into the cam cleat and through it a short distance. This is where the line would likely suffer wear in real-world use—where the cams pinch it as it's pulled and released.
