## A CLOSER LOOK

**T**ube, connector, and wiring details revealed some of the more obvious differences in the construction quality of the refrigeration units we tested.

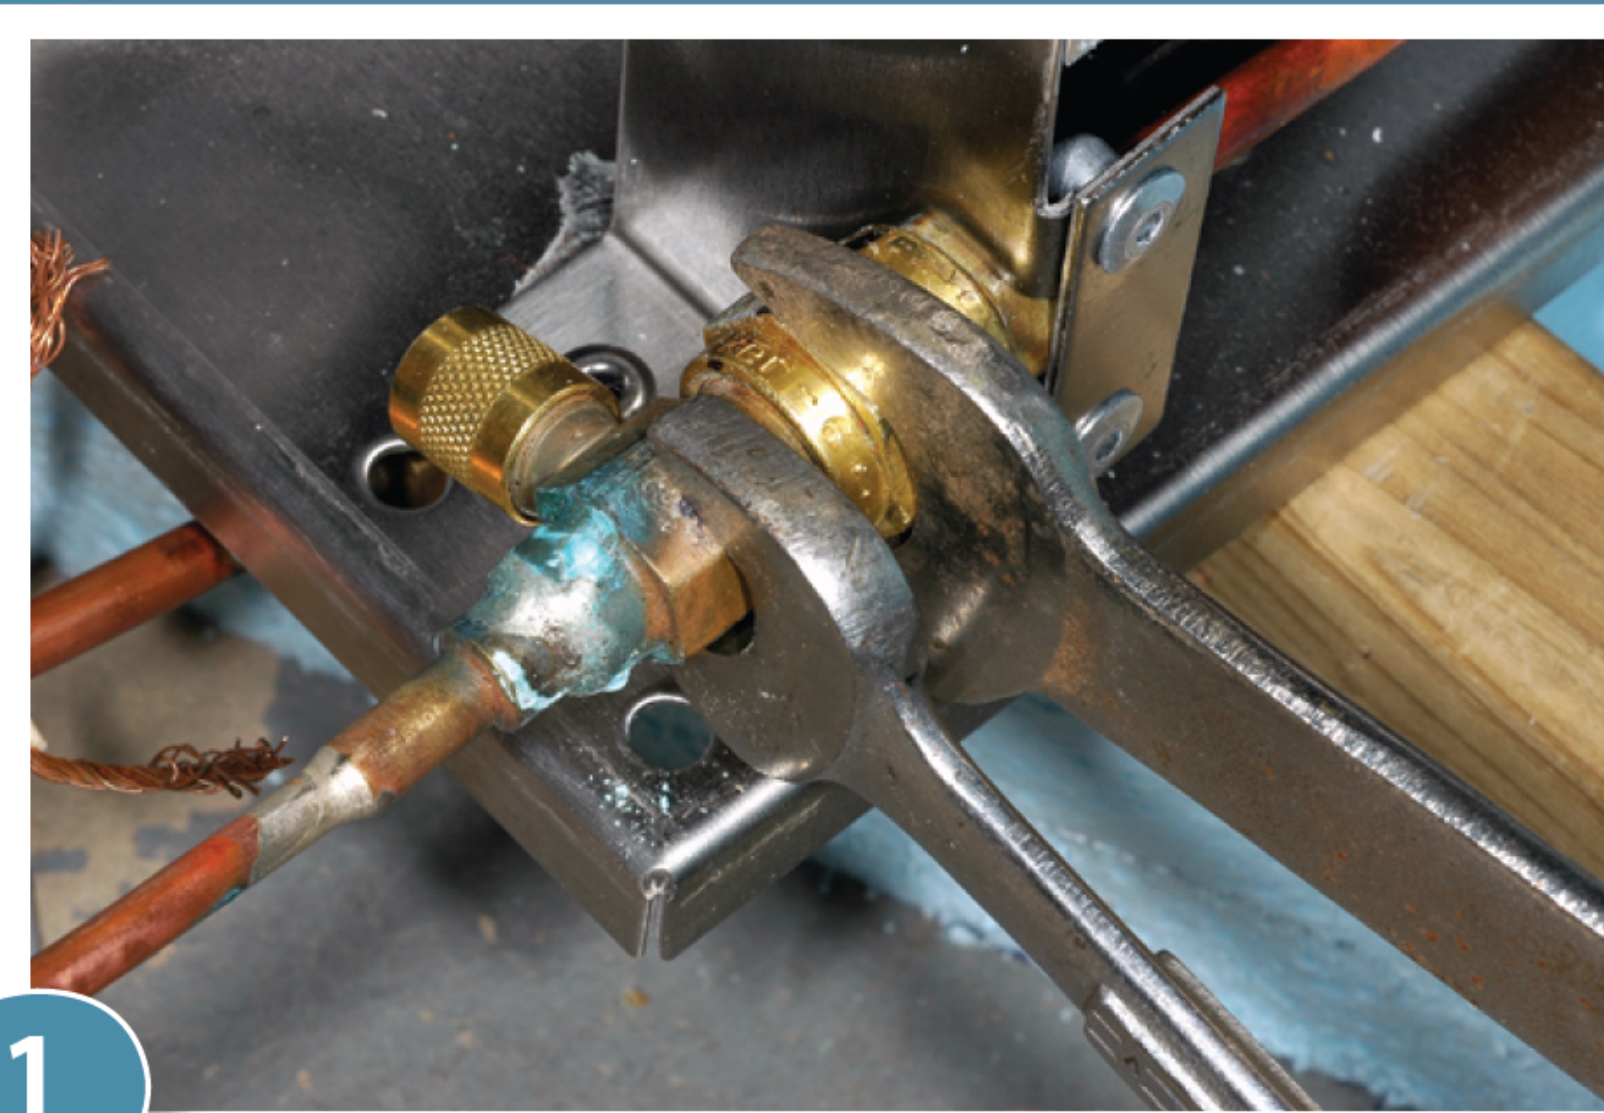
1

**1.** Soldered unions on the Adler Barbour showed signs of corrosion and, once installed, could not be removed without refrigerant replacement.

*Adler Barbour CU-100*

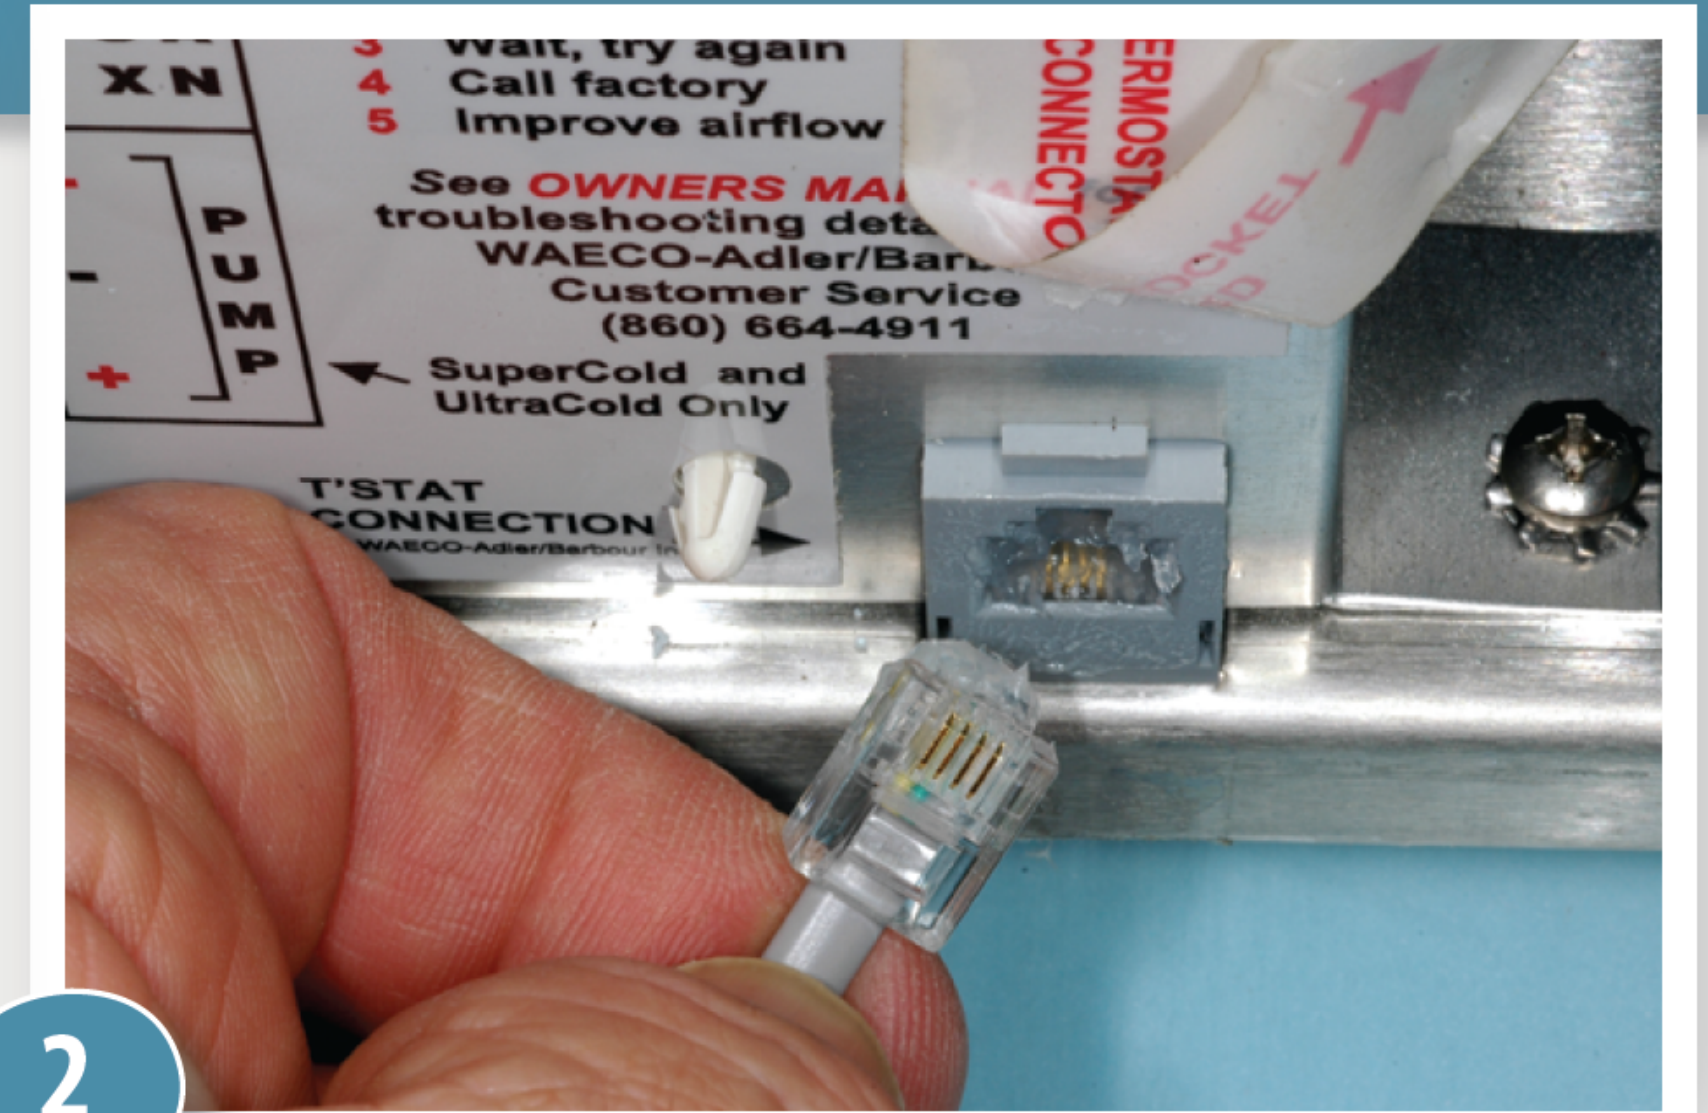
2

**2.** The Adler Barbour uses the undesirable RJ-11-type plug to connect the thermostat to the control unit.

*Adler Barbour CU-100*

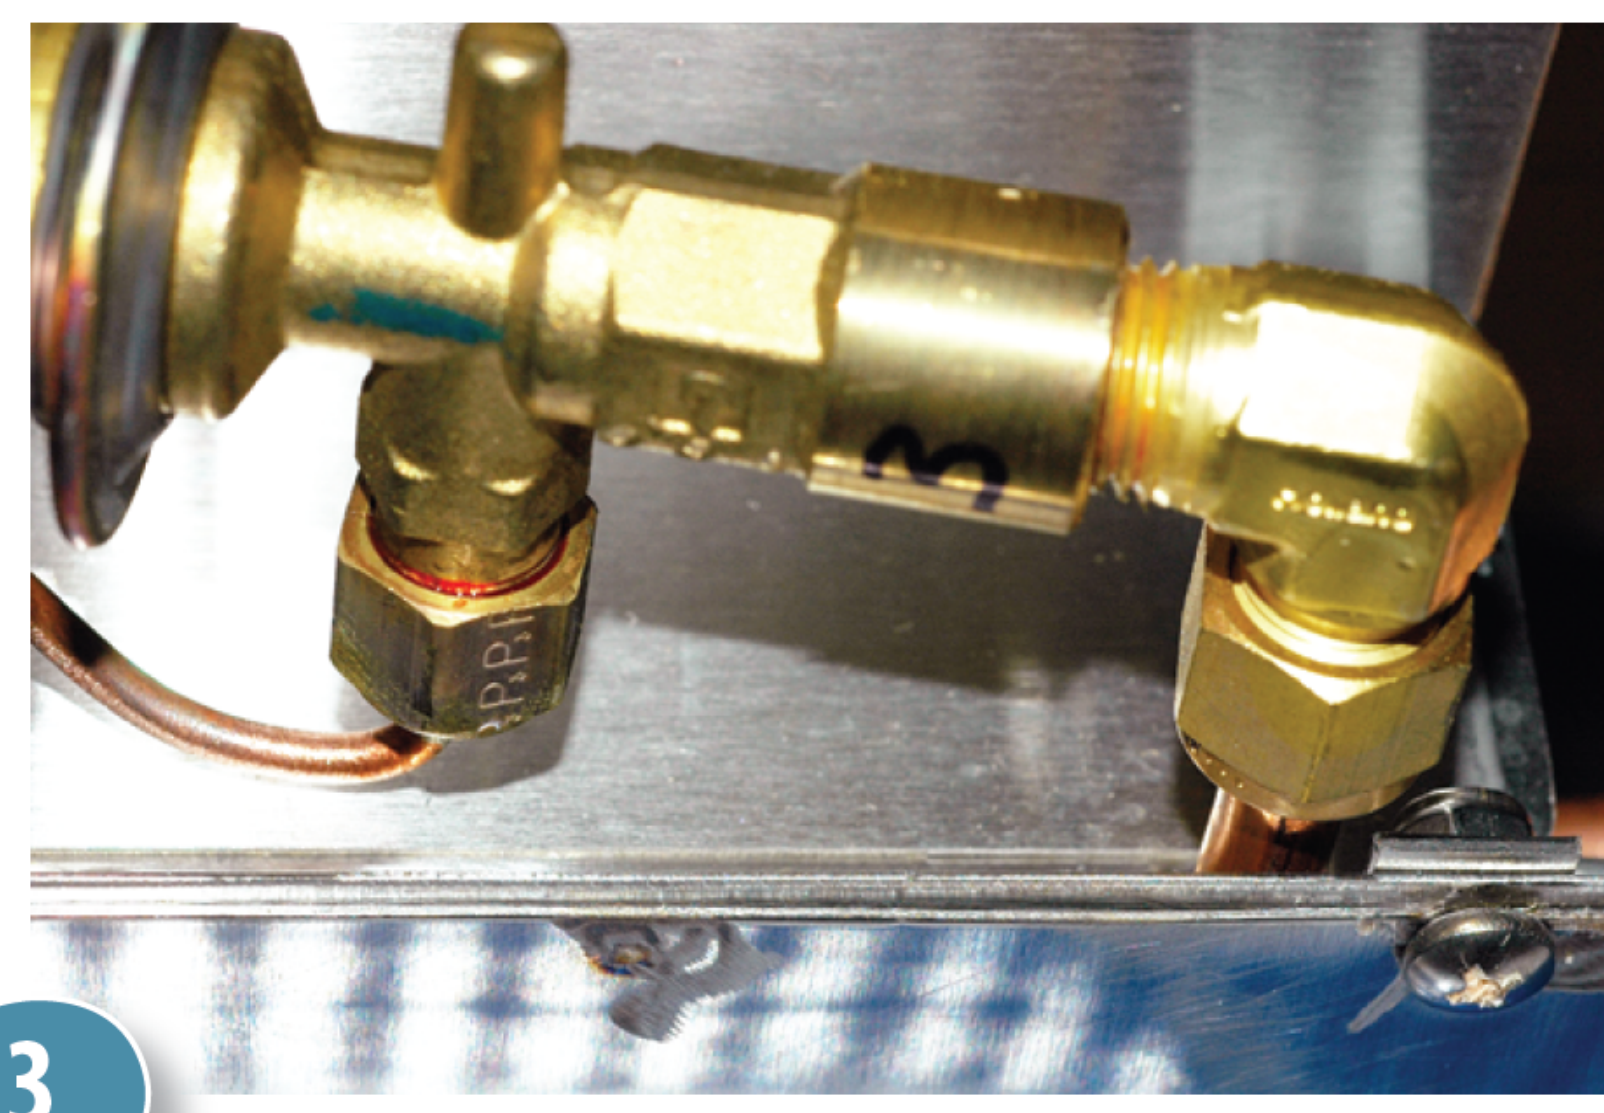
3

**3.** The Sea Frost system uses an expansion valve to meter the pressure of the liquid refrigerant entering the evaporator plate.

*Sea Frost BD*

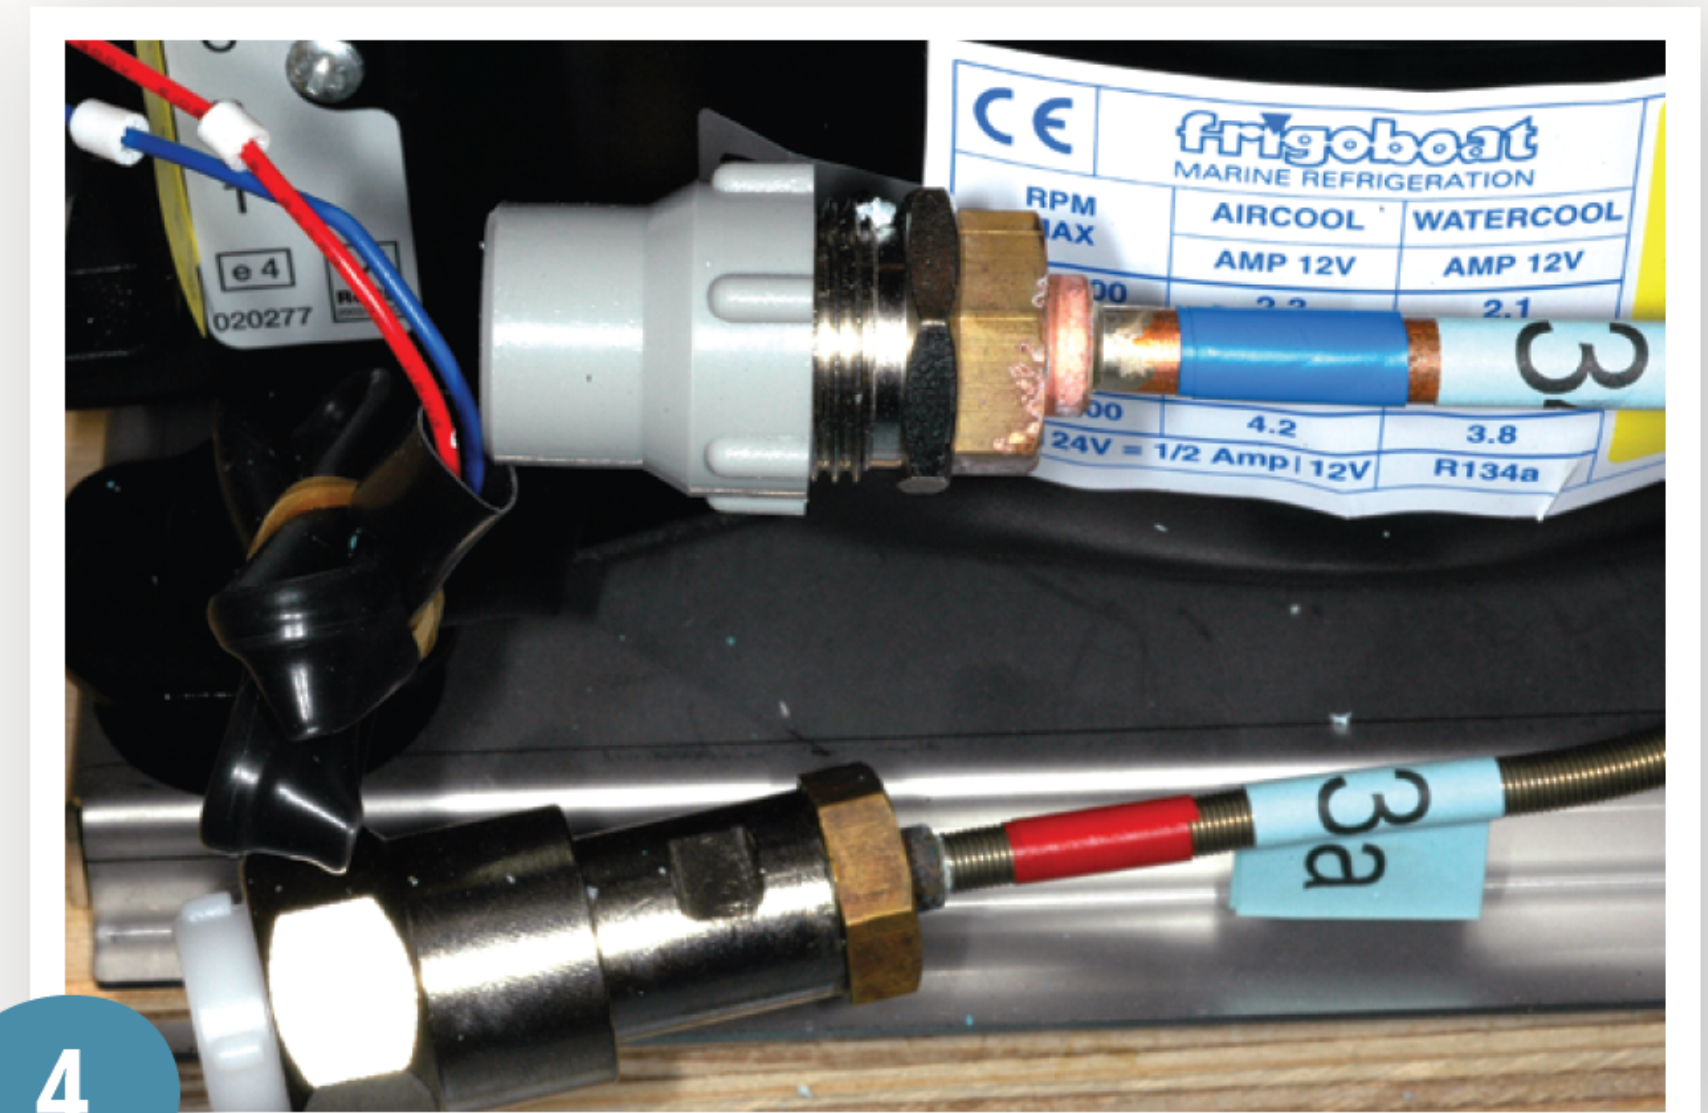
4

**4.** The well-made unions on the Frigoboat system could be taken apart without requiring a complete recharge.

*Frigoboat Capri 35F*
