FENDER TORTURE

ABRASION TEST RESULTS

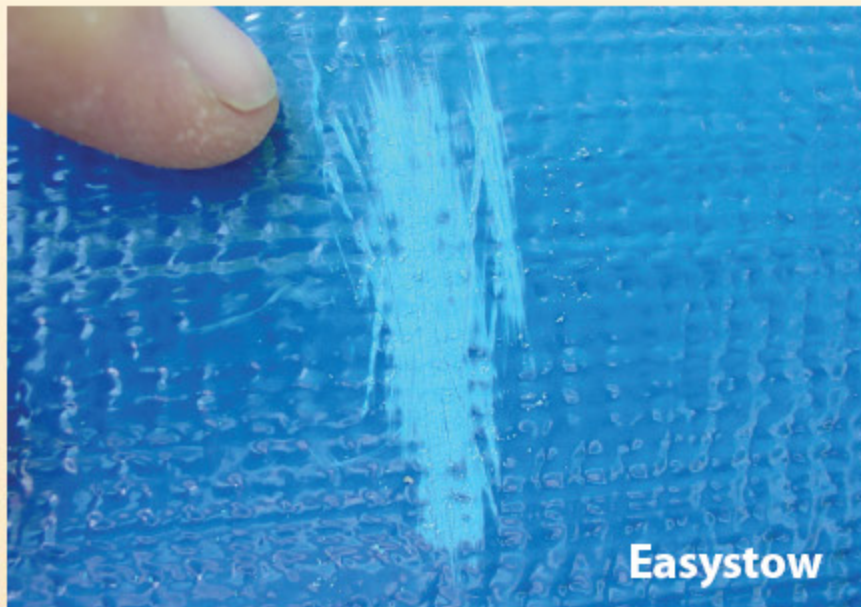
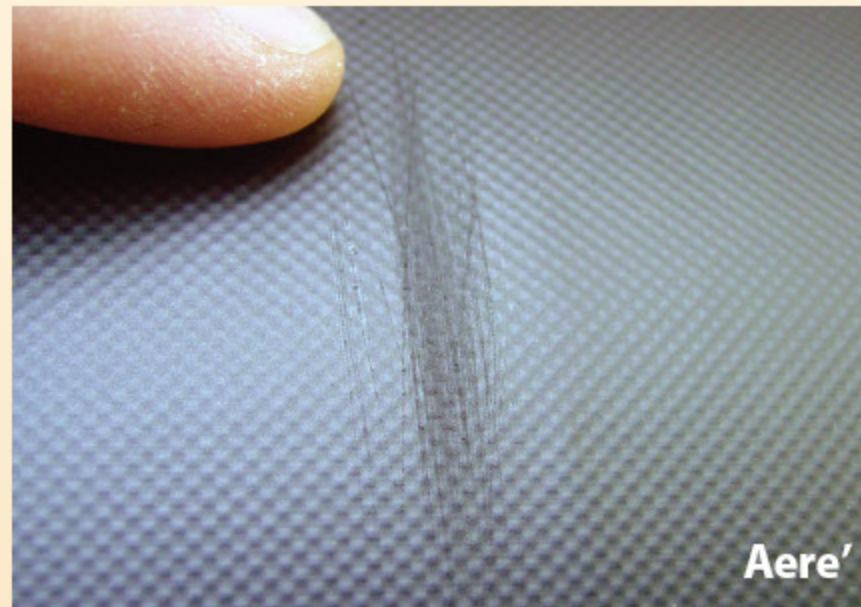
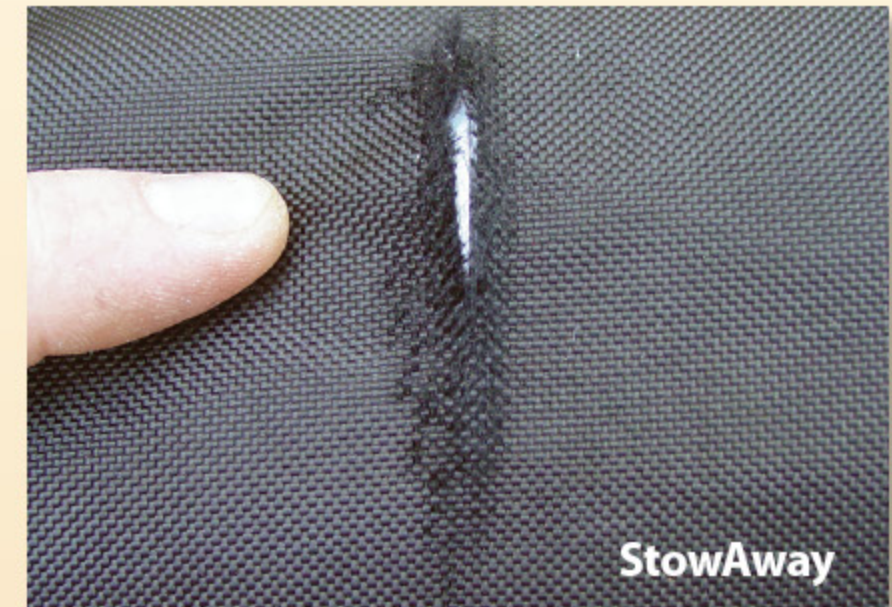
Testers used a rasp to evaluate the fenders' abrasion resistance. The Easystow showed minimal damage with just a few scratches on the cover, while the Aere' fender had little to no damage. The StowAway's nylon cover, however, wore all the way through to the bladder, proving it to be the least resistant to abrasion.

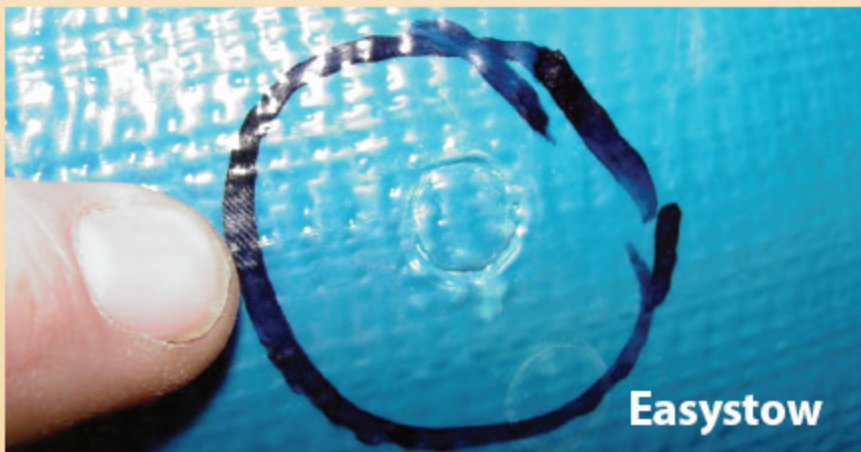
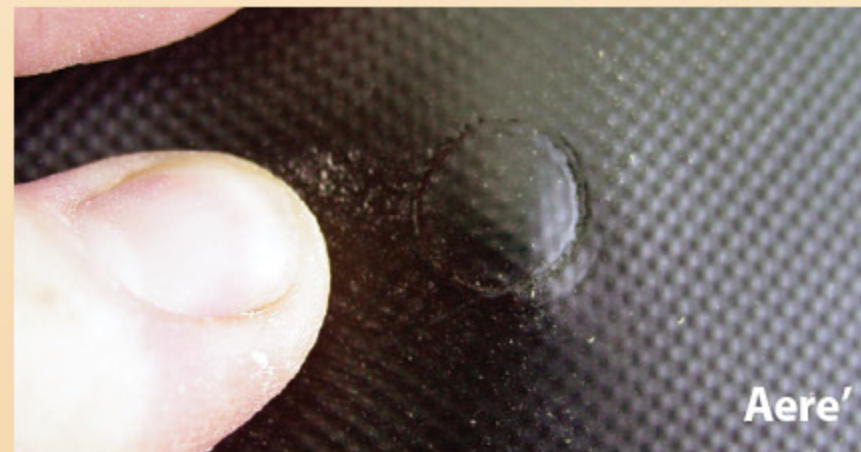
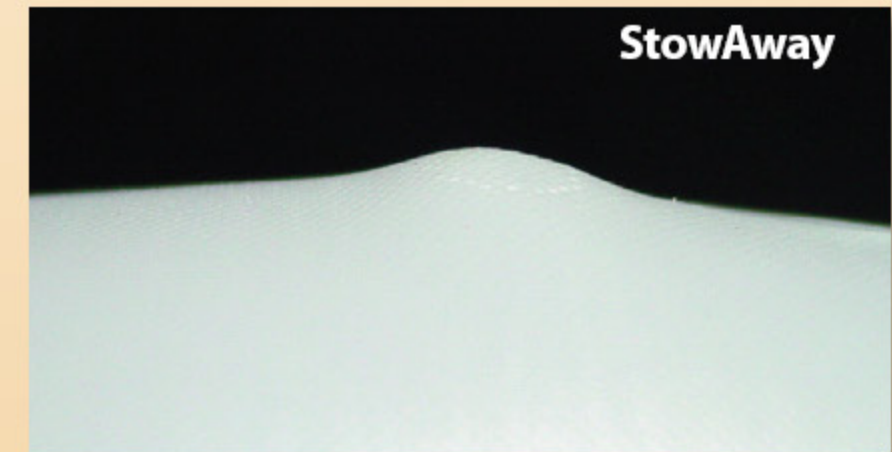
PUNCTURE RESISTANCE TEST RESULTS

Crushing the fender between a loaded compression plank and a board with a bolt and screw mounted to it enabled testers to determine each fender bladder's resistance to punctures and point loading. The Easystow fender suffered some minor surface damage from the bolt, but structurally, it was still sound with no inner bladder damage. The Aere' showed a noticeable indentation where the hardware had been, but no significant damage to the bladder. The StowAway skin showed no cuts or scratches, but the actual bladder was deformed. A small lump formed where the material had been compressed.
