SAFETY

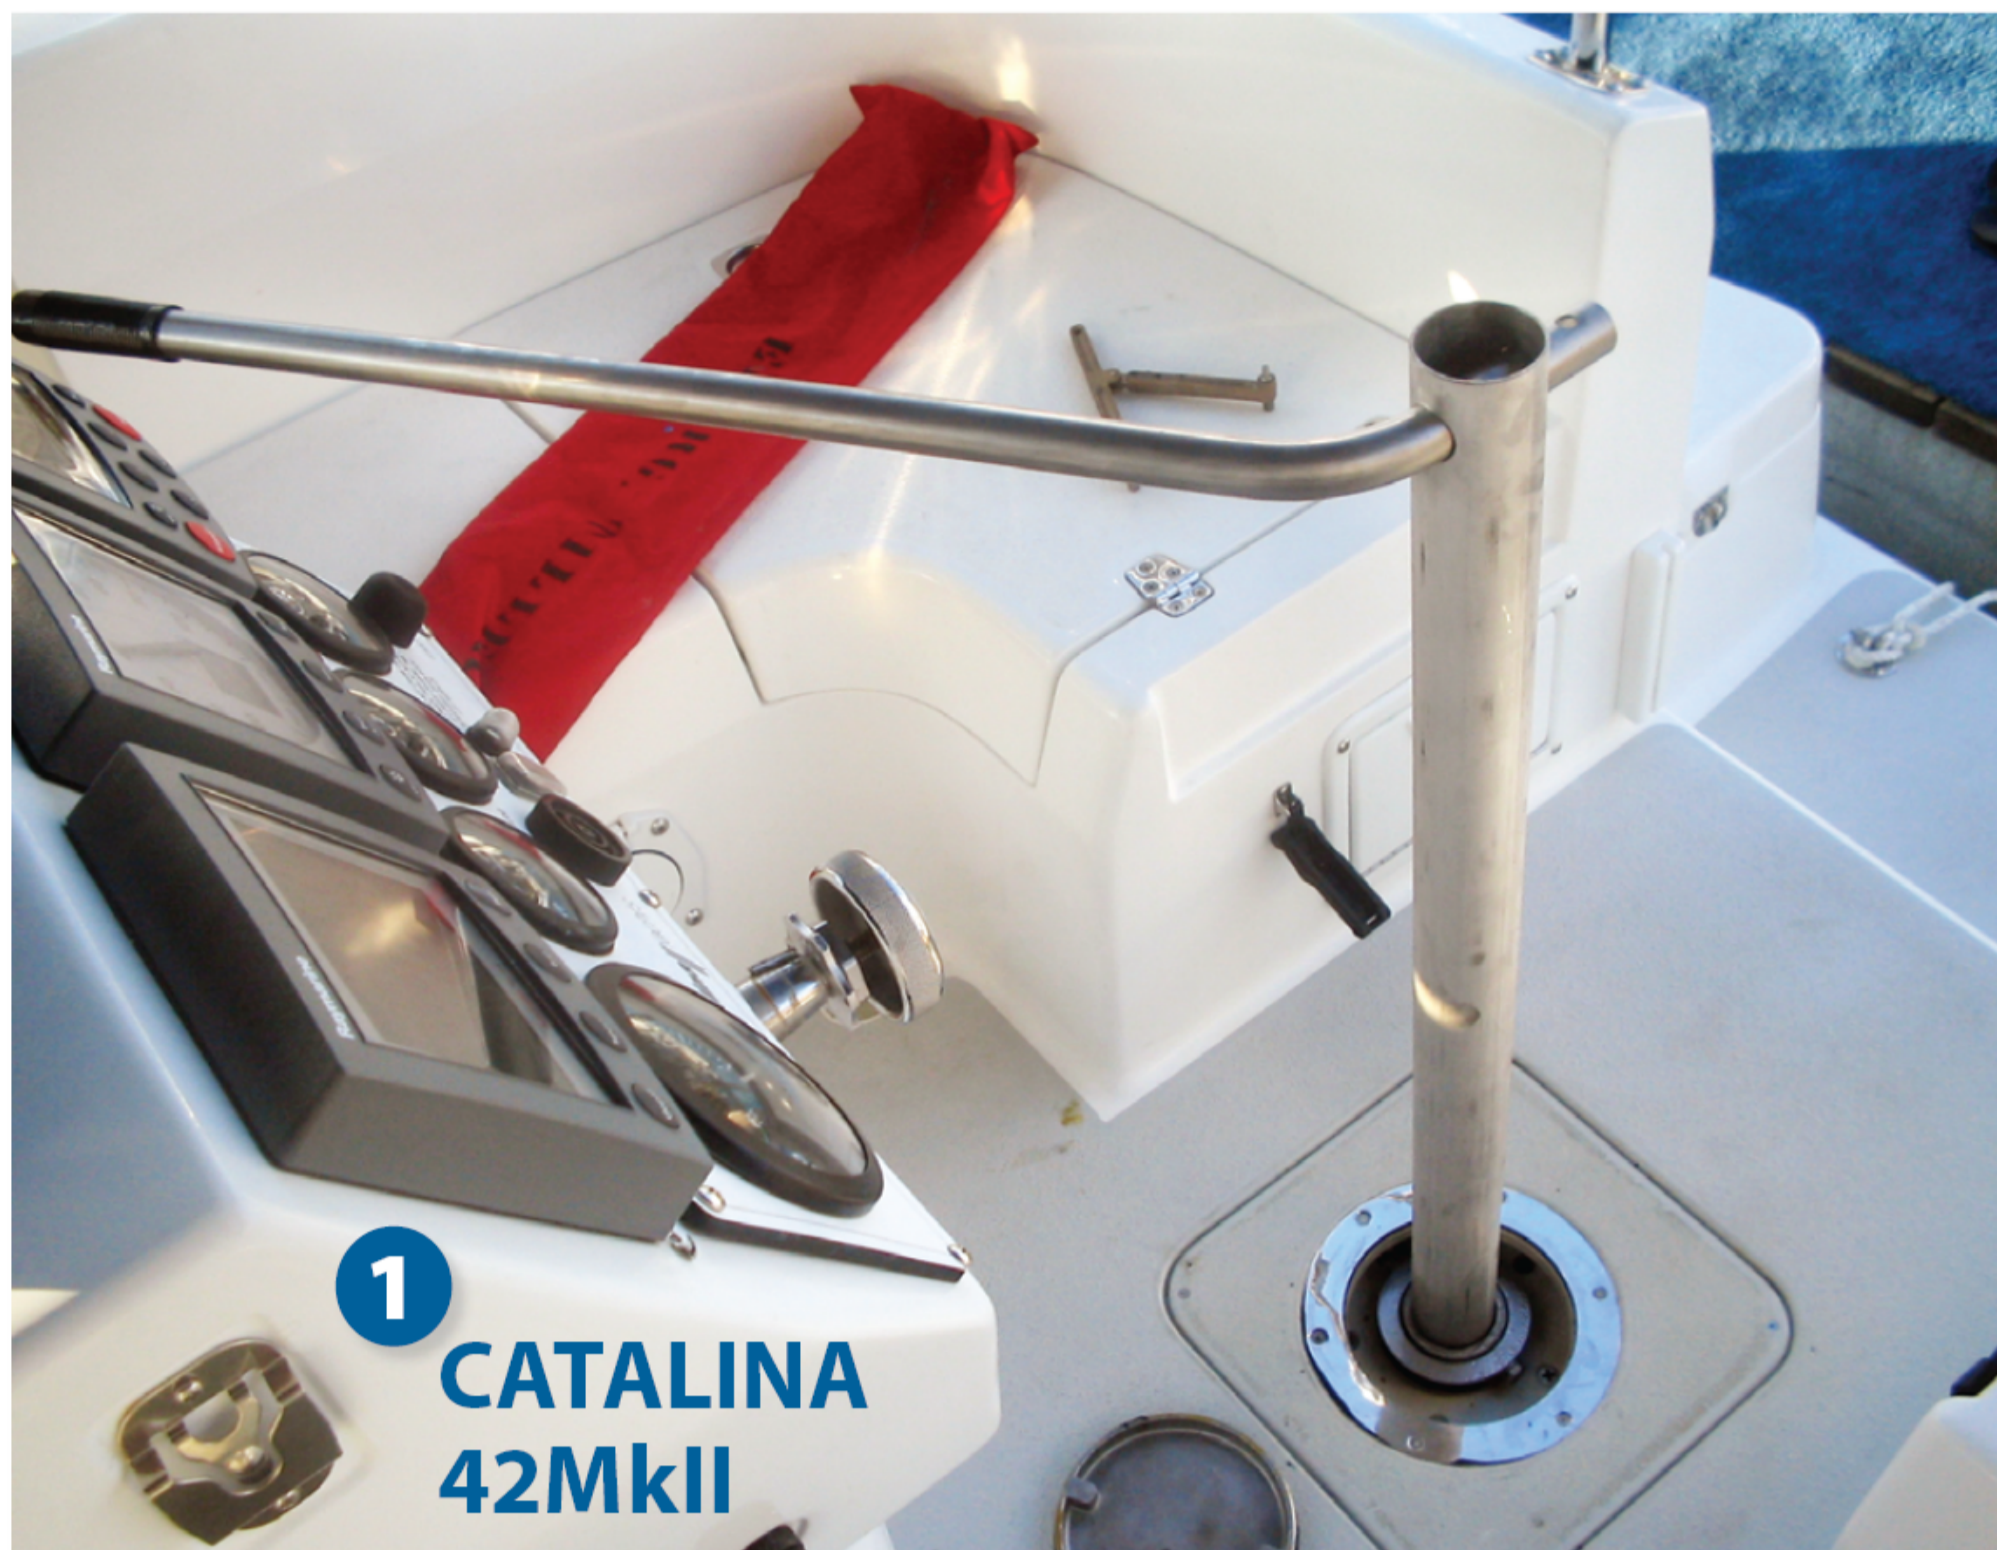
1 **Catalina 42MkII:** The red bag contains deck key and tiller, but gravitates toward the bilge. Corrosion could seize the deck plate. Tiller's arm diameter is small.

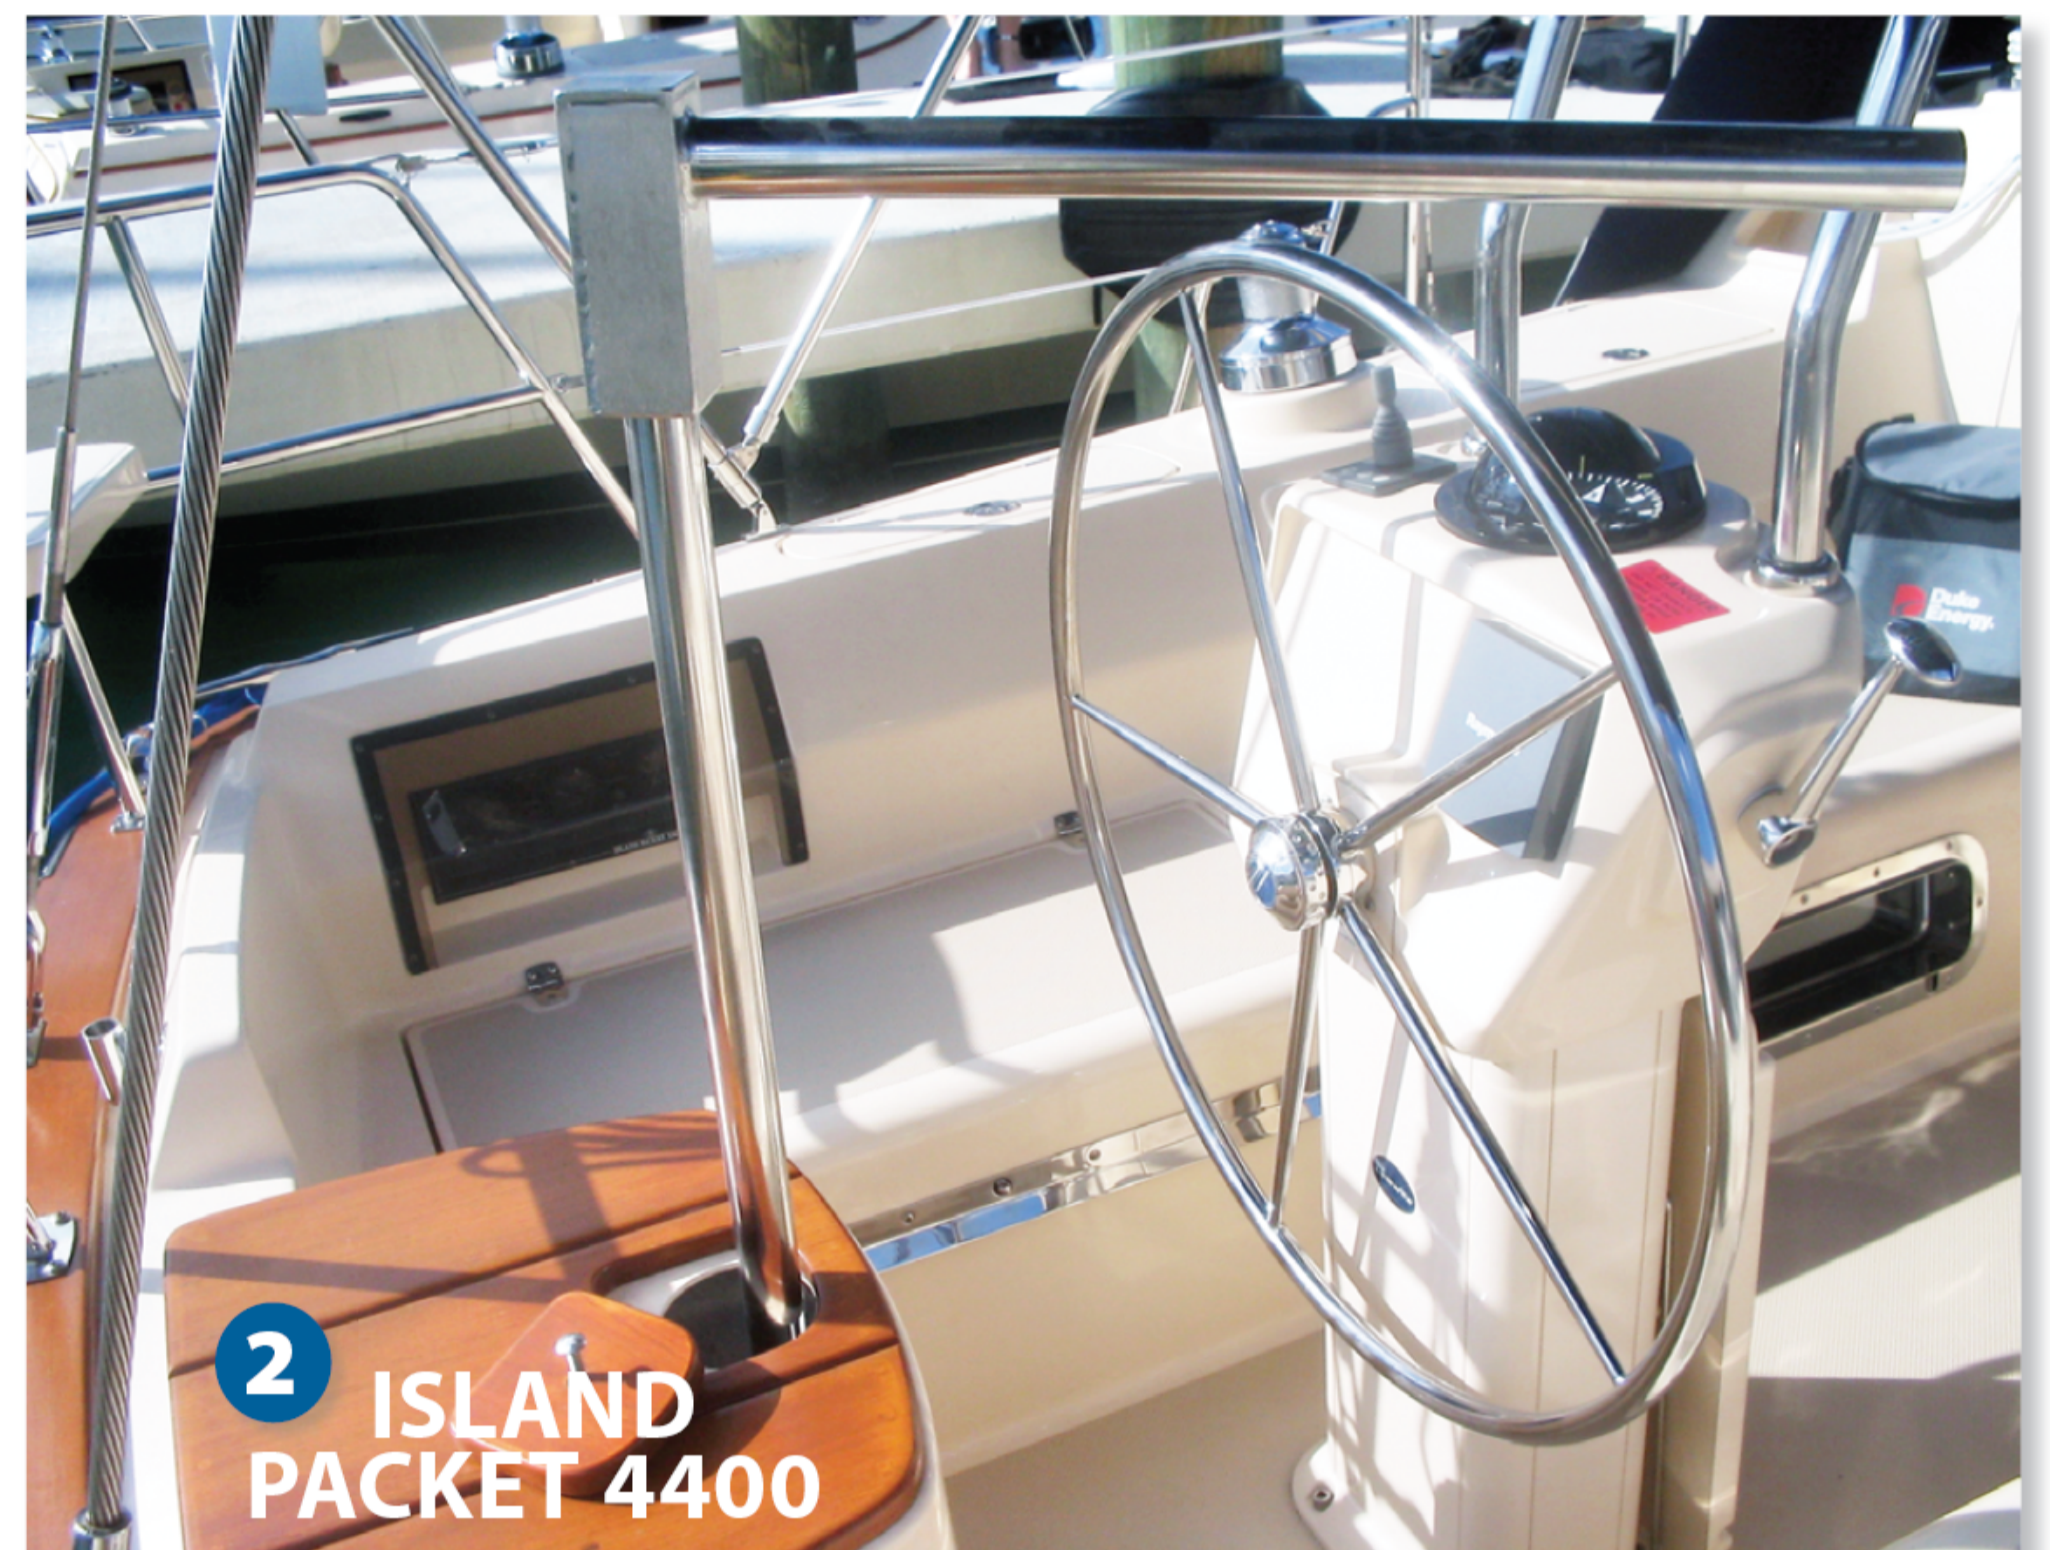
2 **Island Packet 4400:** This tiller stows neatly at top of cockpit locker. Access to rudder stock is easy and resists flooding. Tiller did not lock into place and is too high for comfort.

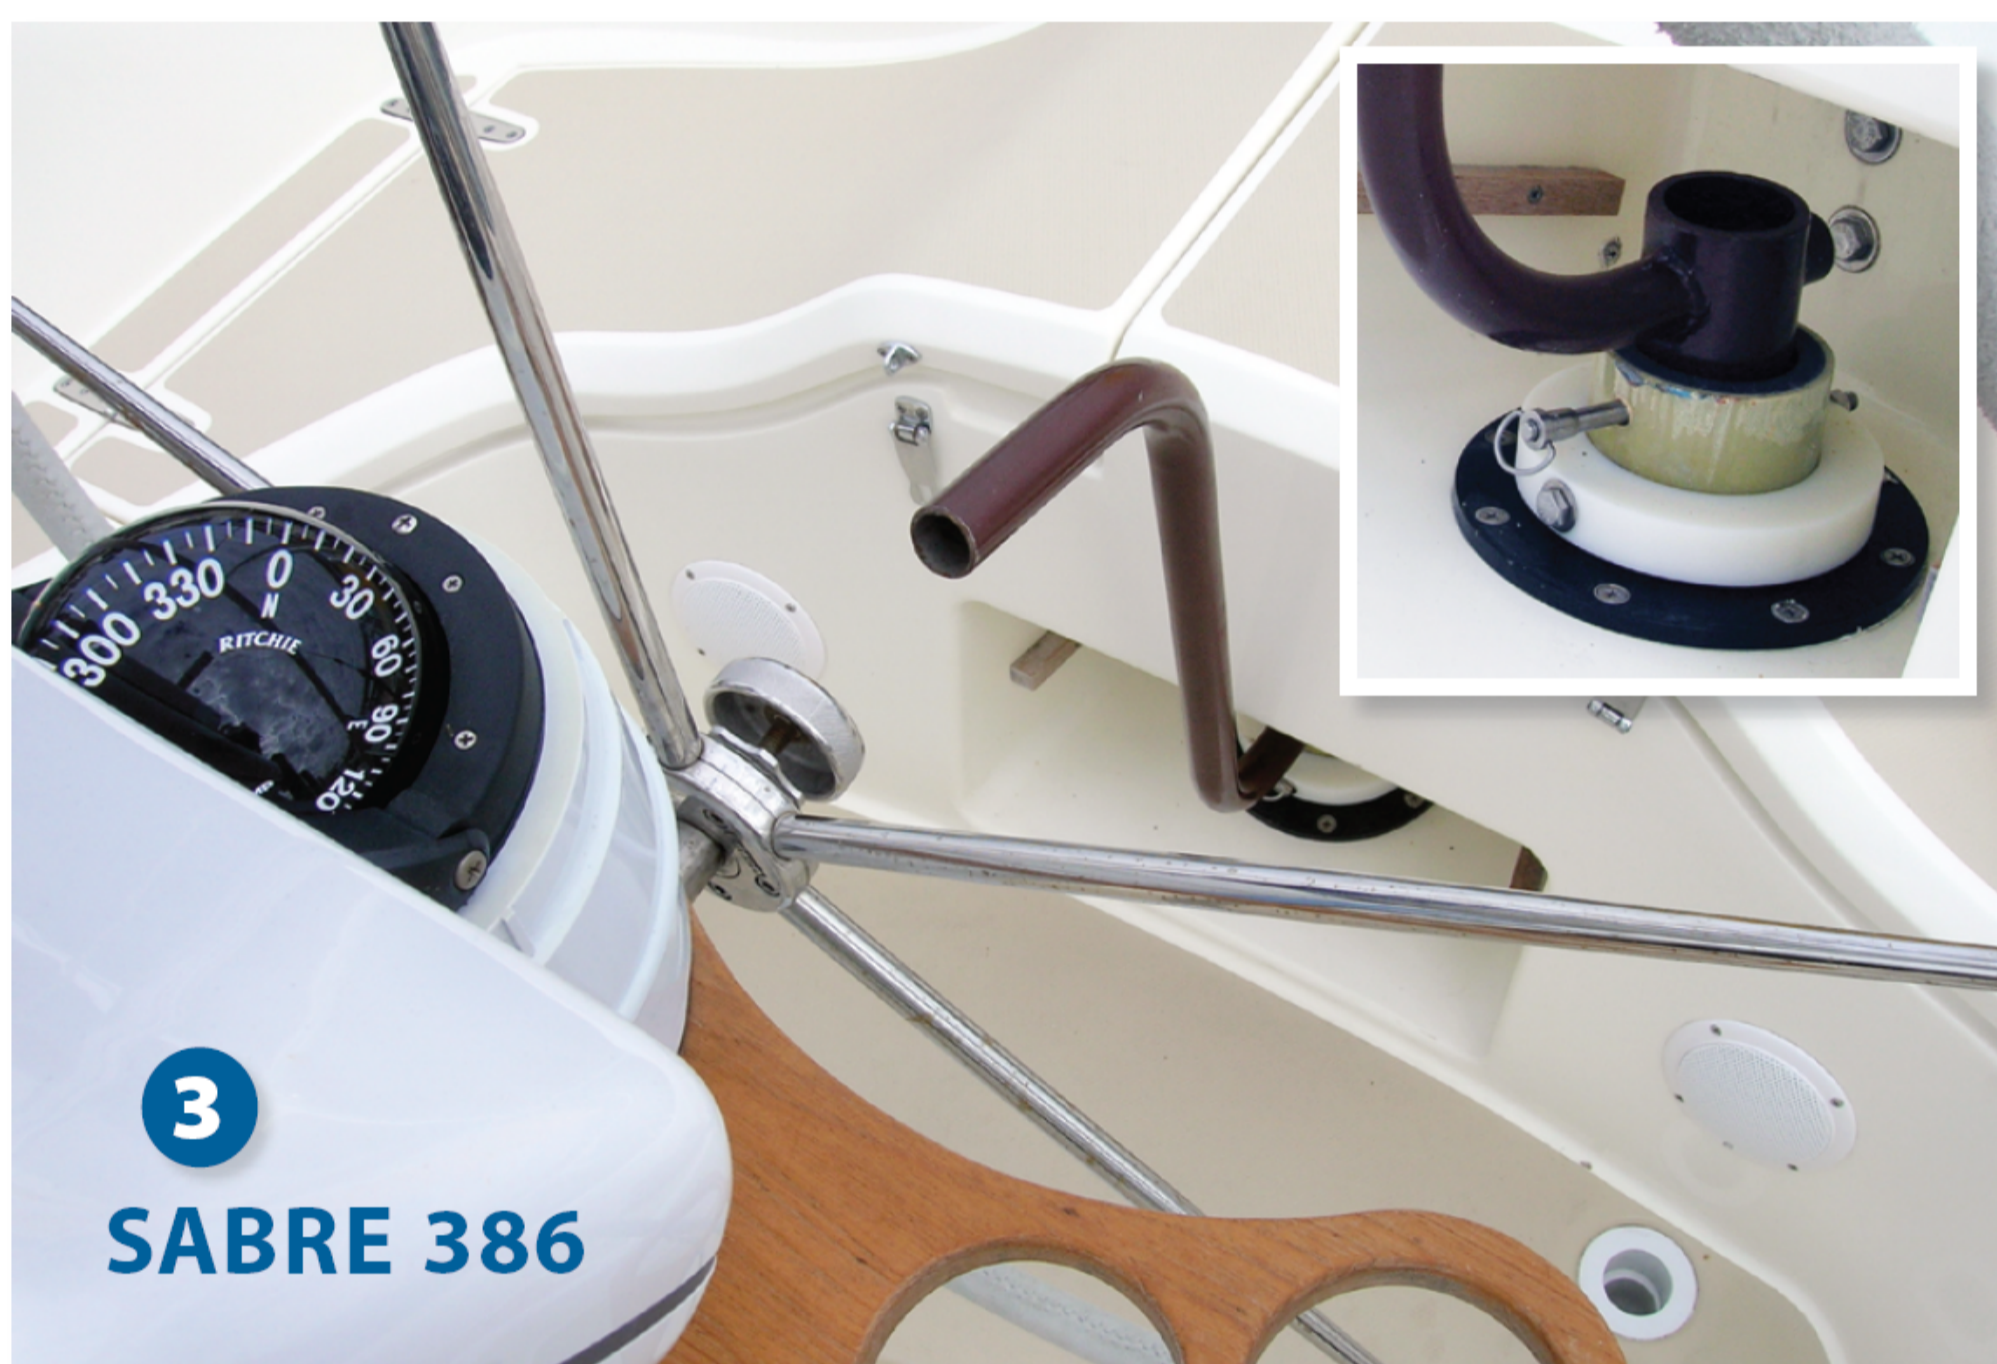
3 **Sabre 386:** This one-piece tiller pins into rudder stock (inset), which is easily accessible. Leverage isn't great, but add some eyes for steering lines and you're set.

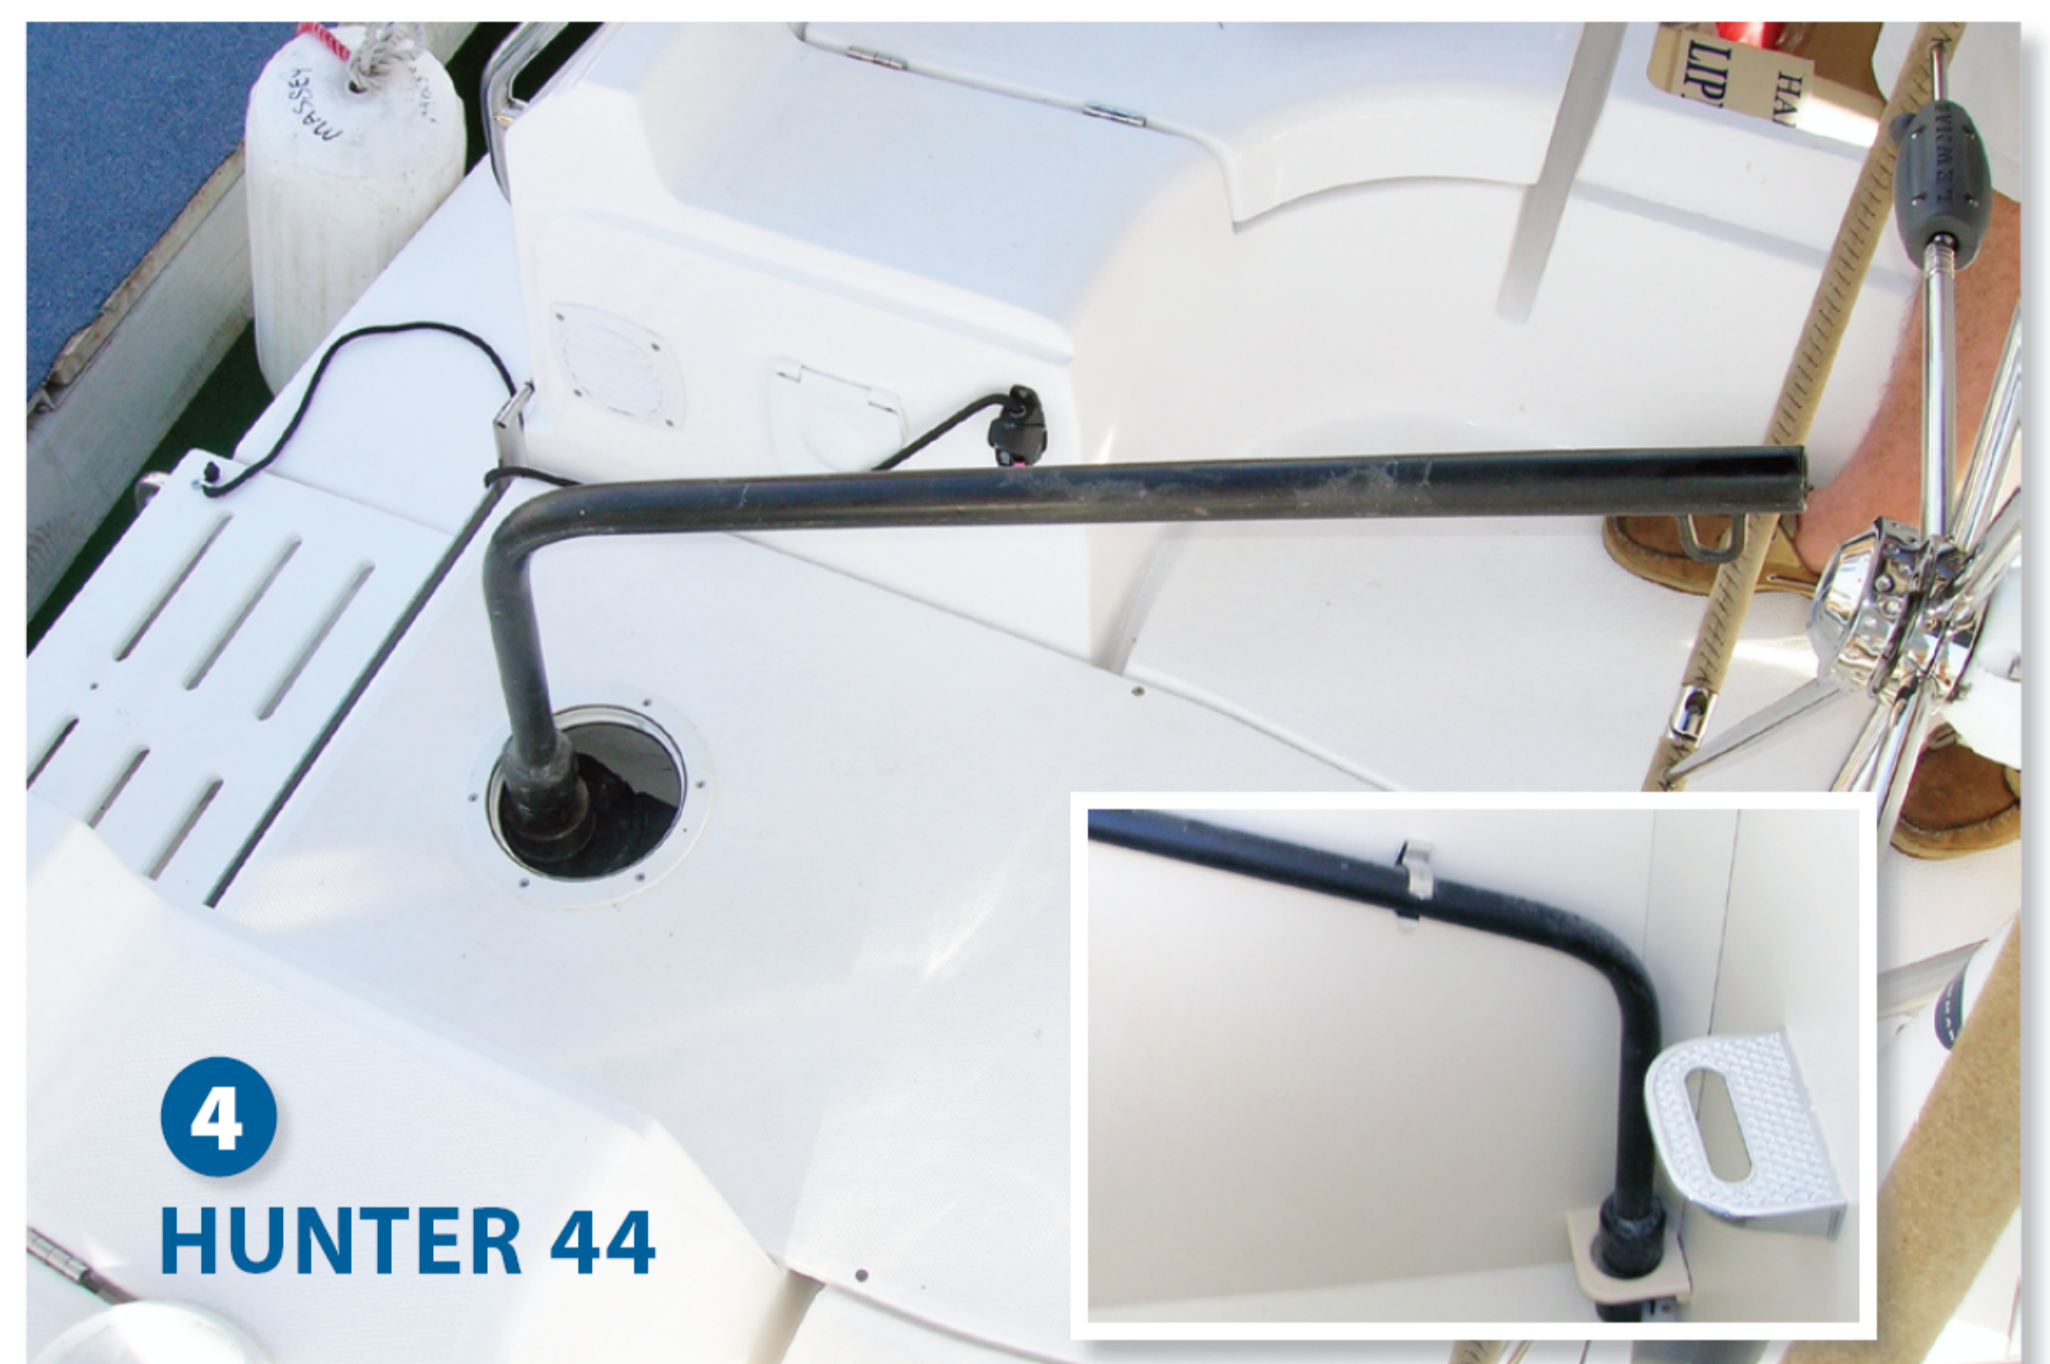
4 **Hunter 44:** . The tiller was hard to fit. The plastic deck plate won't seize, but downflooding is a risk. An eye for steering lines and dedicated locker spot (inset) are pluses.

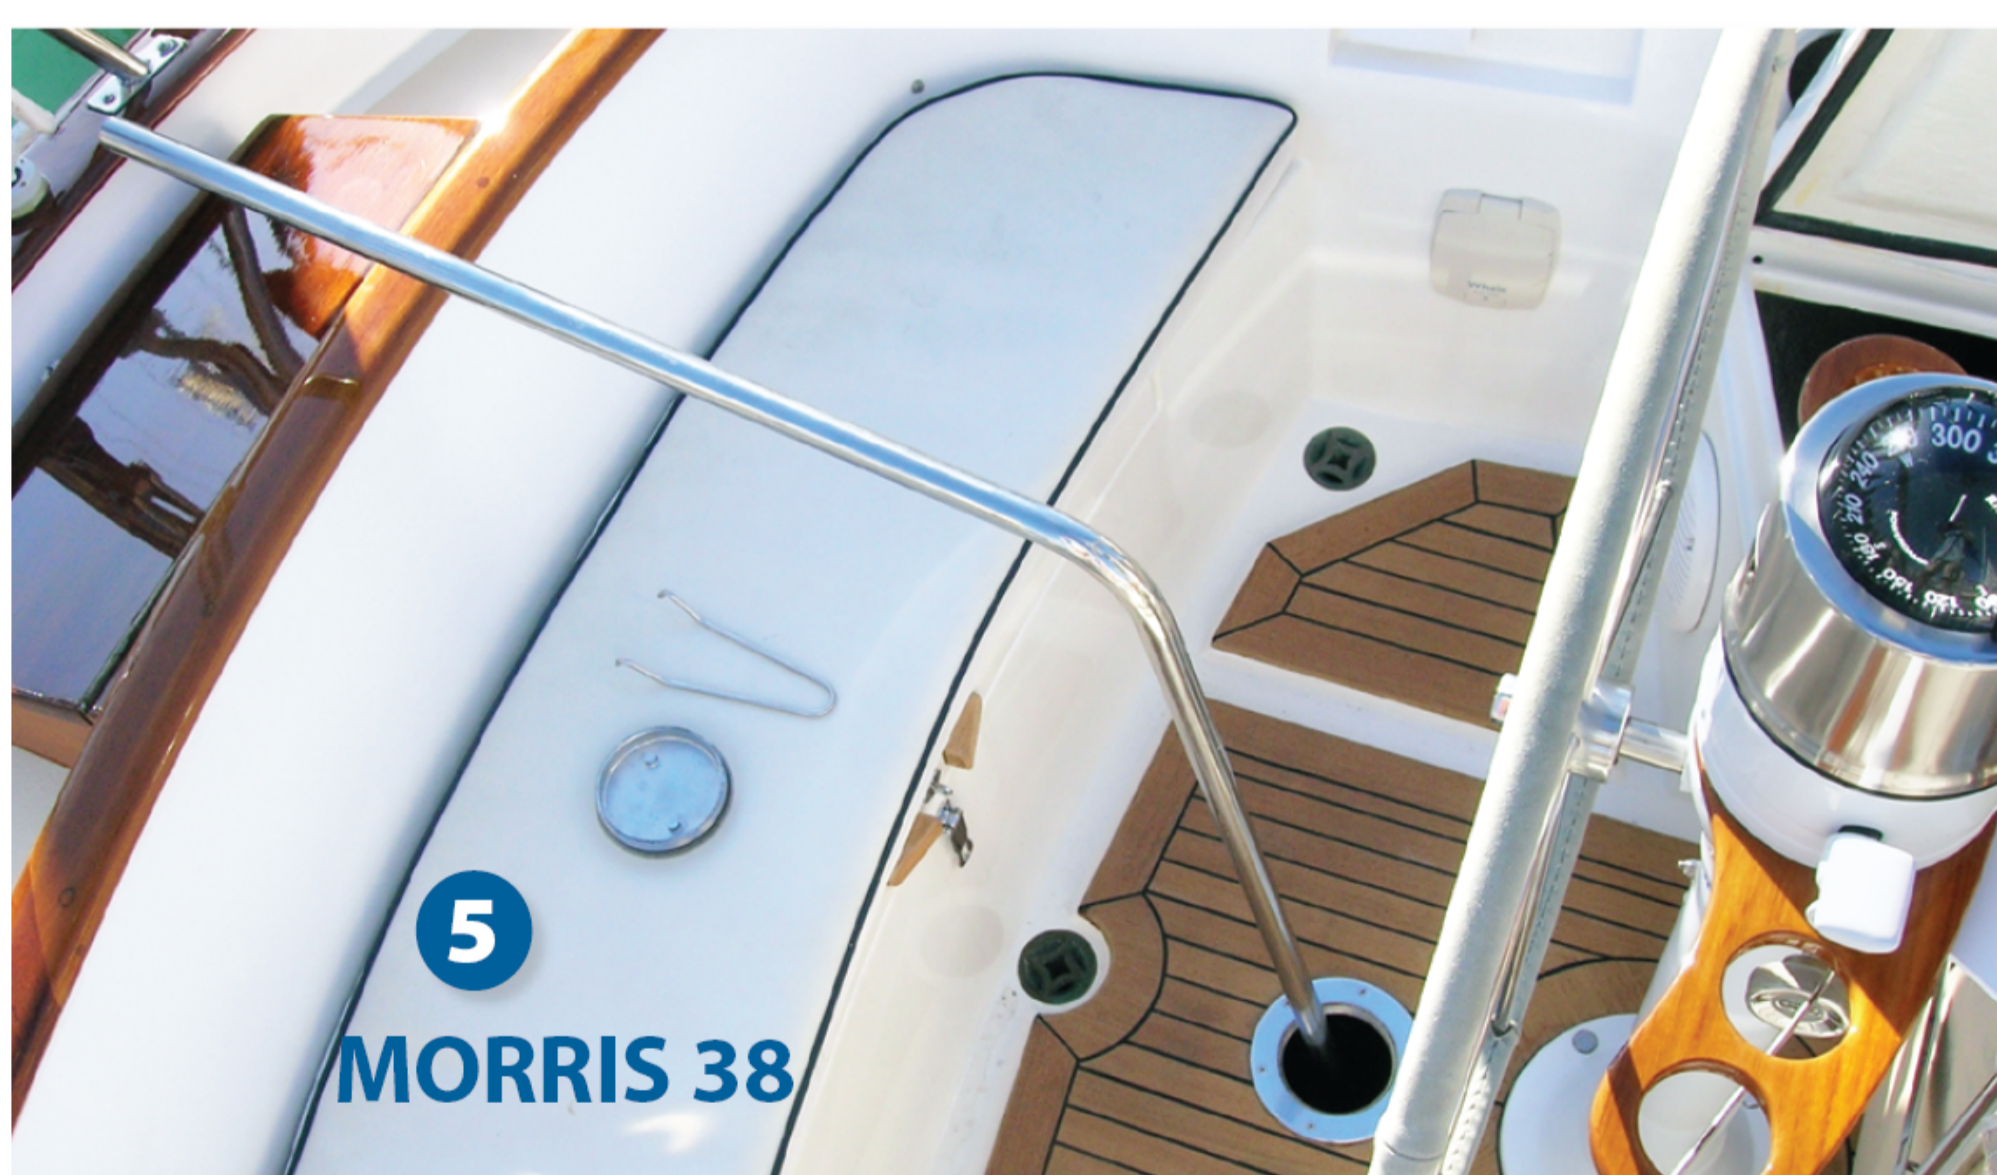
5 **Morris 38:** The wimpy deck plate key was located after much locker digging. The metal deck plate is likely to bind. Tiller diameter is small, with no eyes for steering lines.

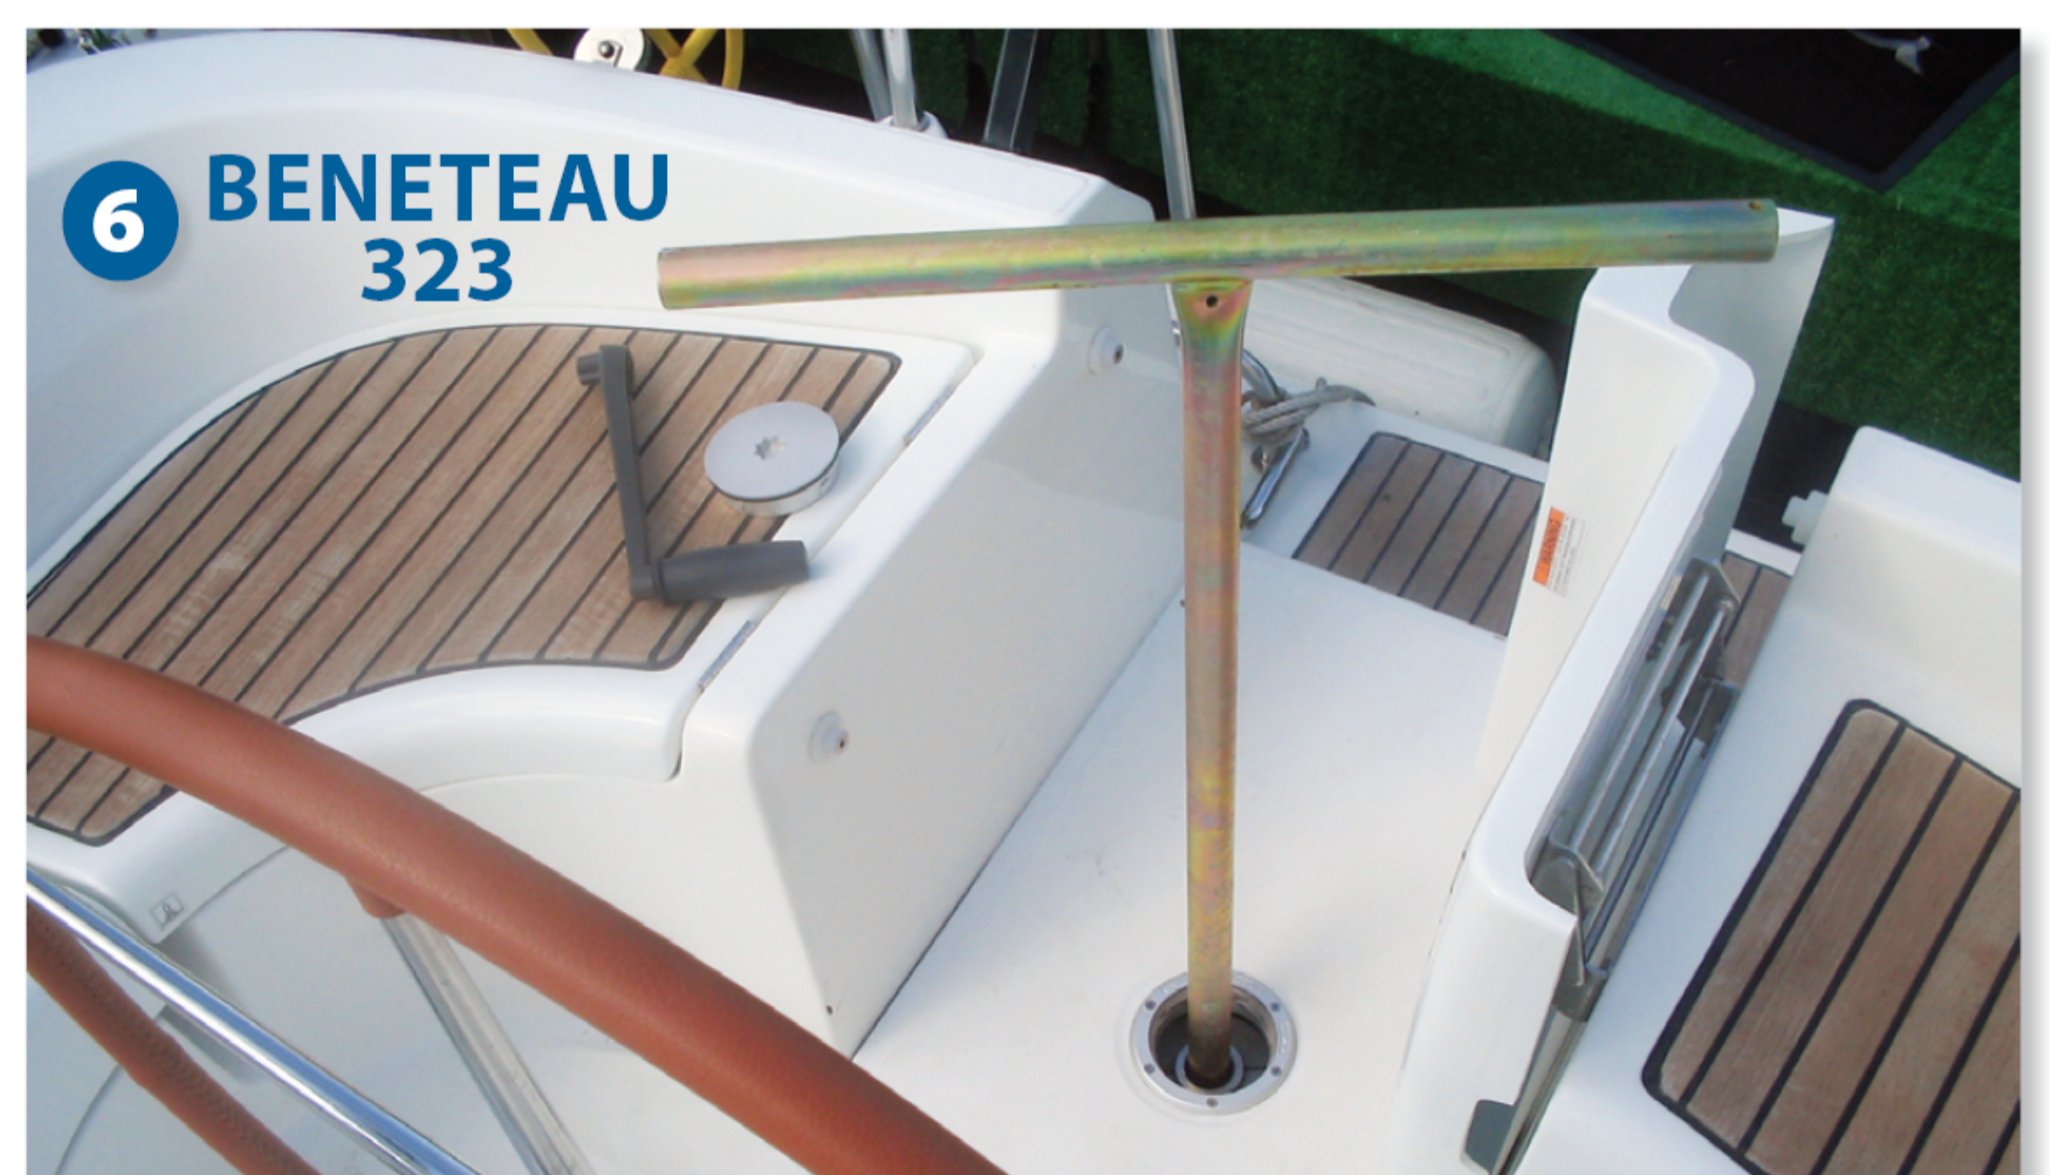
6 **Beneteau 323:** This welded T-bar tiller had most of the problems found on the other boats, plus a design that would be tiresome without steering lines.
