Broken Barnacle

Single-fluke anchor snaps under pressure.

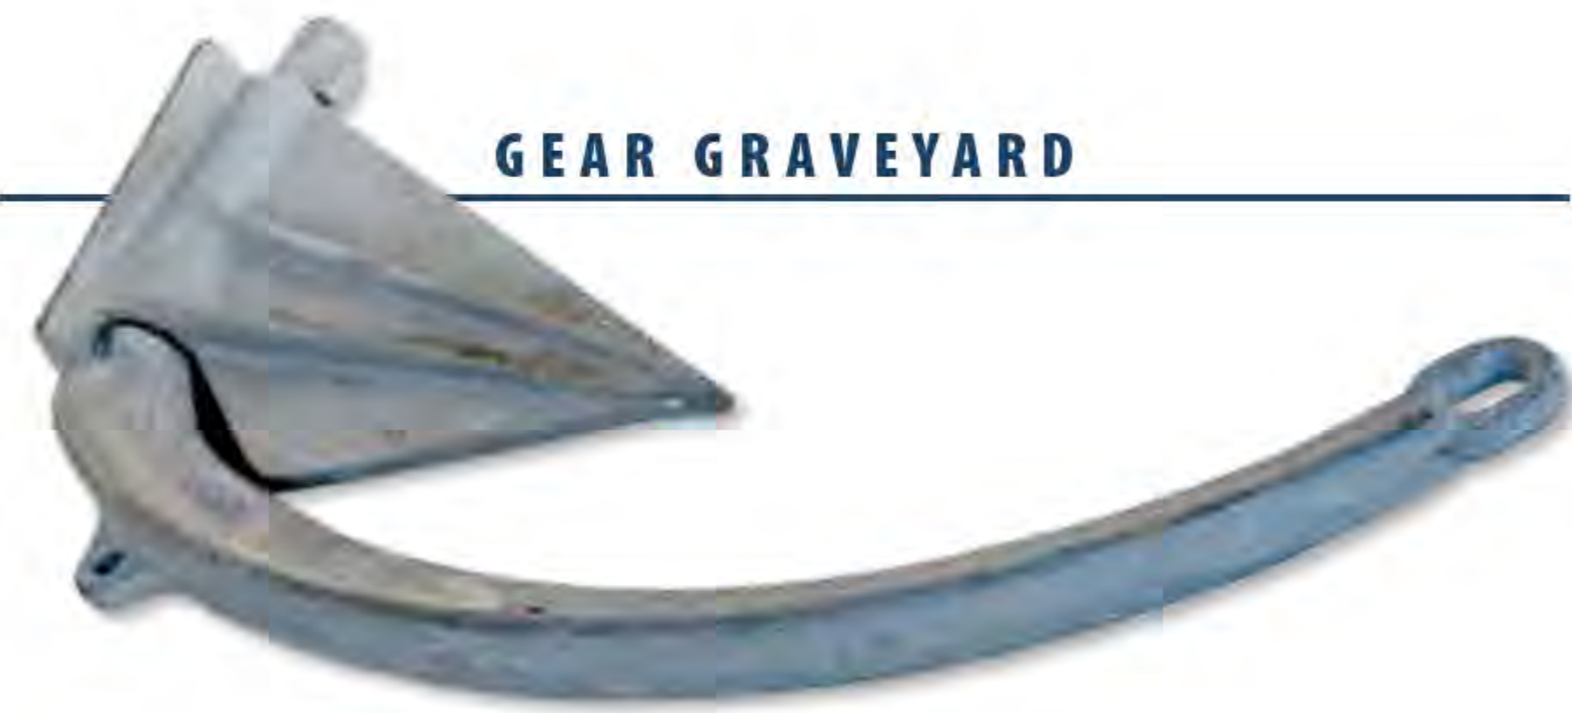
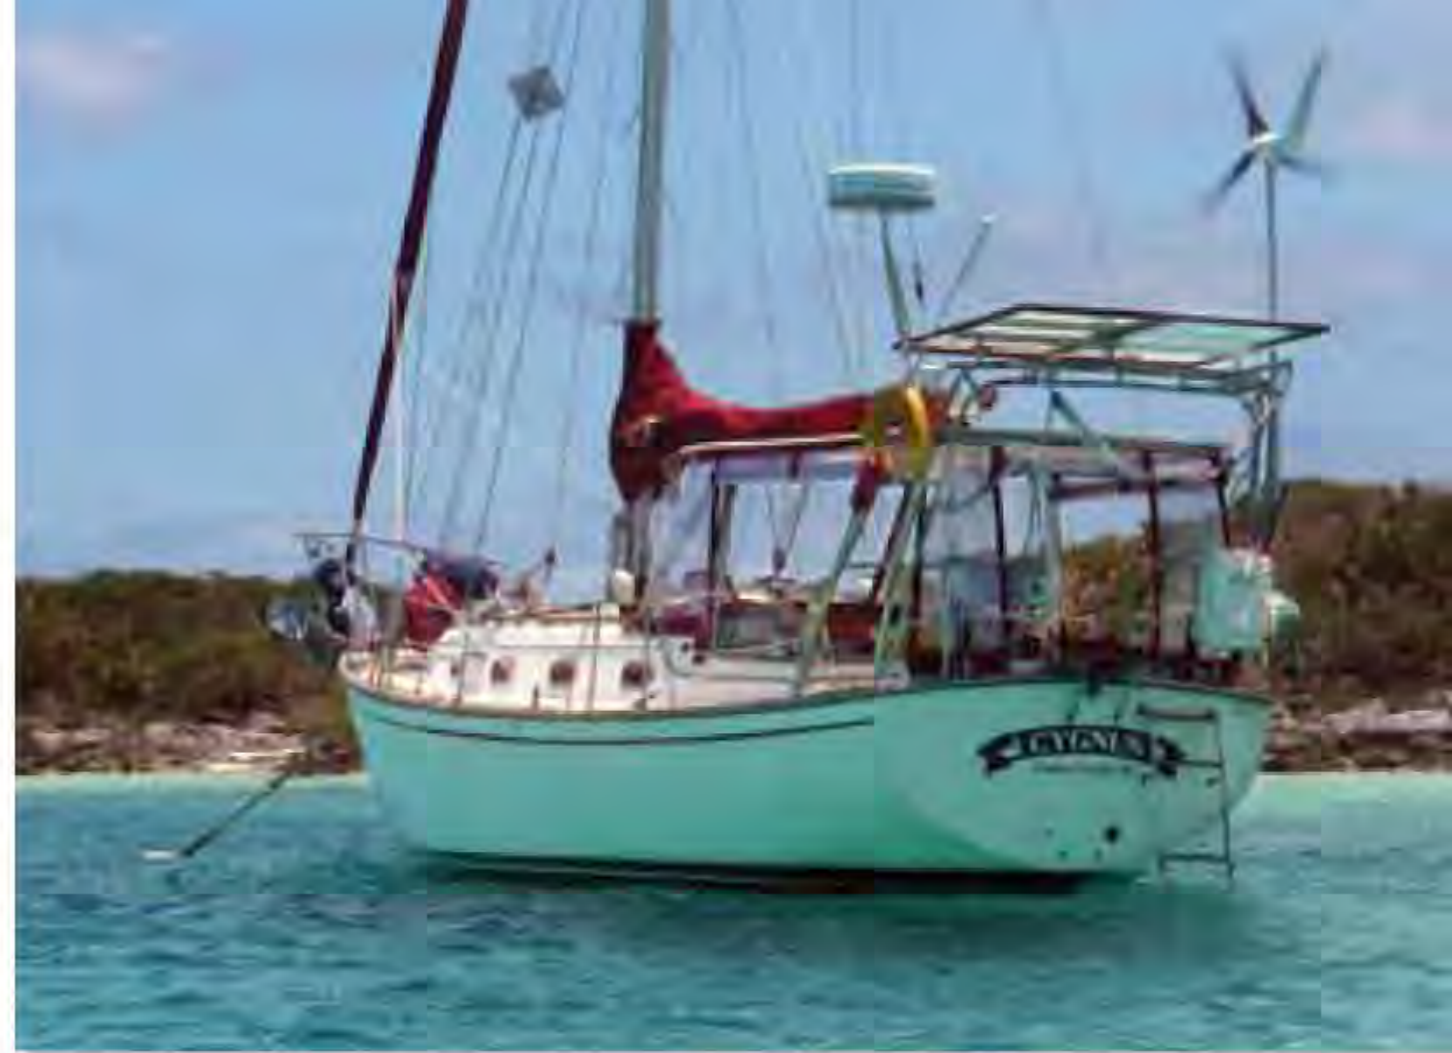
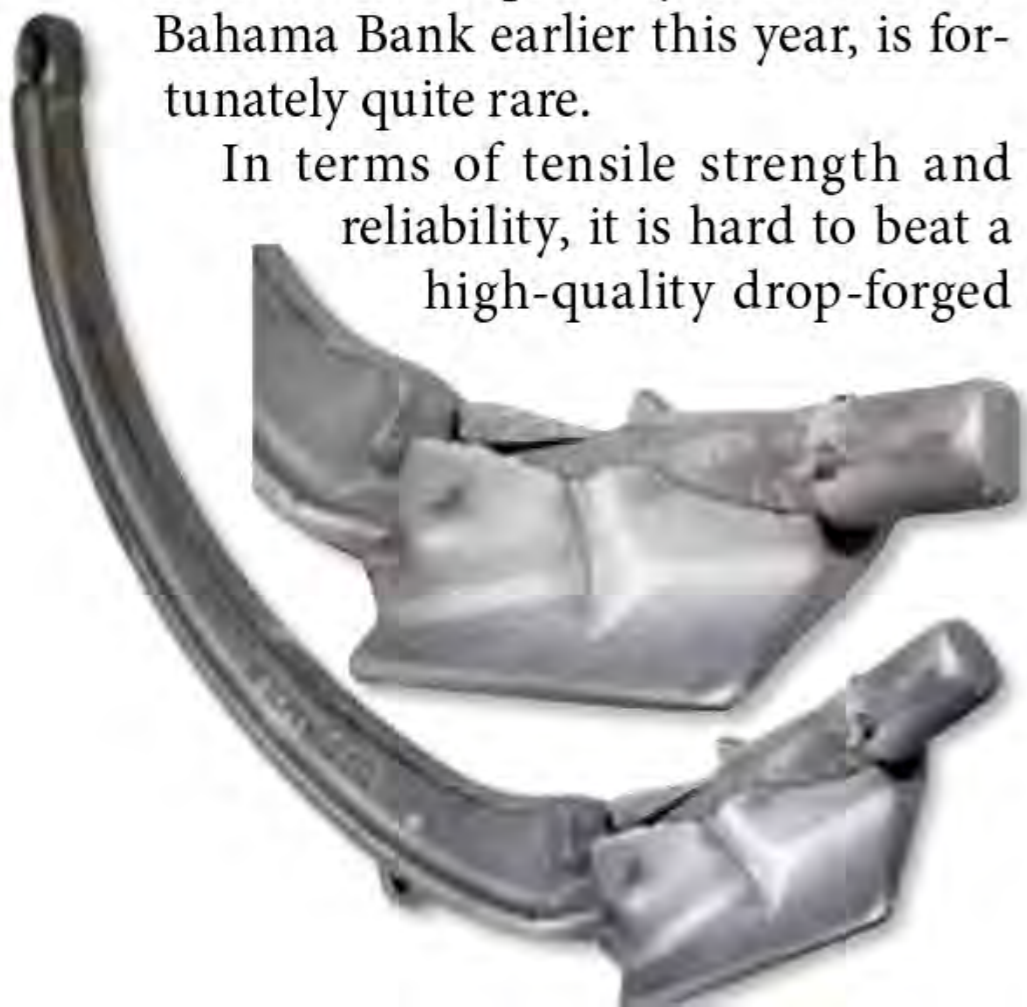
Ted Goodwin's aluminum anchor (below left), clearly marked "Barnacle," closely resembles the steel version PS tested in 2007 (above left). Goodwin's anchor broke while his Island Packet 35 (above) was anchored in the Bahamas.

ter 300 yards. When Goodwin retrieved the Barnacle in the morning, its single fluke was missing completely.

A close inspection of the broken section reveals a hollow area with a relatively thin wall thickness at the location of the break. *Practical Sailor* tested a steel Barnacle in 2007, but we could not locate the company recently, and the anchor appears to be out of production. These anchors can still be found on chandlery shelves, however. Based on Goodwin's experience and our inspection of the break, the aluminum version of the Barnacle anchor is one we would avoid. ▲
