Downwind Downer: Shackle on Spinnaker Block Bites the Dust

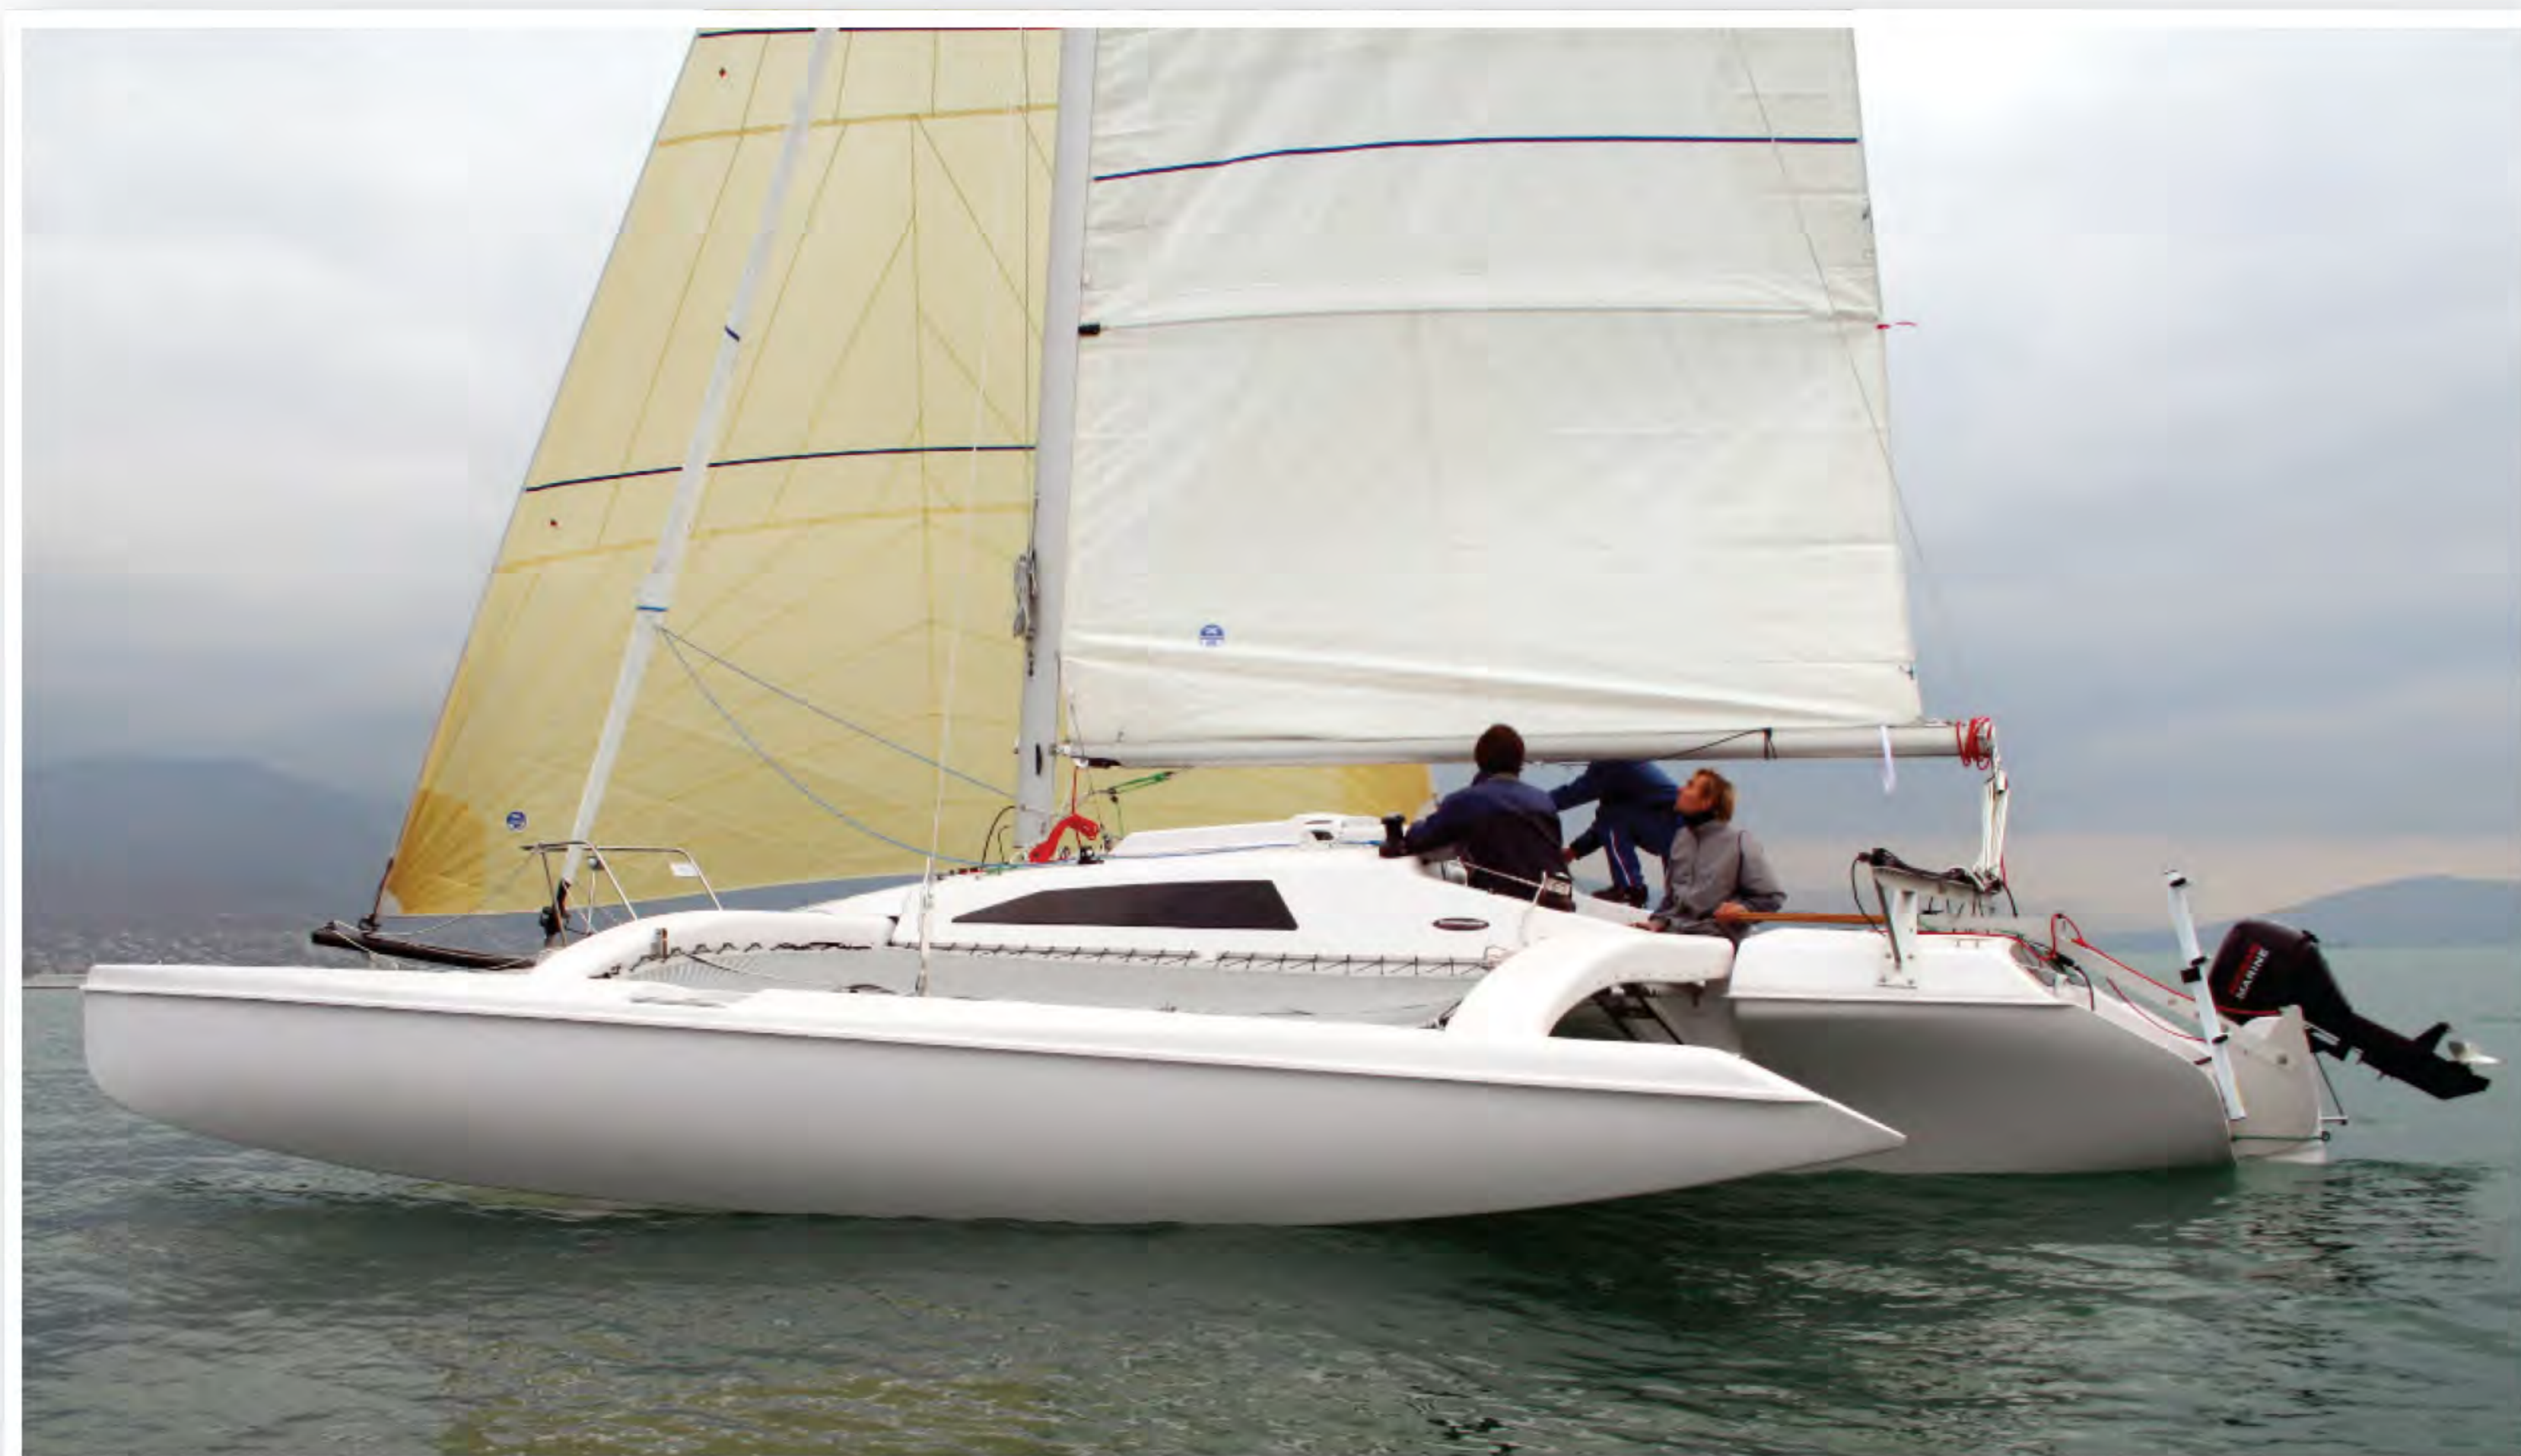
.....
A combination of time, corrosion, and off-axis, cyclical loading likely contributed to this Nicro shackle's failure. The side and top views of the failure point show where the shackle simply sheared.

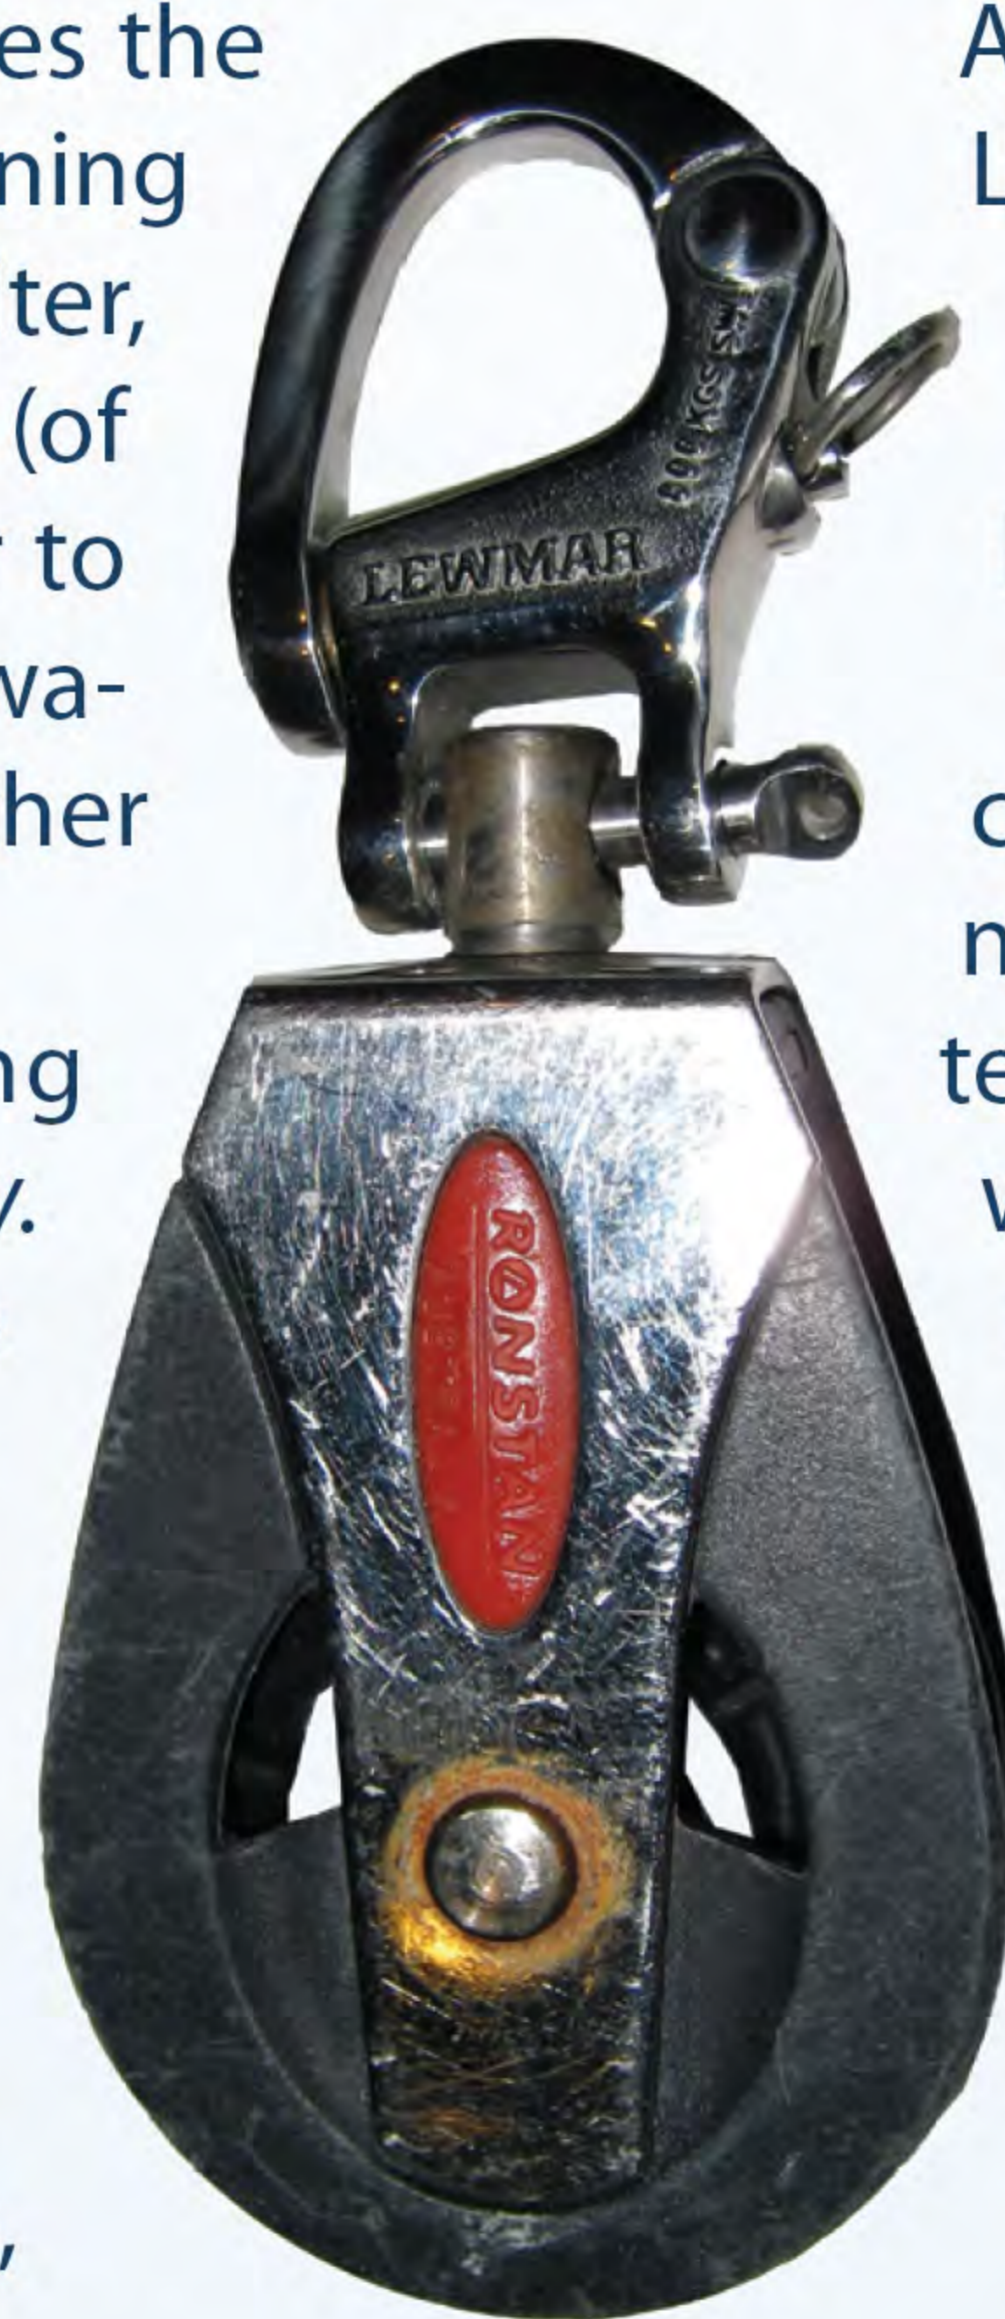
Corsairs in the 30-foot range, like this Corsair 31RS and reader Sam Showalter's F-31, are better suited using blocks in the 55- to 70-millimeter range as leads for spinnaker sheets, according to block-maker Ronstan.

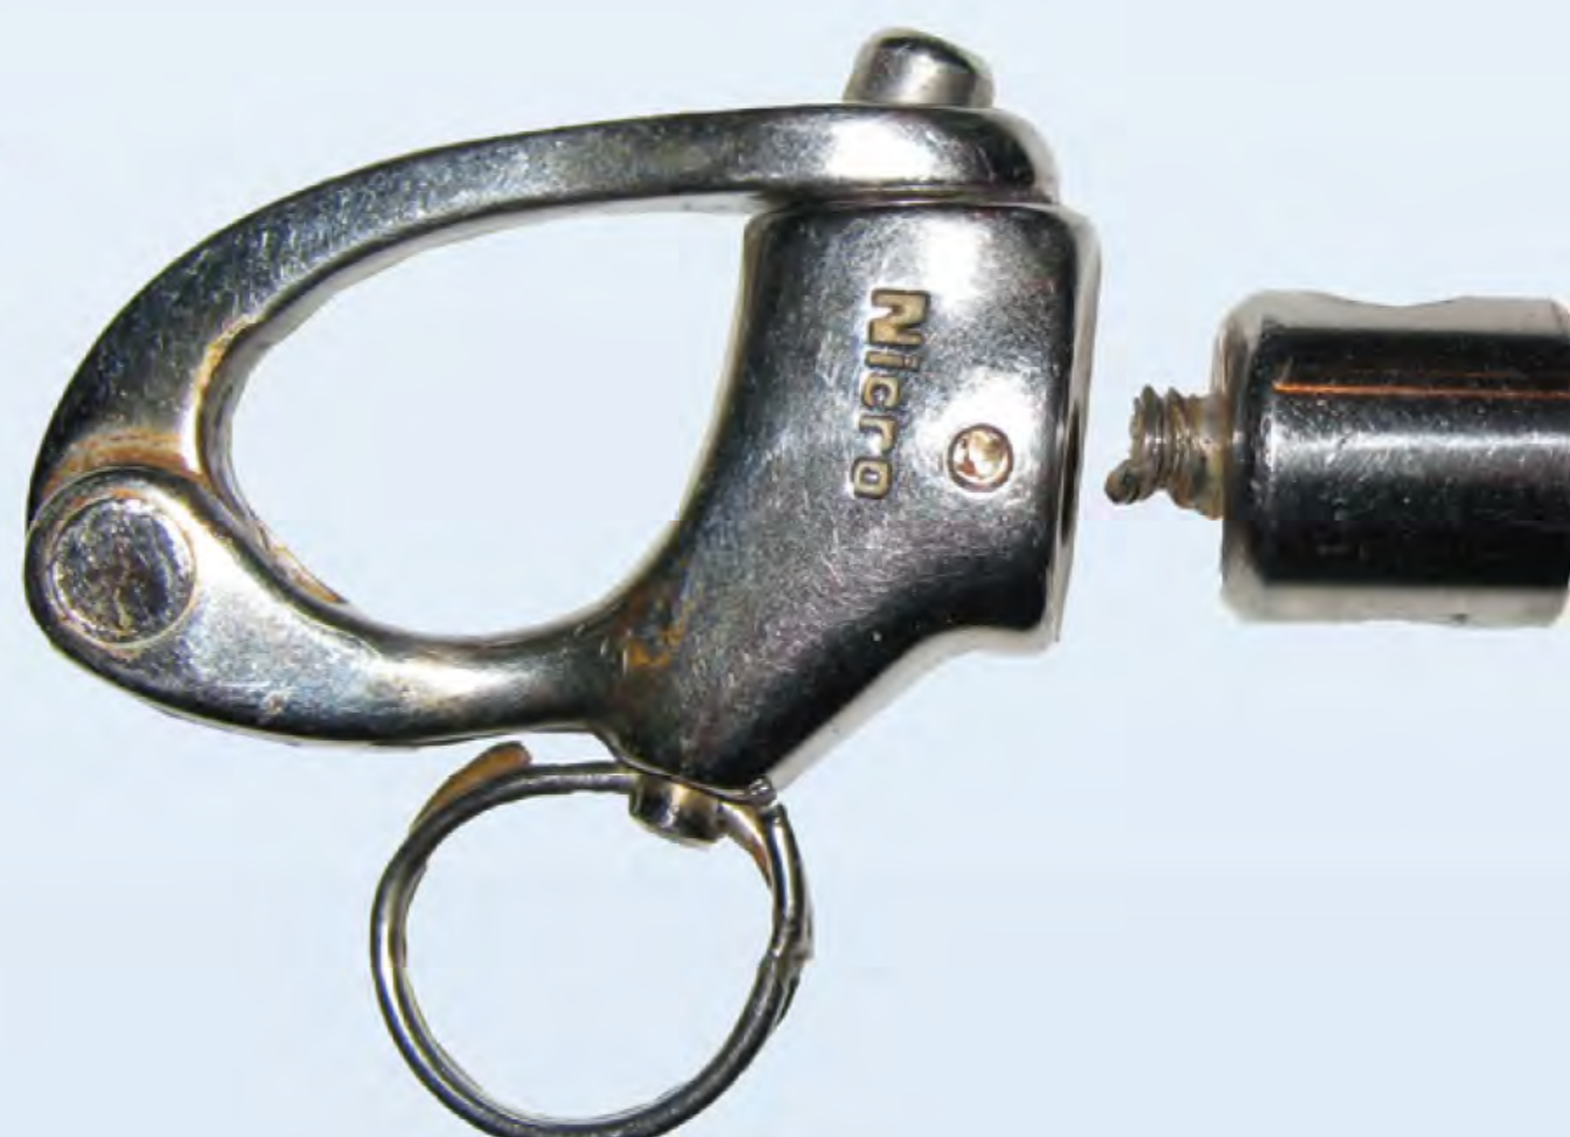
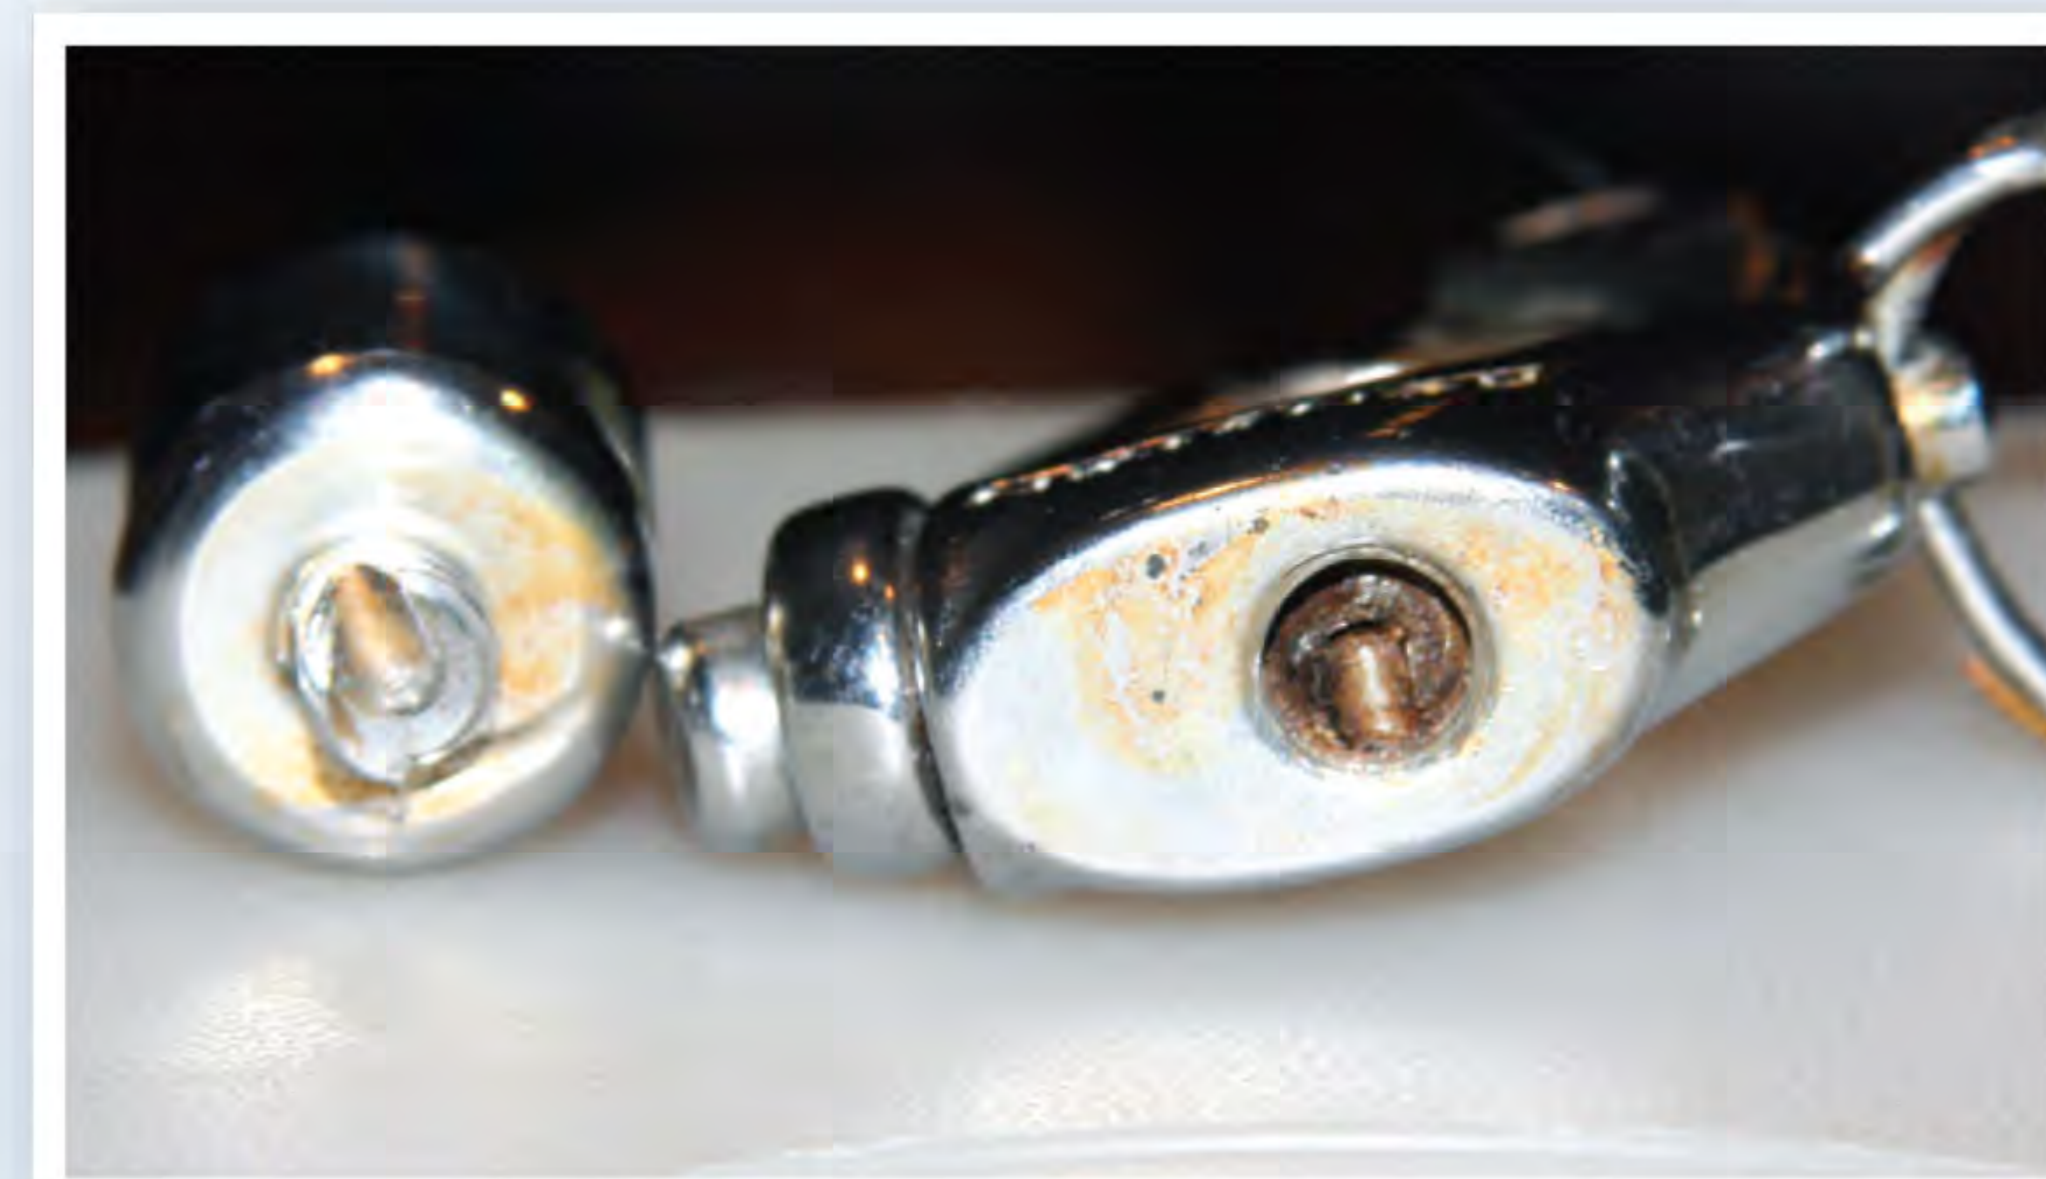
Ronstan 50 with Lewmar replacement shackle

After approximately eight years in service, the Nicro snapshackle on a Ronstan Series 50 Orbit block sheared at the swivel pin. (See photos below right.) Showalter fixes the block to the aft quarter of his Corsair, using it as a turning block for the spinnaker sheet. According to Showalter, the swivel pin failed under a modest load, at 2 a.m. (of course) during the 2007 Harvest Moon Race. Prior to failure, the block had not seen a great deal of saltwater action, and it was always stored out of the weather when not in use.

Showalter said that this was the second such failure on his boat, and he worries that poor design is at fault. "The pin that keeps the parts from unscrewing takes away about 30 percent of the area, and also causes stress concentration and a place for corrosion to begin," he wrote in an e-mail to *PS*. "The pin is so close to the edge of the shackle that there are only about two threads engaged before the pin hole.

After the incident, Showalter purchased several Lewmar shackles to replace the Nicro shackles on his blocks. (See photo at page center.) He expects that the swivel pin on the Lewmar will not fail before the block.
