## A CLOSER LOOK

### Radio Autopsy

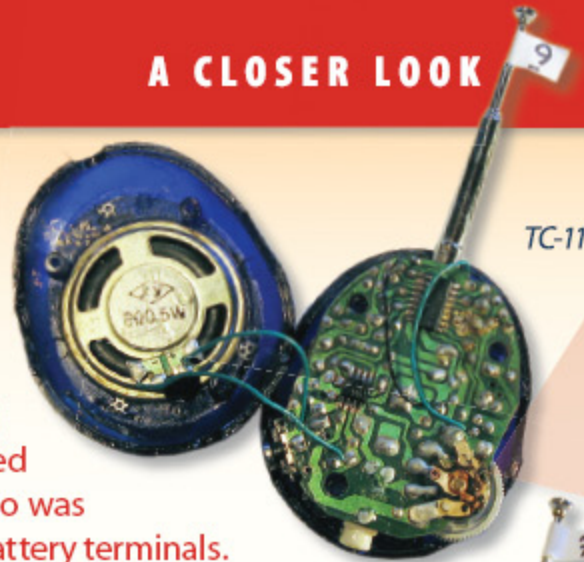
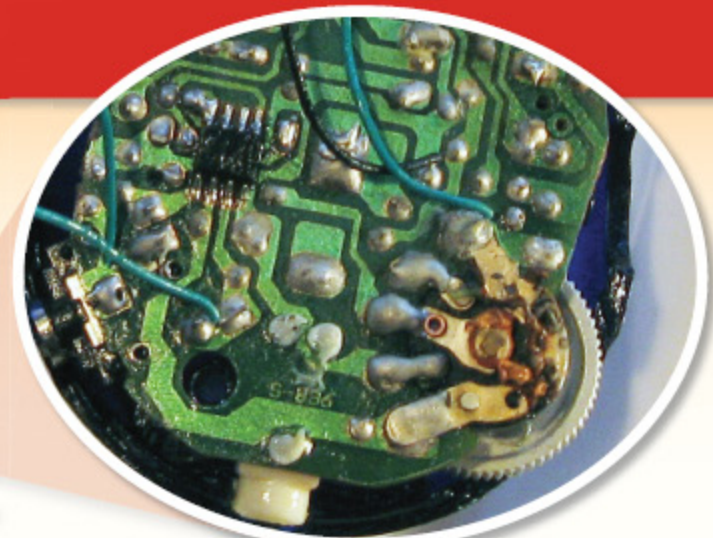
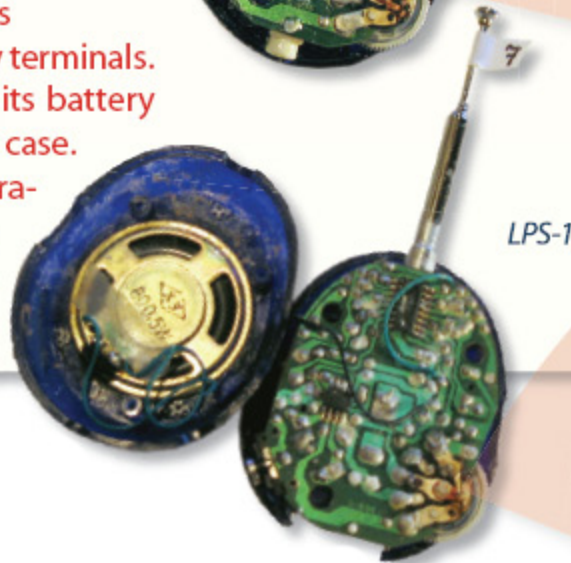
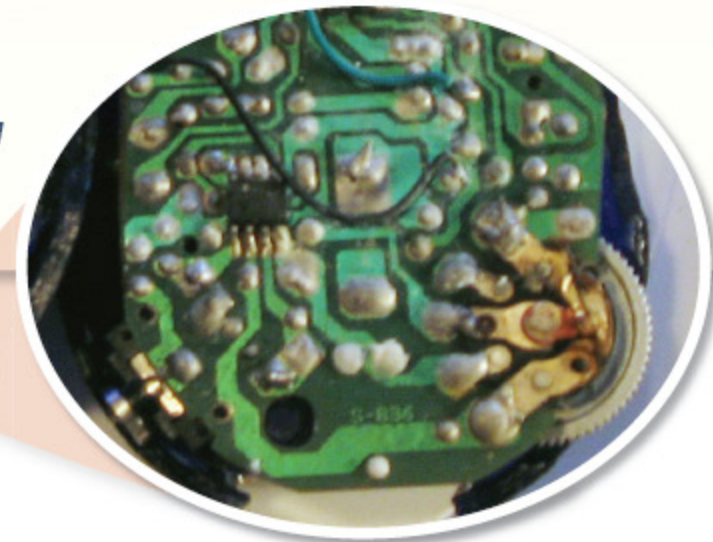
A peek at the innards of two radios after the submersion test shows how well the TC-11-treated product (top) fared, in comparison to the one coated with LPS-1 (bottom). The TC-11 test radio was the only one without corrosion on its battery terminals. The LPS-1 radio suffered corrosion to all of its battery terminals and had white deposits inside its case. The zoomed-in photos at far right show the radios' volume-control potentiometers, which were reduced to a chunk of rust on all 10 test radios.
