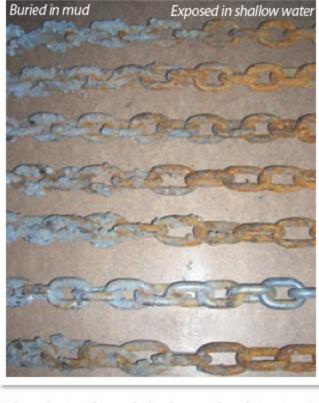
The photo above left shows the deterioration of the chain sections. The difference between those sections suspended in shallow water and those buried in mud is obvious. These links have come a long way from the shiny ones we dropped 12 months before (photo, above right).
