Wire Endurance Test

PS takes a scientific look at the causes and cures for failures in electrical conduits and connectors.

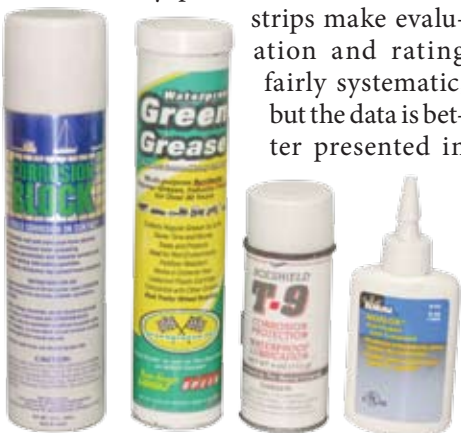
.....
Most of the anti-corrosion coatings began losing effectiveness after just two weeks in the test chamber; from left: Corrosion Block, Green Grease, Boeshield T-9, and Noalox.

- The thinnest of the anti-corrosion coatings began to fail almost immediately, as evidenced by darkening of the wire under the coatings.

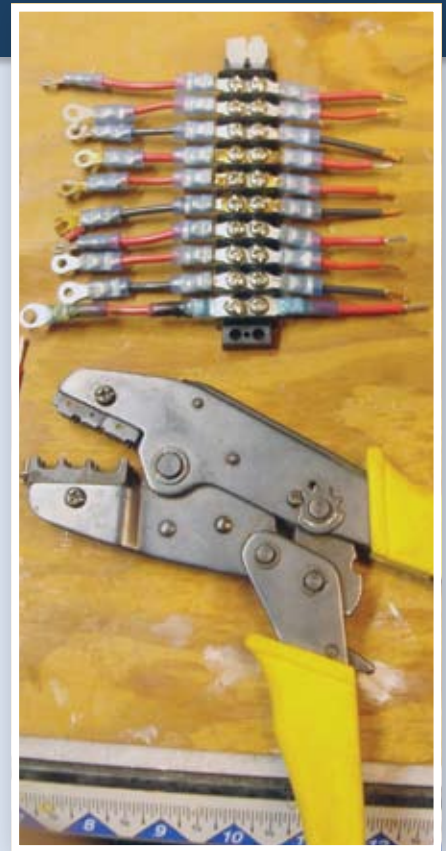
Used properly, a good-quality ratchet-style crimper offers consistent crimps that resist corrosion.

On insulated terminals, use an elliptical pattern crimping tool (Ancor's crimper earned kudos in our 2003 test). Make sure it's sized properly for the wire and terminal you're crimping. Better quality tools tend to make more efficient junctions between the wire and metal fitting.

Tug vigorously on the finished product to test the junction. In a good connection, the wire should fail before the crimp.

We found that when using low-pressure hand crimpers, we could still see voids in the crimp; with a properly adjusted ratchet crimper the metals flowed together.

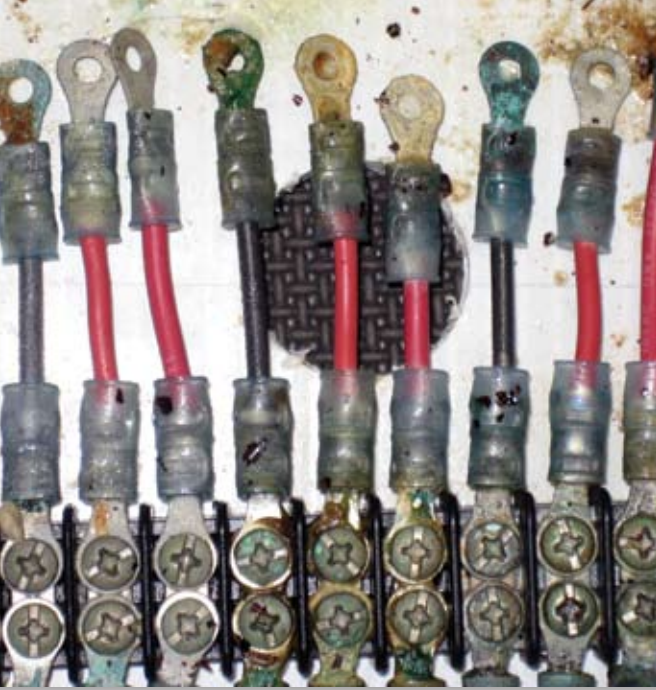
After six months, protection from the anti-corrosion sprays had worn off, but some greases still worked.

- Noalox (aluminum wiring corrosion preventative) and No-Ox-Id (terminal grease), the only grease products intended for this sort of use, outperformed all others. However, because of the sacrificial nature of Noalox, it may have a shorter lifespan.

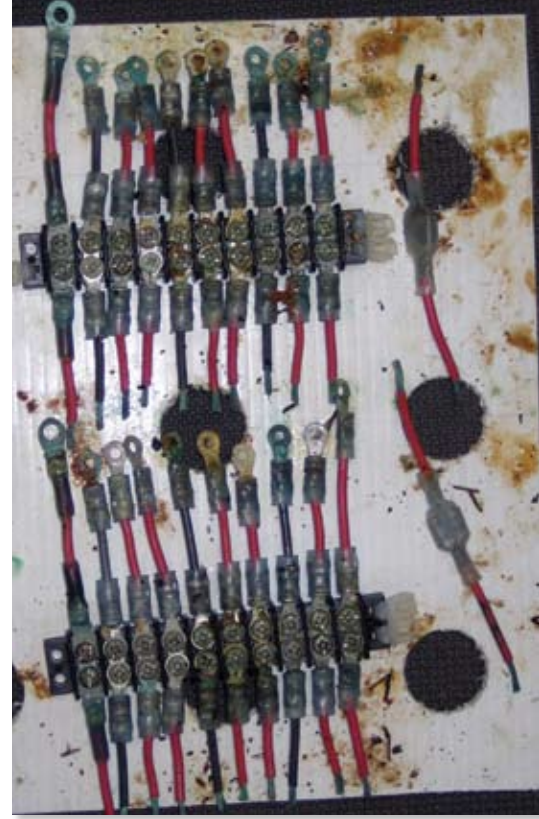
Although not suited for heavy exposure applications, the test included some push-pull connectors (on right).

- Push-on connectors are unreliable in damp environments, even if occasional equipment replacement or service is foreseen. Better, leave a coil of extra wire and use crimp connections. Alternatively, add a junction box in a drier location.
