Wire Endurance Test Part II

PS checks in on wires, crimps, and terminals after a one-year exposure test.

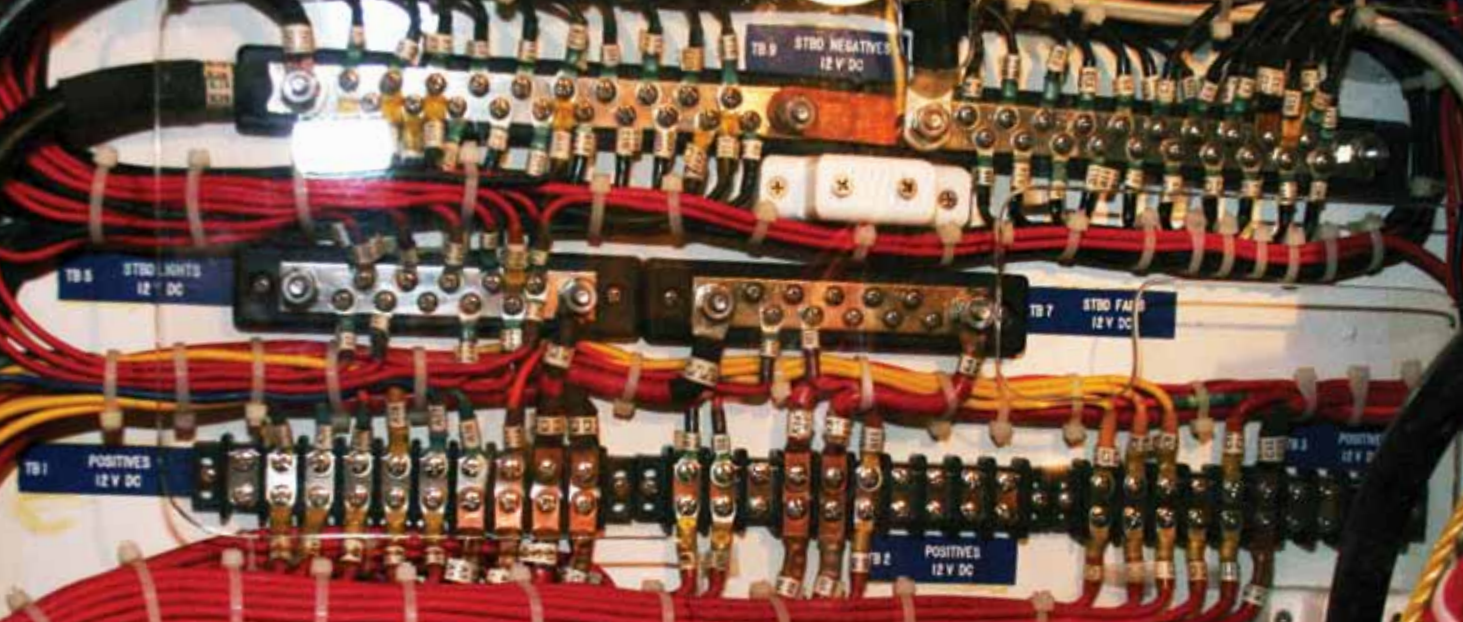
There is no completely, dry clean location on a cruising boat. Salt air will eventually seek out unprotected wires and terminals.

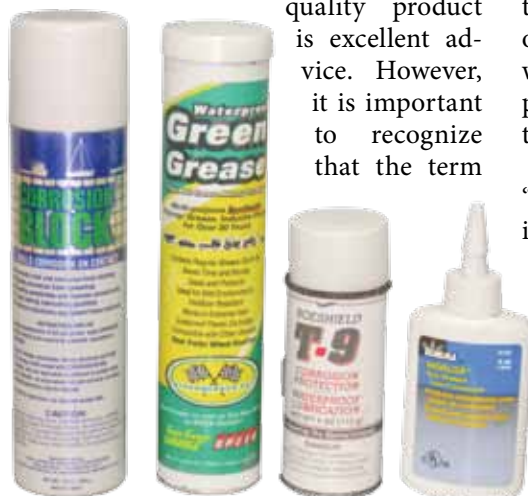
.....
Testers compared four anti-corrosion products, from left: Corrosion Block, Green Grease, Boeshield T-9, and Noalox. The September 2008 issue carried a detailed report on several other suitable products.

As for the corrosion preventatives, Boeshield provided less visible long term protection than other spray products, and it fared little better than untreated samples. It did, however, protect the push-on connector. This was a surprise, since Boeshield did well for the first six months. Corrosion-Block provided significant protection for both wires and terminal block screws under very tough conditions. Terminal grease provided some protection in torture chamber conditions for wires and excellent protection for terminal block screws. No-Alox did not perform as well. Again a surprise, as this product showed promise in the beginning.

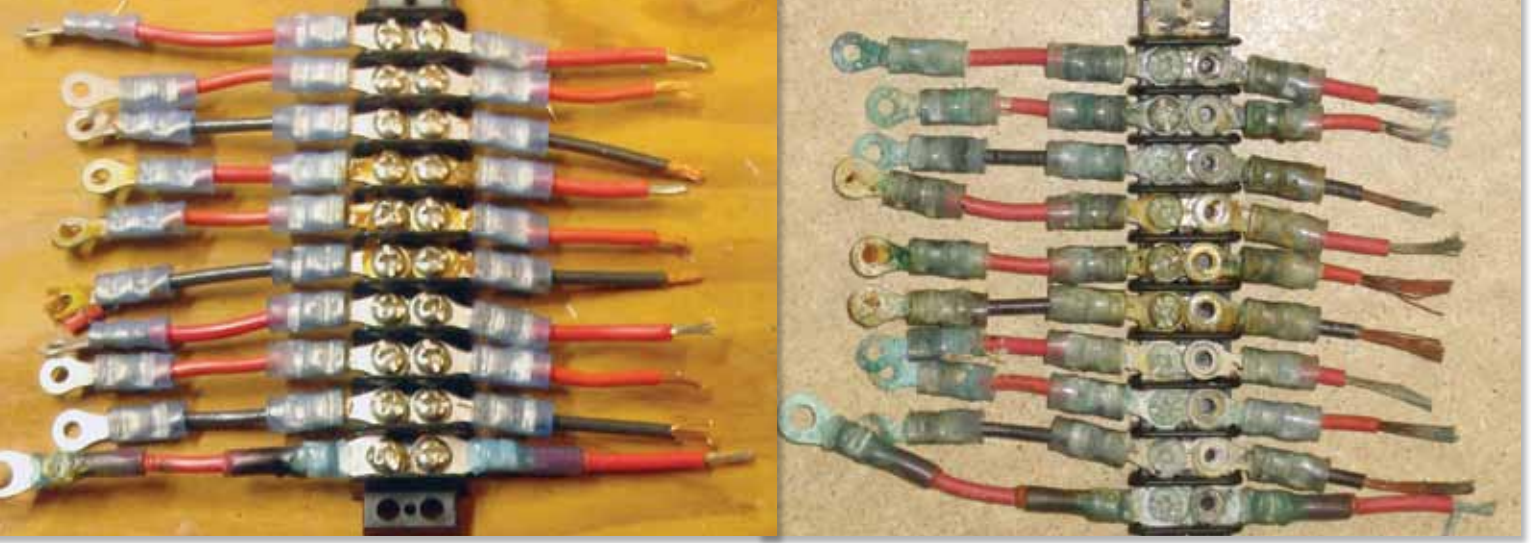
Before (above left) and after (above right) photos show the effects of one year in the moisture/heat chamber. The samples are arranged vertically in the same order as the table below. The auto wire has a black insulating jacket. Note how the sacrificial tin has begun to wear away on the tin samples, as well as the relative clean condition of the samples coated with No-Ox-Id (4-6 from top).

After 12-months in the test chamber, the thicker No-Ox-Id did a good job of warding off corrosion. The spray-on Corrosion Block also provided good long-term protection.

Tinned wire suffered less visible corrosion than bare copper wire, and interestingly, none of the preventative treatments appeared to have improved the tinned wire's corrosion resistance.

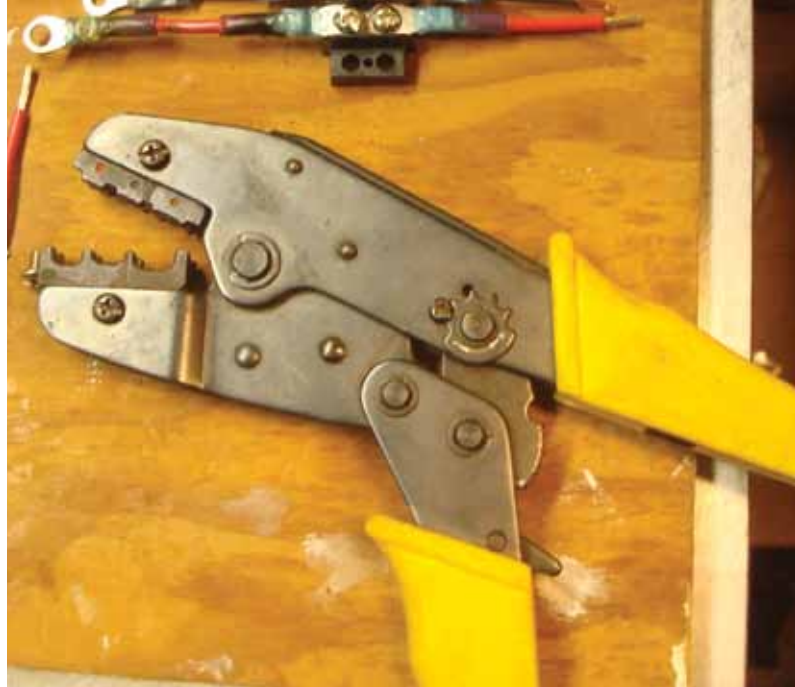
A good dual crimper with hardened removable dies can be bought at an electrical supply house for \$40 to \$70.

PS tested only well-formed crimps made with a ratchet crimper. These meet the industry standard, are easy to make, and have proven very reliable. Most of the terminal fittings for this test were tinned copper fittings made by Ancor (ring crimp connectors and terminal blocks) or Ideal (heat-sealed crimp connectors and push-on connectors). We also tested a limited number of tin-tin spade connections. We tested two types of terminal strips. Three

Ultimately, the key to long-term protection is at the terminal. Connections that are well sealed will greatly prolong the life of ordinary automotive wire, while the best tinned wire will fail prematurely if terminal connections are not well sealed. The most important consideration seems to be making a good tight connection. That we had no crimp failures in true torture chamber conditions speaks volumes for a good tight crimp, where the strands and the terminal are essentially welded together by the pressure of the crimp. ▲
