## HOW WE TESTED

# Wax On, Wax Off

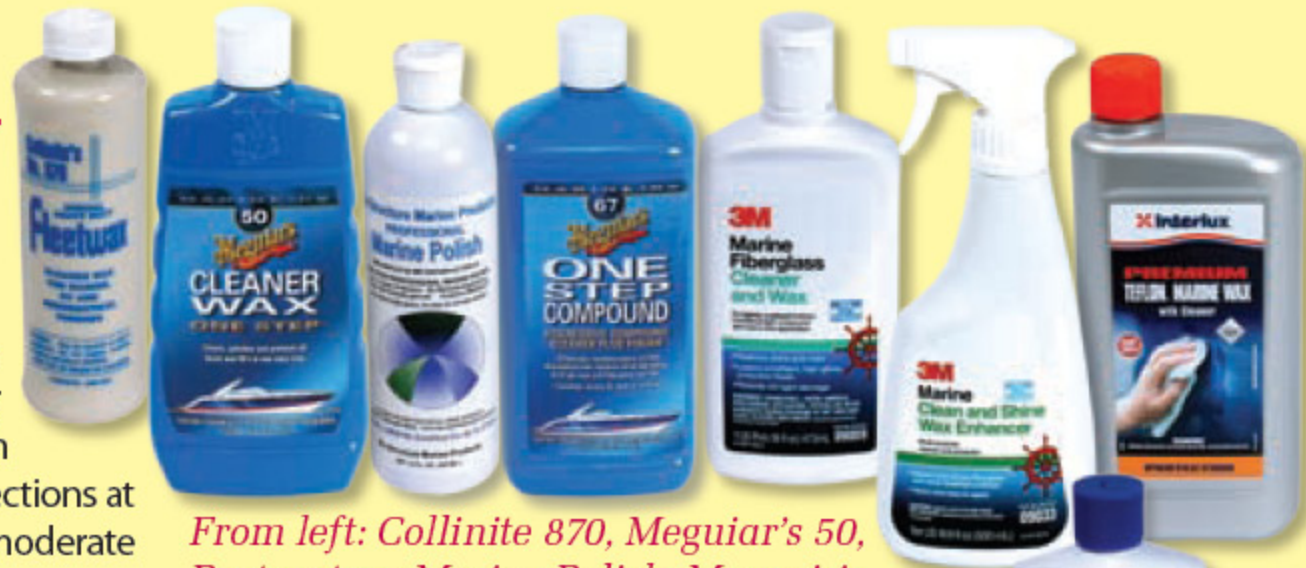
*From left: Collinite 870, Meguiar’s 50, Restructure Marine Polish, Meguiar’s 67, 3M Fiberglass Cleaner Wax, 3M Clean & Shine, Interlux Premium, West Marine One Step, Star brite Cleaner Wax, and Simoniz.*
