Irwin 37

A lot of boat for the money, as long as minor points like sailing performance aren't important to you.

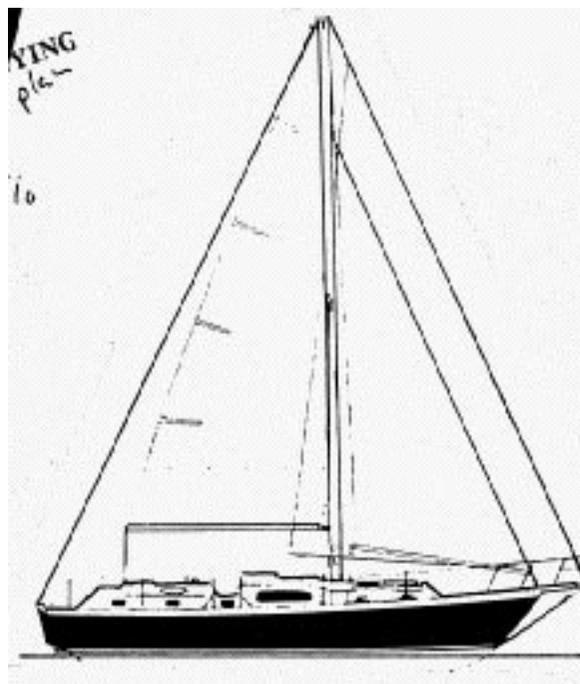
Specifications

| LOA | 37' 0" |
| LWL | 30' 0" |
| Beam | 11' 6" |
| Draft | 4' 0"/5' 6" (shoal/full keel) |
| Displacement | 20,000 lbs. |
| Ballast | 7,800 lbs. |
| Sail area | 625 sq. ft. |

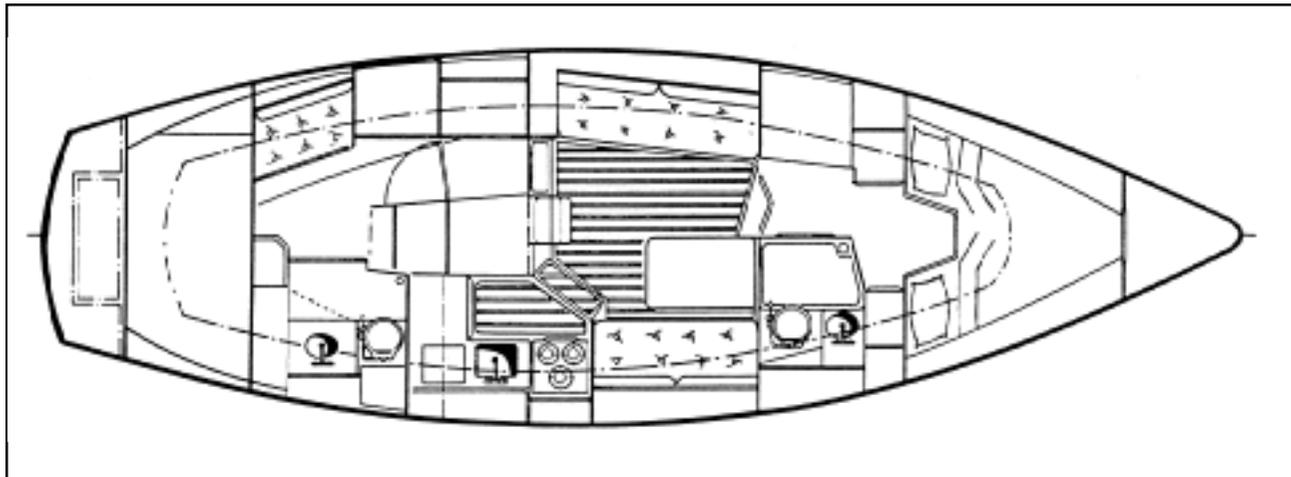
We may not like the way she sails or her construction quality, but the interior layout is very good. Still, there are some problems when it comes to storage.

Two other points about the interior deserve comment, one favorably and one not so. Engine access

and sound insulation are among the best we have seen in a production boat, helped by removable panels on the sides of the walk-through. To check the dipstick and heat exchanger water there is no need to move the companionway ladder. In short, if the engine of the 37 seizes from lack of oil or overheats for lack of water, the owner has only himself to blame.
