CONSTRUCTION DETAILS

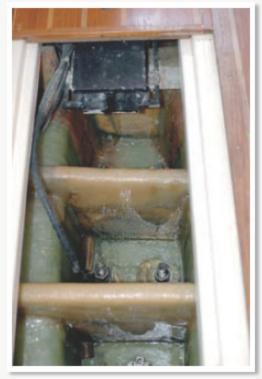
Fiberglass athwartship floor frames helped reinforce the keel stub and cope with the side force imposed by the lead ballast keel.
