## U.S. Navy Contract Emphasizes Structural Integrity

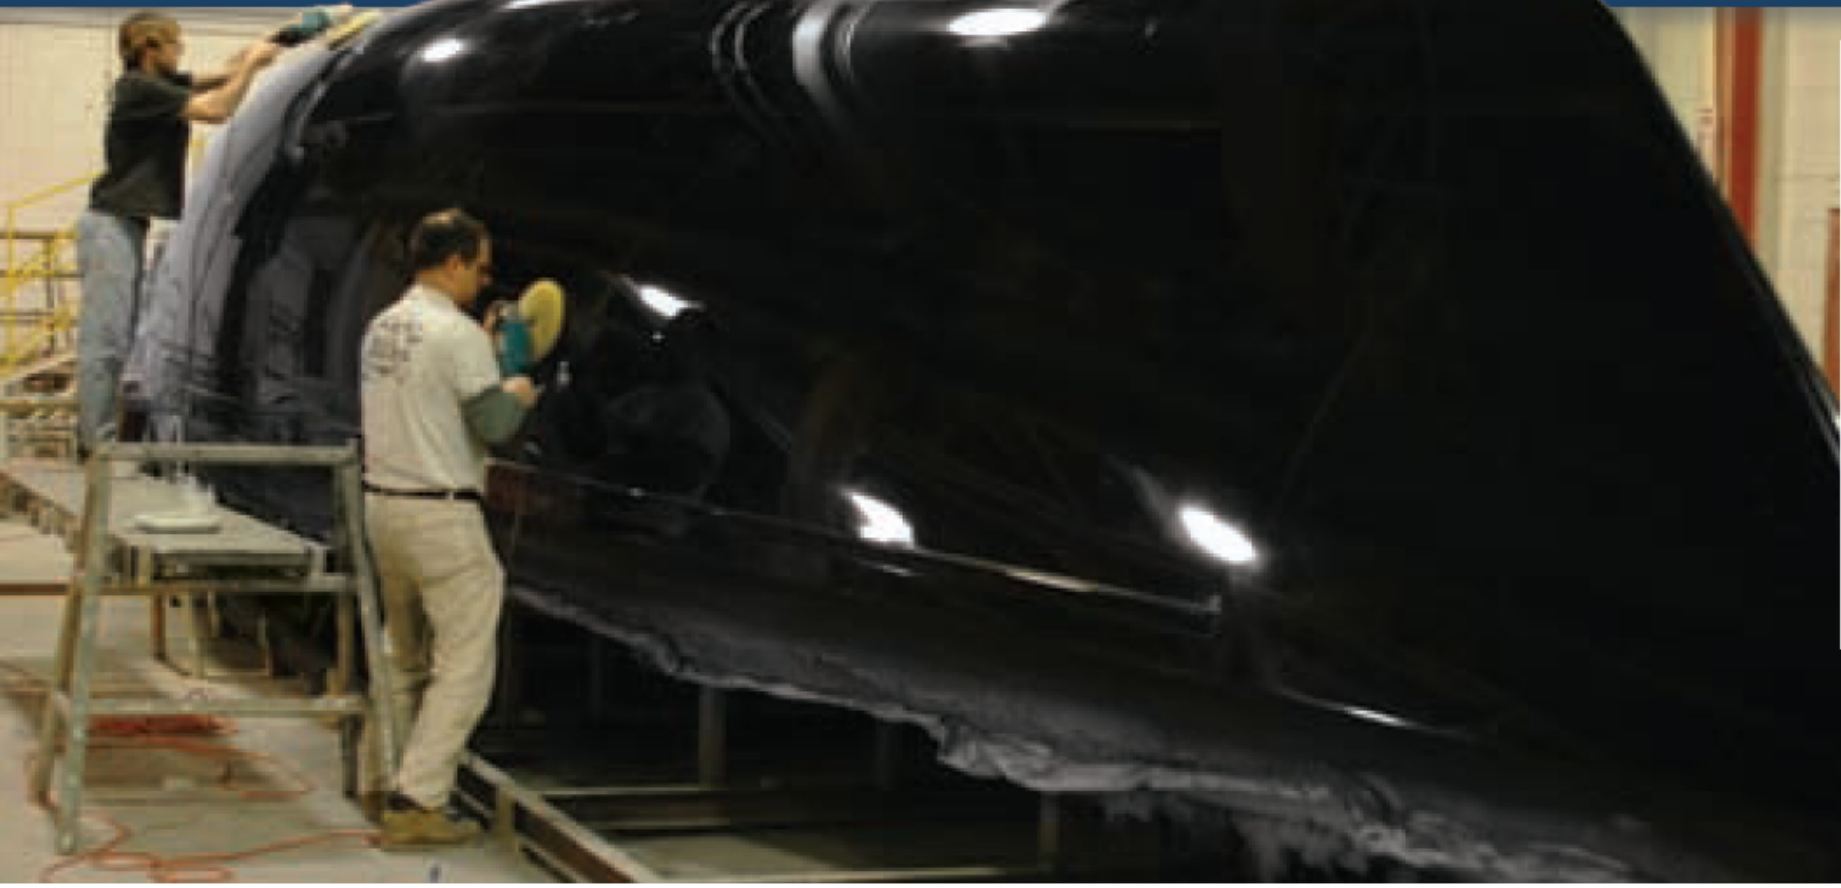
*The plug is polished before being used to make the mold (above). A rugged weldment reinforces the mast partners (top right). Rudder bearing loads (right) are transferred via a star-shaped grid.*
