## A Long-term Test

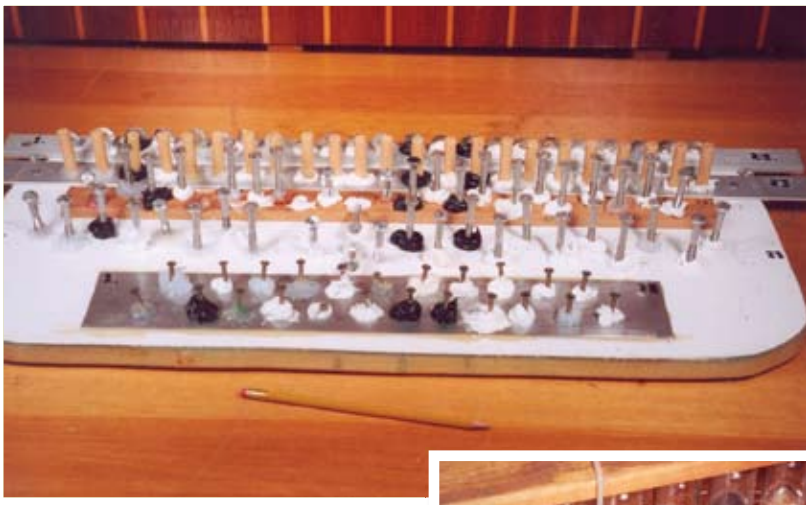
Readers might want to review the initial April 1, 2005, report. As shown in these photos, the surfaces are fiberglass; wood (teak and oak); aluminum (raw and anodized); stainless steel, and brass—all used in various combinations with wood dowels, stainless bolts and washers, and brass screws.

The caulks and sealants were used in globs (to provide more exposure to sun, rain, snow, etc.) instead of thin layers as they would be in most applications. Having more body meant that the curing time had to be generous.

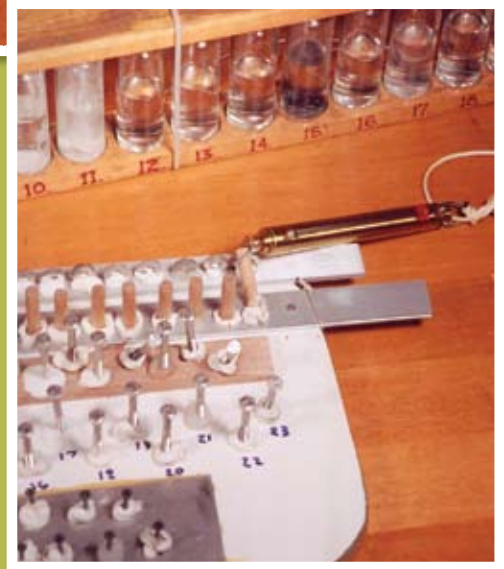
The panel and the bottle rack containing small bottles used to check waterproofness (see photo, above right), were placed outdoors on June 1, 2005.

Although the bottles were subjected to the hot summer sun and repeatedly frozen solid during the winter, either the sealant test must

be considered a flop or it proves that one need not worry about the sealing nature of these products, at least for a year.
