CORE CHECK

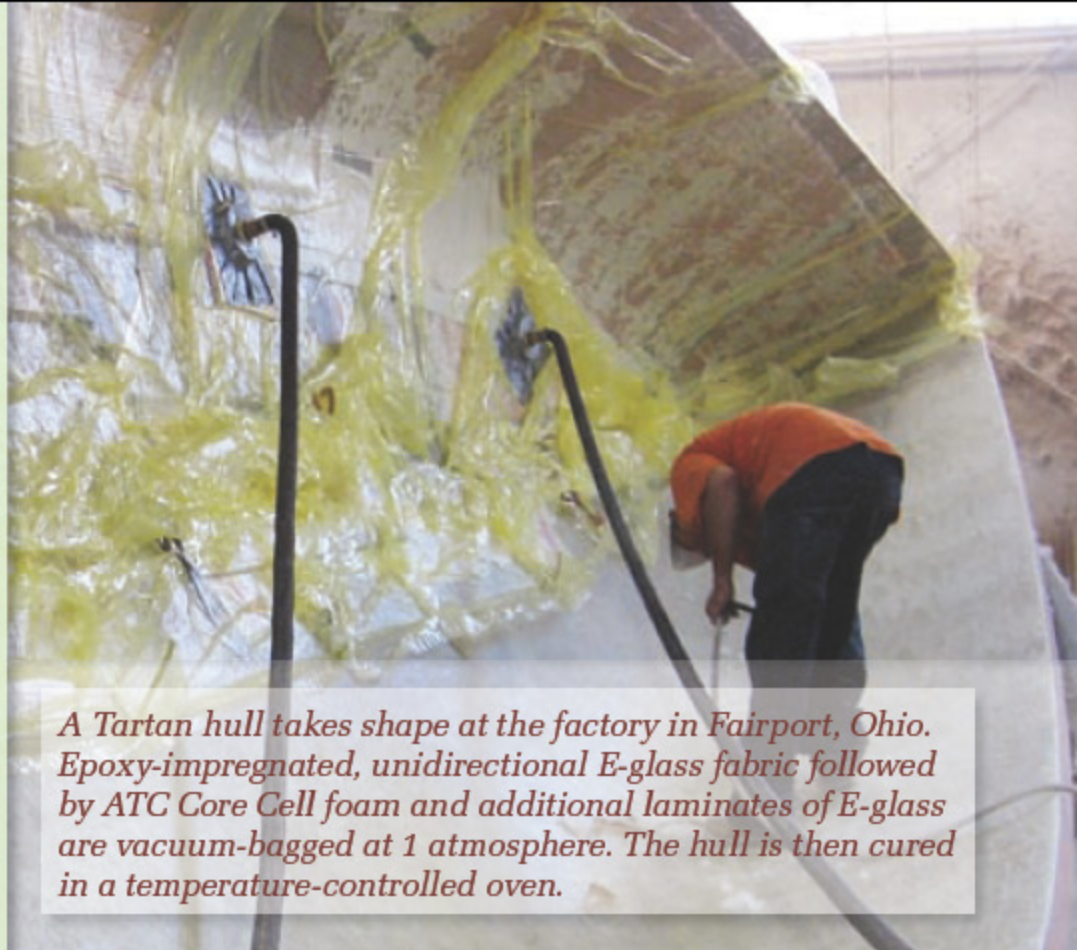
A Tartan hull takes shape at the factory in Fairport, Ohio. Epoxy-impregnated, unidirectional E-glass fabric followed by ATC Core Cell foam and additional laminates of E-glass are vacuum-bagged at 1 atmosphere. The hull is then cured in a temperature-controlled oven.

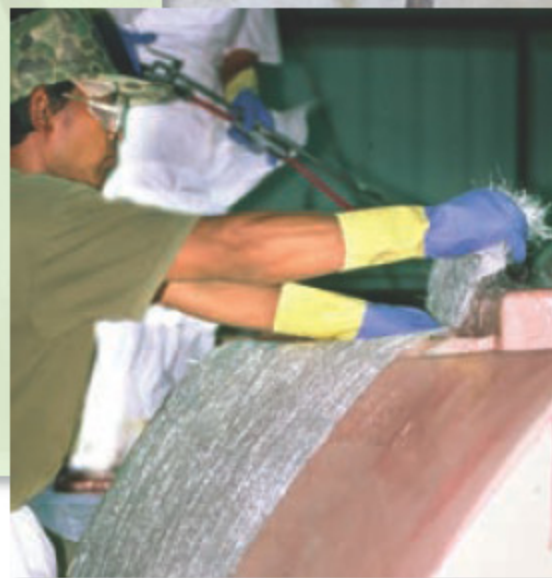
A laminator applies a layer of chopped strand mat to the underside of a cored cockpit well (inverted here). The core is bedded in a resin-rich mixture of chopped strand mat. Hand-lamination requires more resin to eliminate voids. Although reaching panel consistency is nearly impossible, careful application can result in a strong, durable hull.
