## HITS AND MISSES

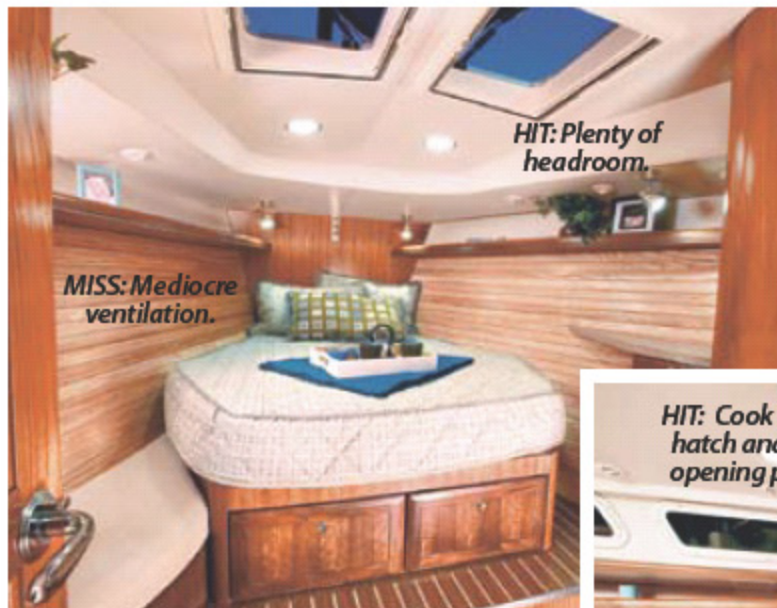
**MISS:** Mediocre ventilation.

**HIT:** Plenty of headroom.

**HIT:** V-berth (above) offers spacious sleeping quarters.

**MISS:** Side-opening V-berth hatches stymie ventilation at anchor.

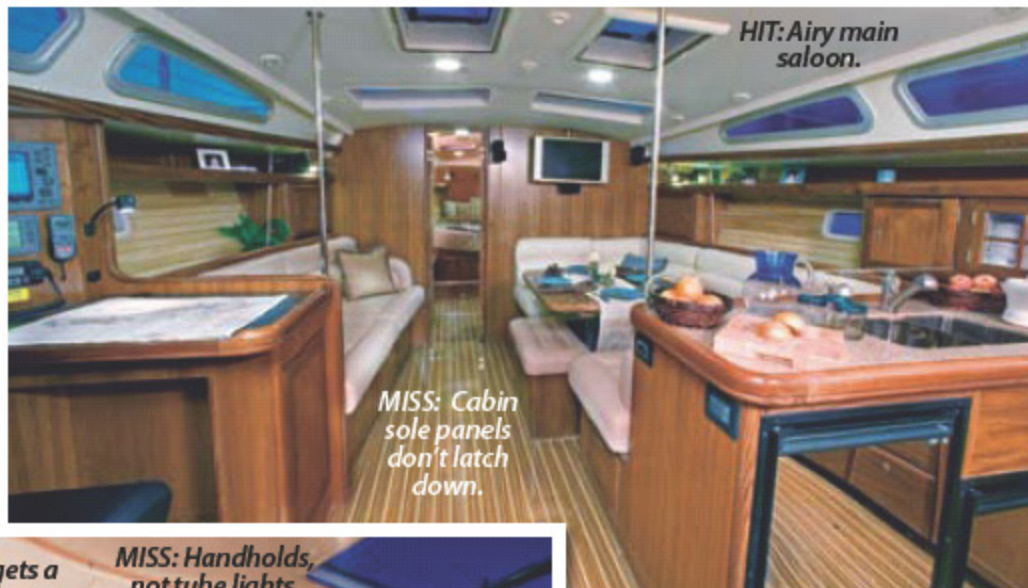
**HIT:** Airy main salon.

**MISS:** Cabin sole panels don't latch down.

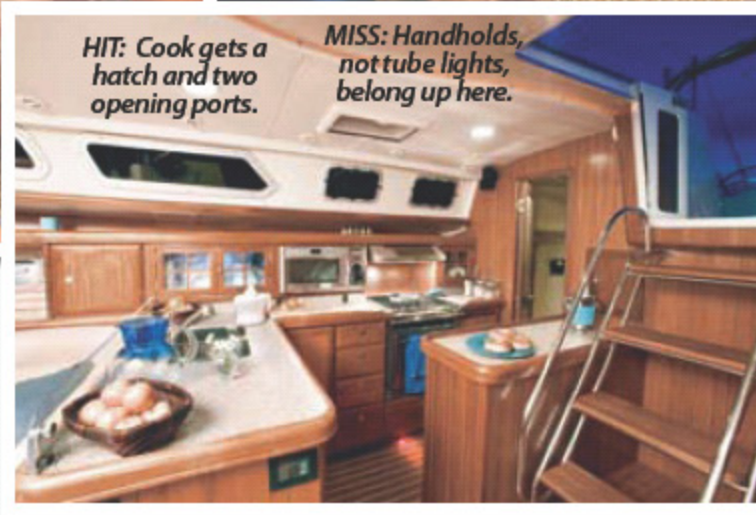
**HIT:** Cook gets a hatch and two opening ports.

**MISS:** Handholds, not tube lights, belong up here.

**HIT:** Roomy salon is great for socializing.

**MISS:** Front-loading fridge and freezer are relatively inefficient.

**HIT:** L-shaped galley is ergonomically arranged.

**MISS:** Bi-fold doors at companionway are too wimpy for our taste.
