Optima leads Monterey in sailboat head-to-head

To compare certain bottom paints actually in use, we are conducting head-to-head anti-fouling tests on four boats (two sail, two power). When painted, each test boat's bottom is taped off into quarters, with one paint on the port bow and starboard stern, and the other on the starboard bow and port stern. This gives nearly equal exposure to sunlight and water flow. Here is an update on our sailboat test after six months. The table below also summarizes our other head-to-head tests.

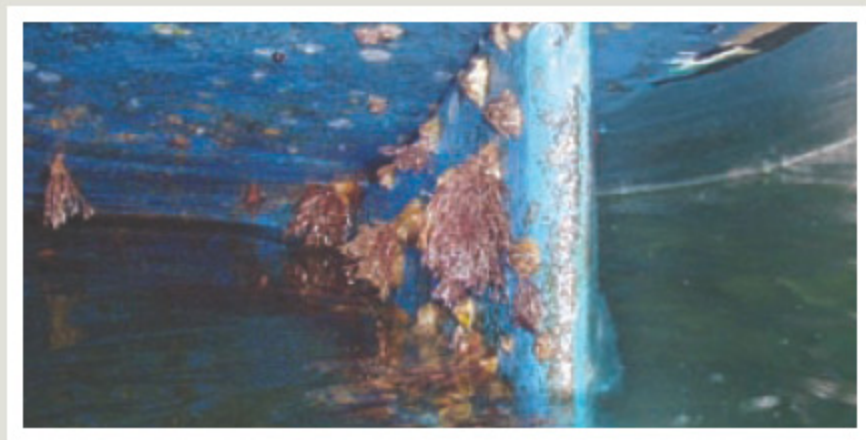
After six months, a small colony of barnacles clustered on the port stern of our Florida test boat (raised here for inspection).

Florida results: This boat mostly sat, so the southeast-facing port quarter (Monterey) saw more sunlight. Nevertheless, we saw a clear difference between the paints in sections with equal sun exposure. Overall, Optima scored Good. It had only a light cover of slime near the keel, and at the waterline was a thicker algae-like coating that wiped away. The Monterey scored Fair on the starboard bow where it had heavier concentrations of algae growth that easily wiped away. It scored Poor on the port stern quarter where it had a thin coat of algae, and along the waterline about 100 barnacles and about 100 soft invertebrates measuring up to about 1 inch long (see photo above). We intend
