Spot Passes Bermuda Test

Position reports take 10 to 20 minutes, but data is accurate and device holds up well.

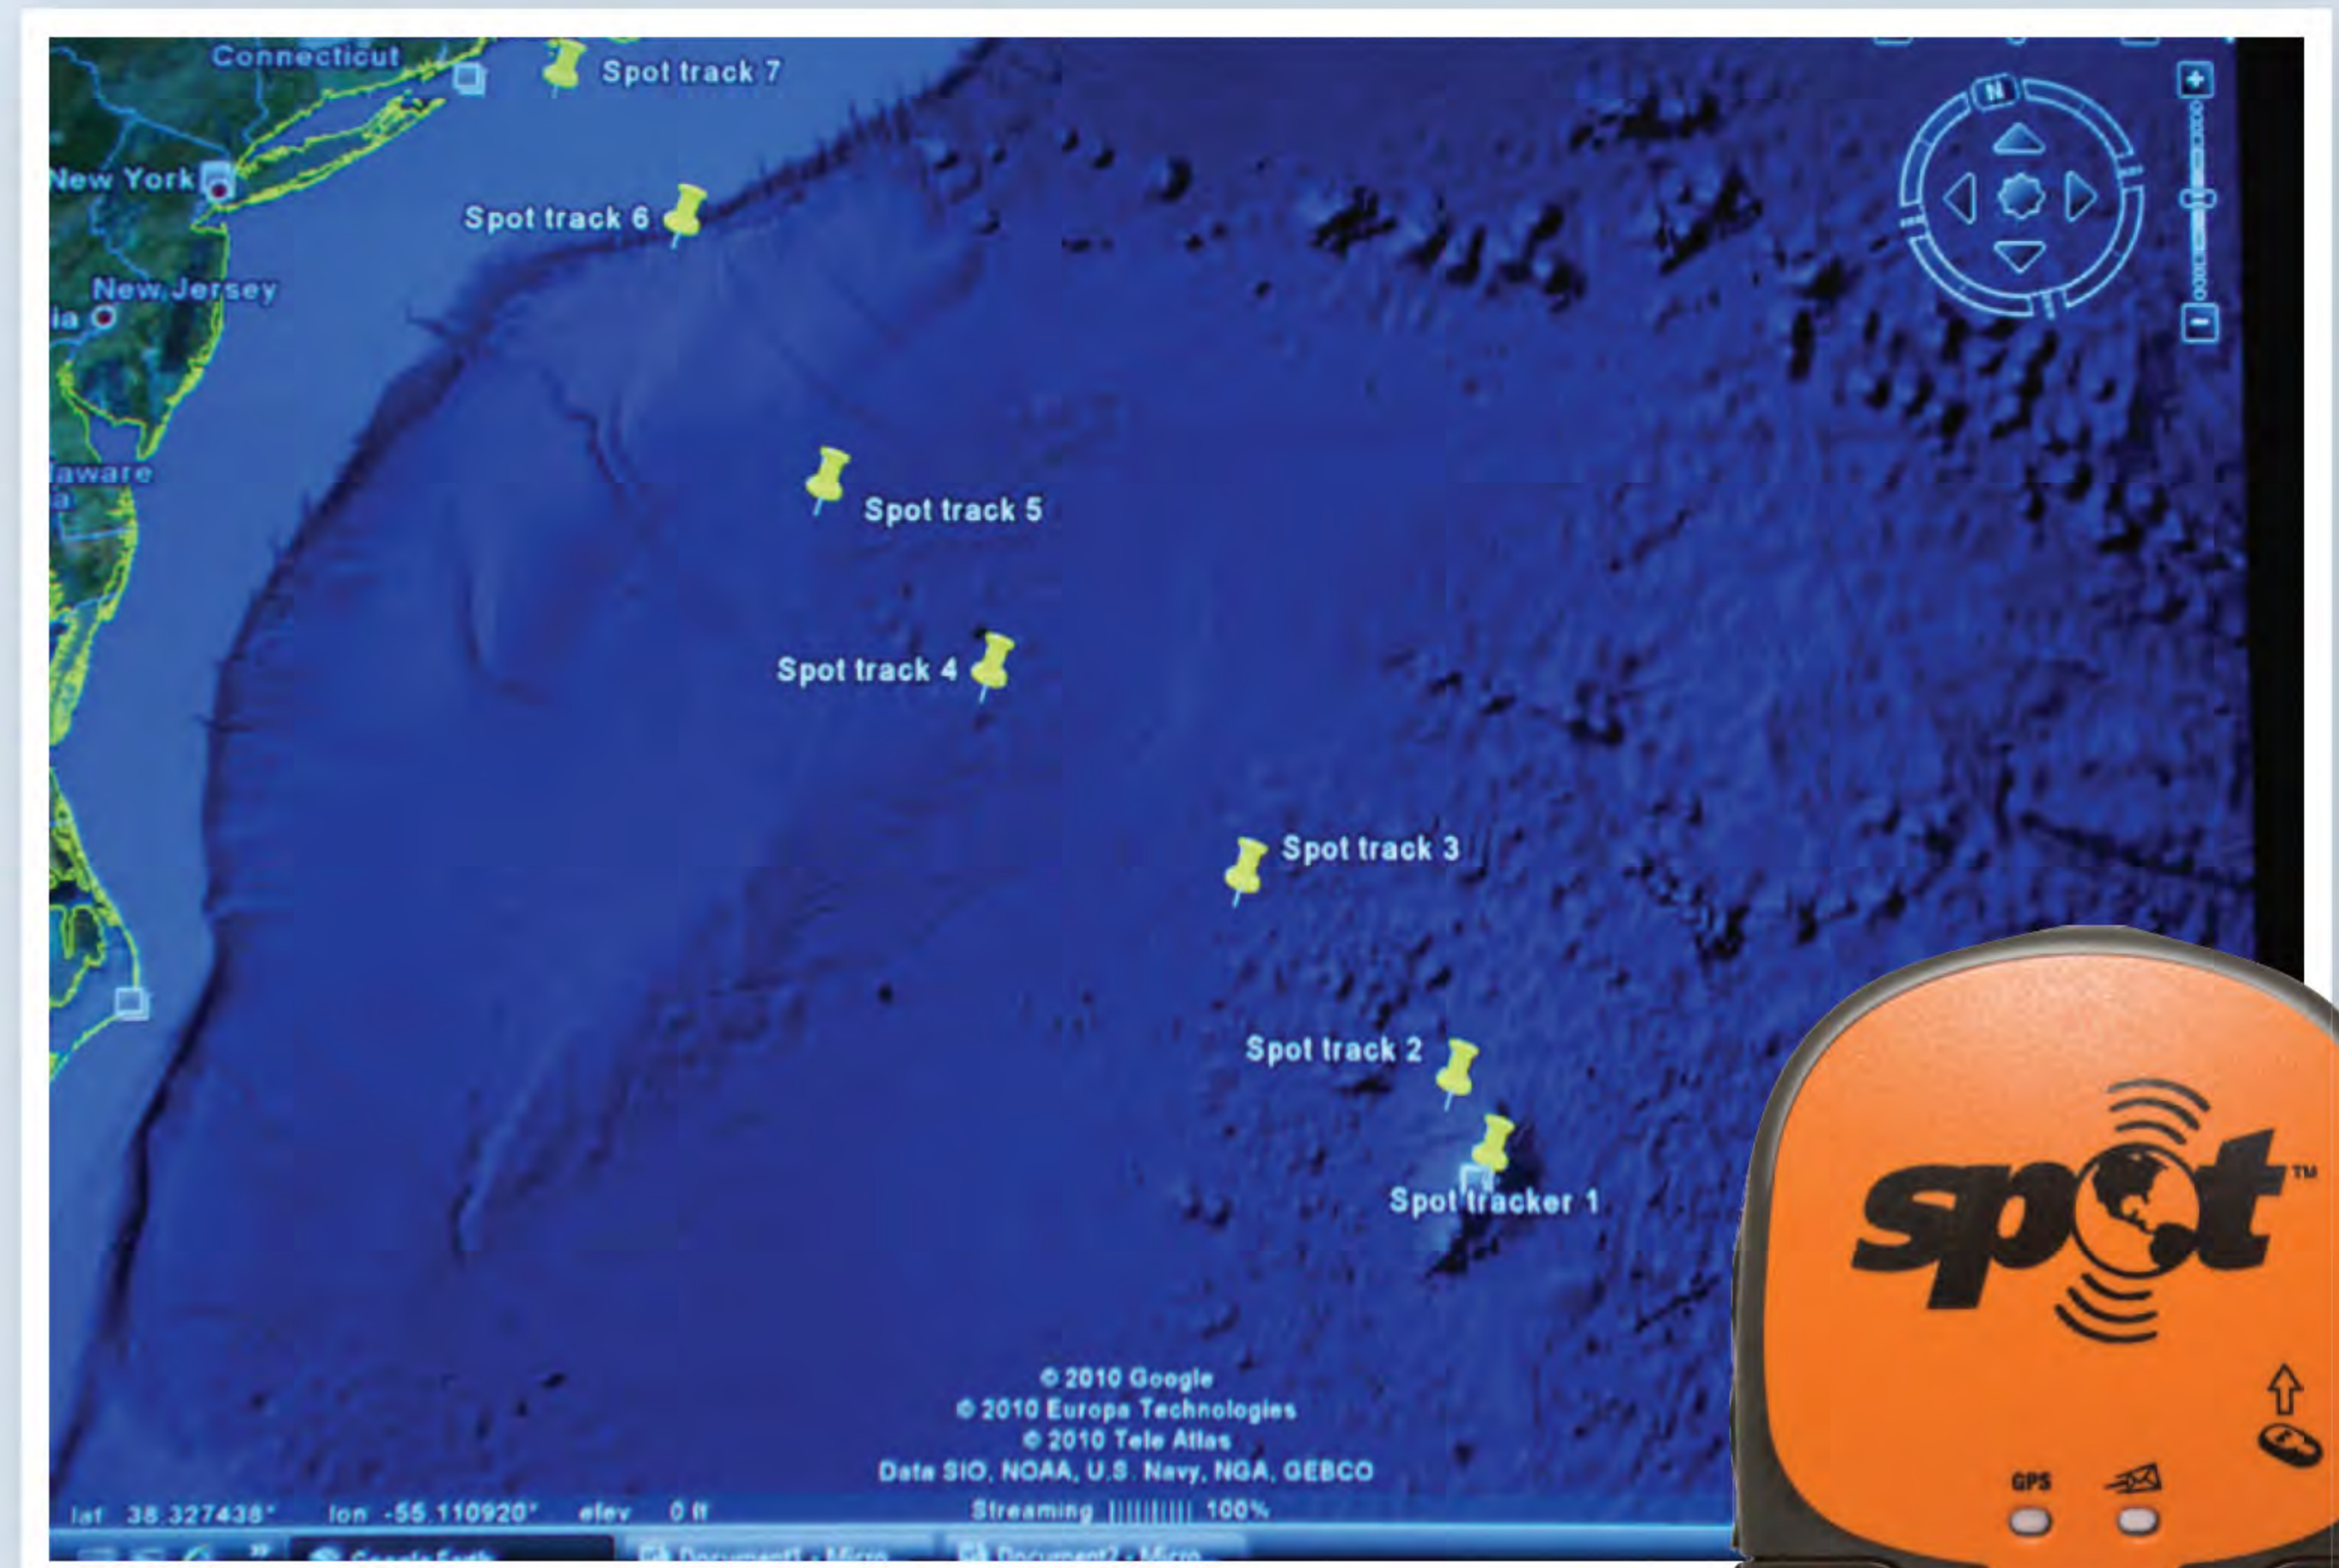
Thumbtacks on a Google Earth page (above) mark positions posted using the original Spot (right). PS has not yet tested the Spot2 (above right), which has a new look (including a much-needed cover for the SOS button), but its introduction was marred by a recall.

The unit worked well from under the boat's canvas dodger but did not acquire satellite signals below deck. Each time a position report was sent, it was automatically forwarded via e-mail from the Spot homepage to pre-designated contacts. The reported positions were later confirmed (to within 100 feet) with logged data from the onboard GPS.
