Six Coatings Face Bench Tests

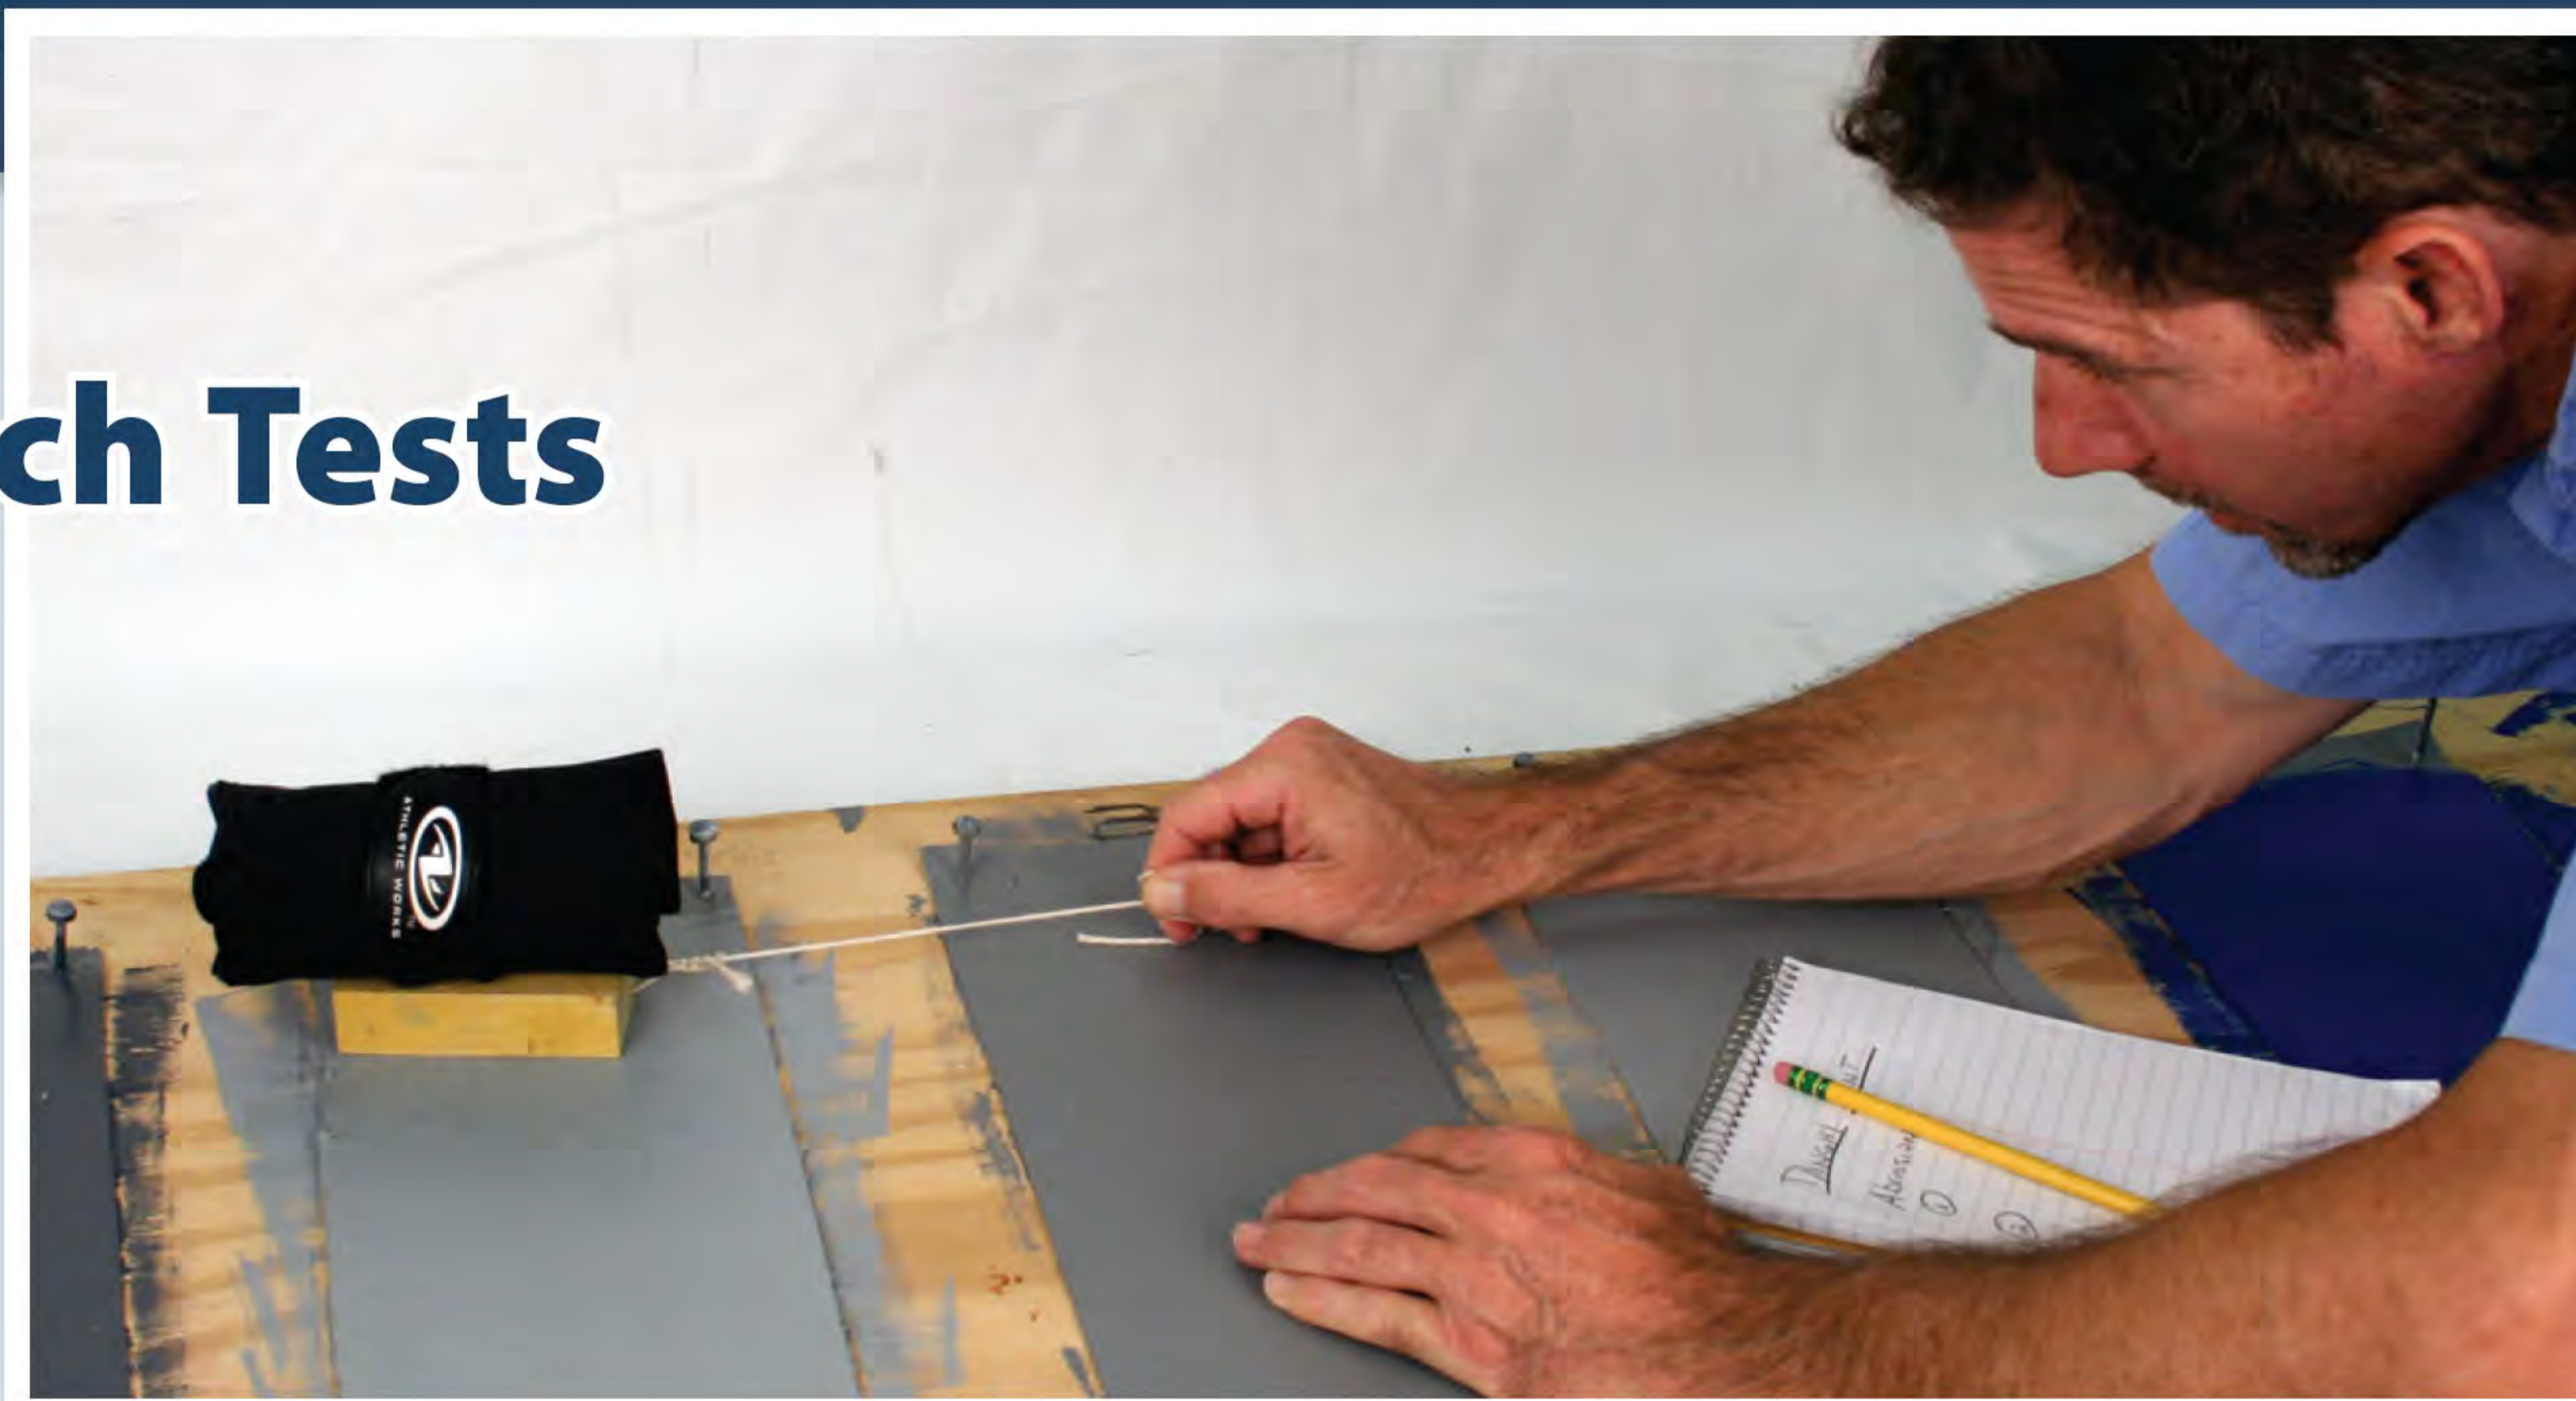
To gauge each coating's abrasion resistance, testers dragged a weighted 320-grit sanding block across each panel three times.

To determine the paints' abrasion resistance, testers dragged a 320-grit sanding block across each panel three times. Atop the block was a two-pound weight, and it was dragged using a string so that each drag had a uniform amount of pressure on it. Paints that showed very little or no scuffing earned the best ratings, and those that showed considerable scuffing were rated Poor.
