## SPECIAL REPORT

A fall gale swept across western Long Island Sound in 2006, driving these boats ashore.

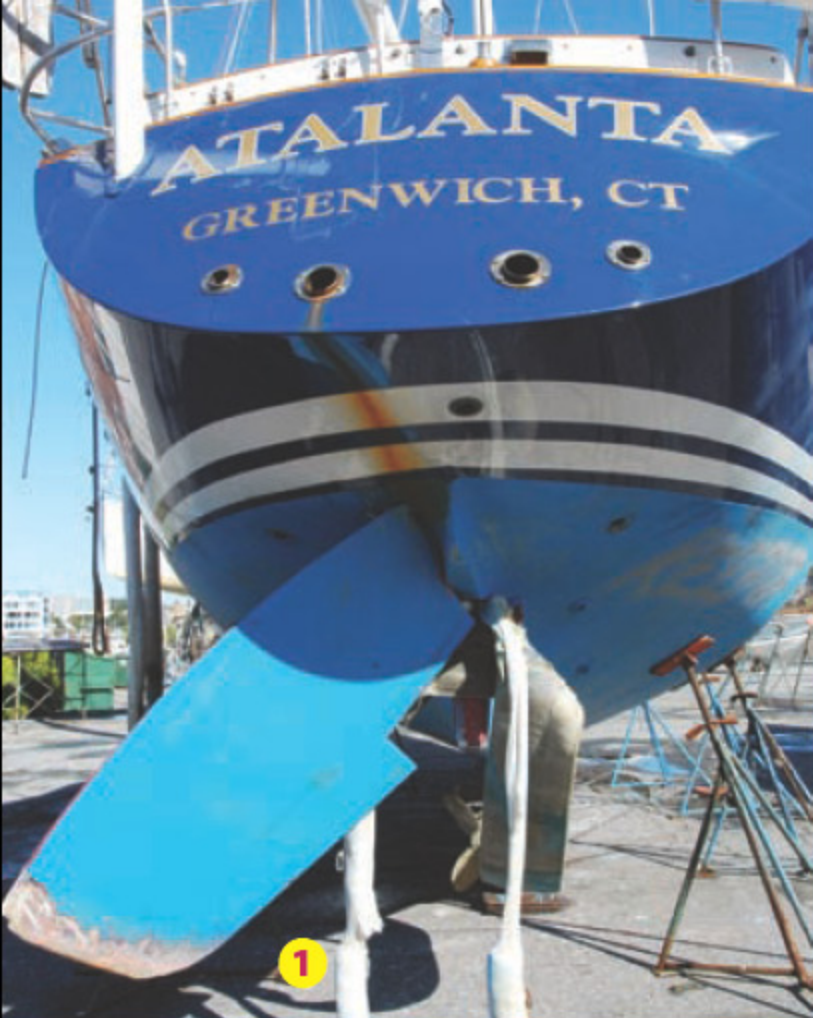
**1.** This Alden 44's lead-ballast keel absorbed much of the pounding, but its shallow draft allowed the rudder to also make contact with the rock jetty.

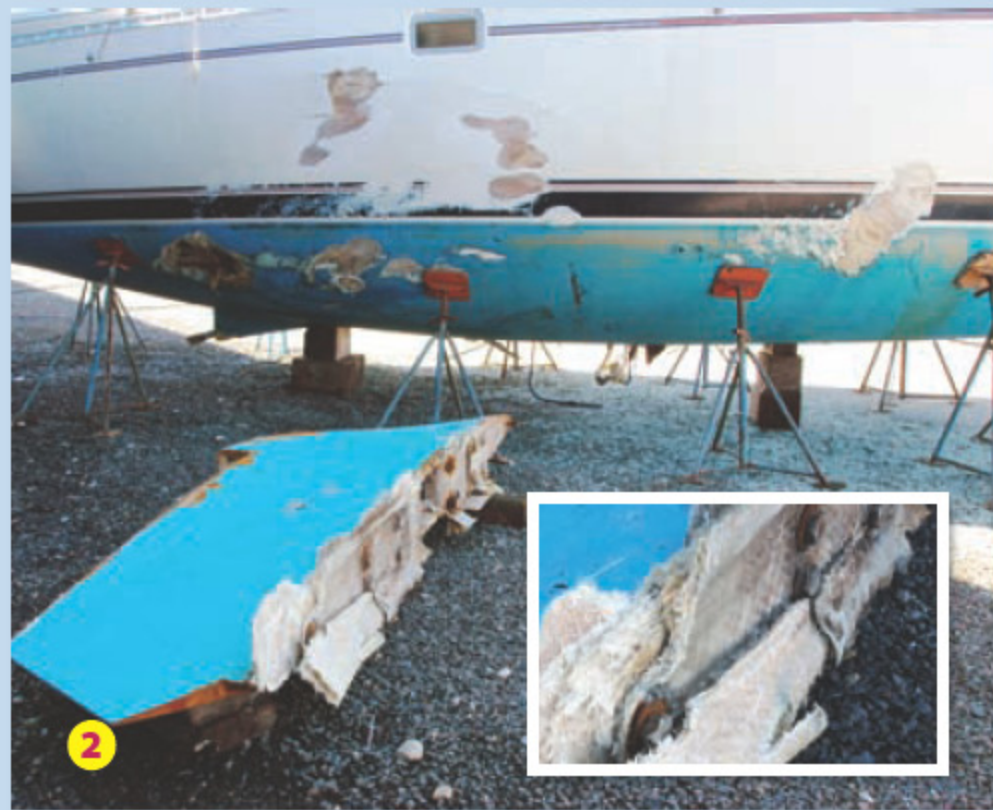
**2.** The junction between the hull and keel (note the keel bolts, inset) was the focal point for loads when this Beneteau fetched up on a rocky outcropping.

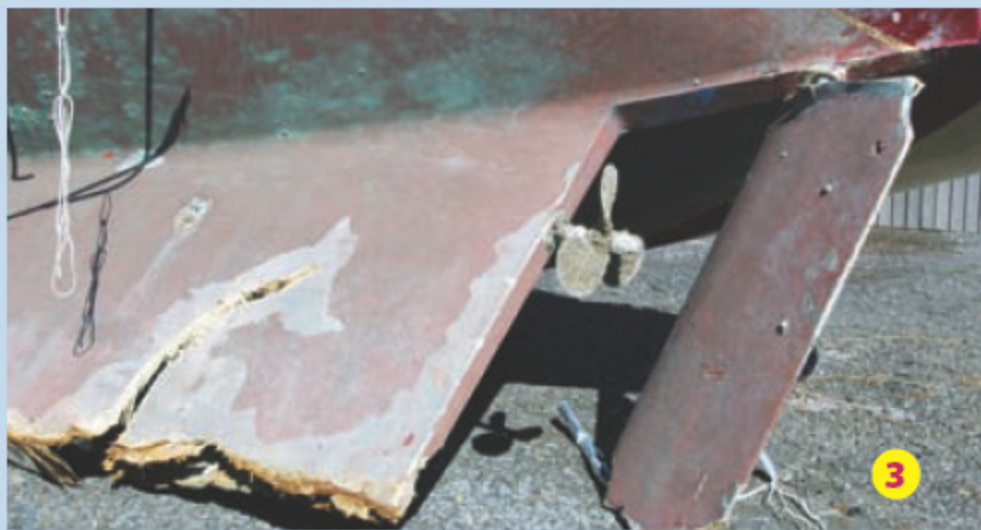
**3.** Attached rudder designs, like this one on an Island Packet 44, aren't immune to damage during a severe grounding episode.
