Starting with a Clean Slate

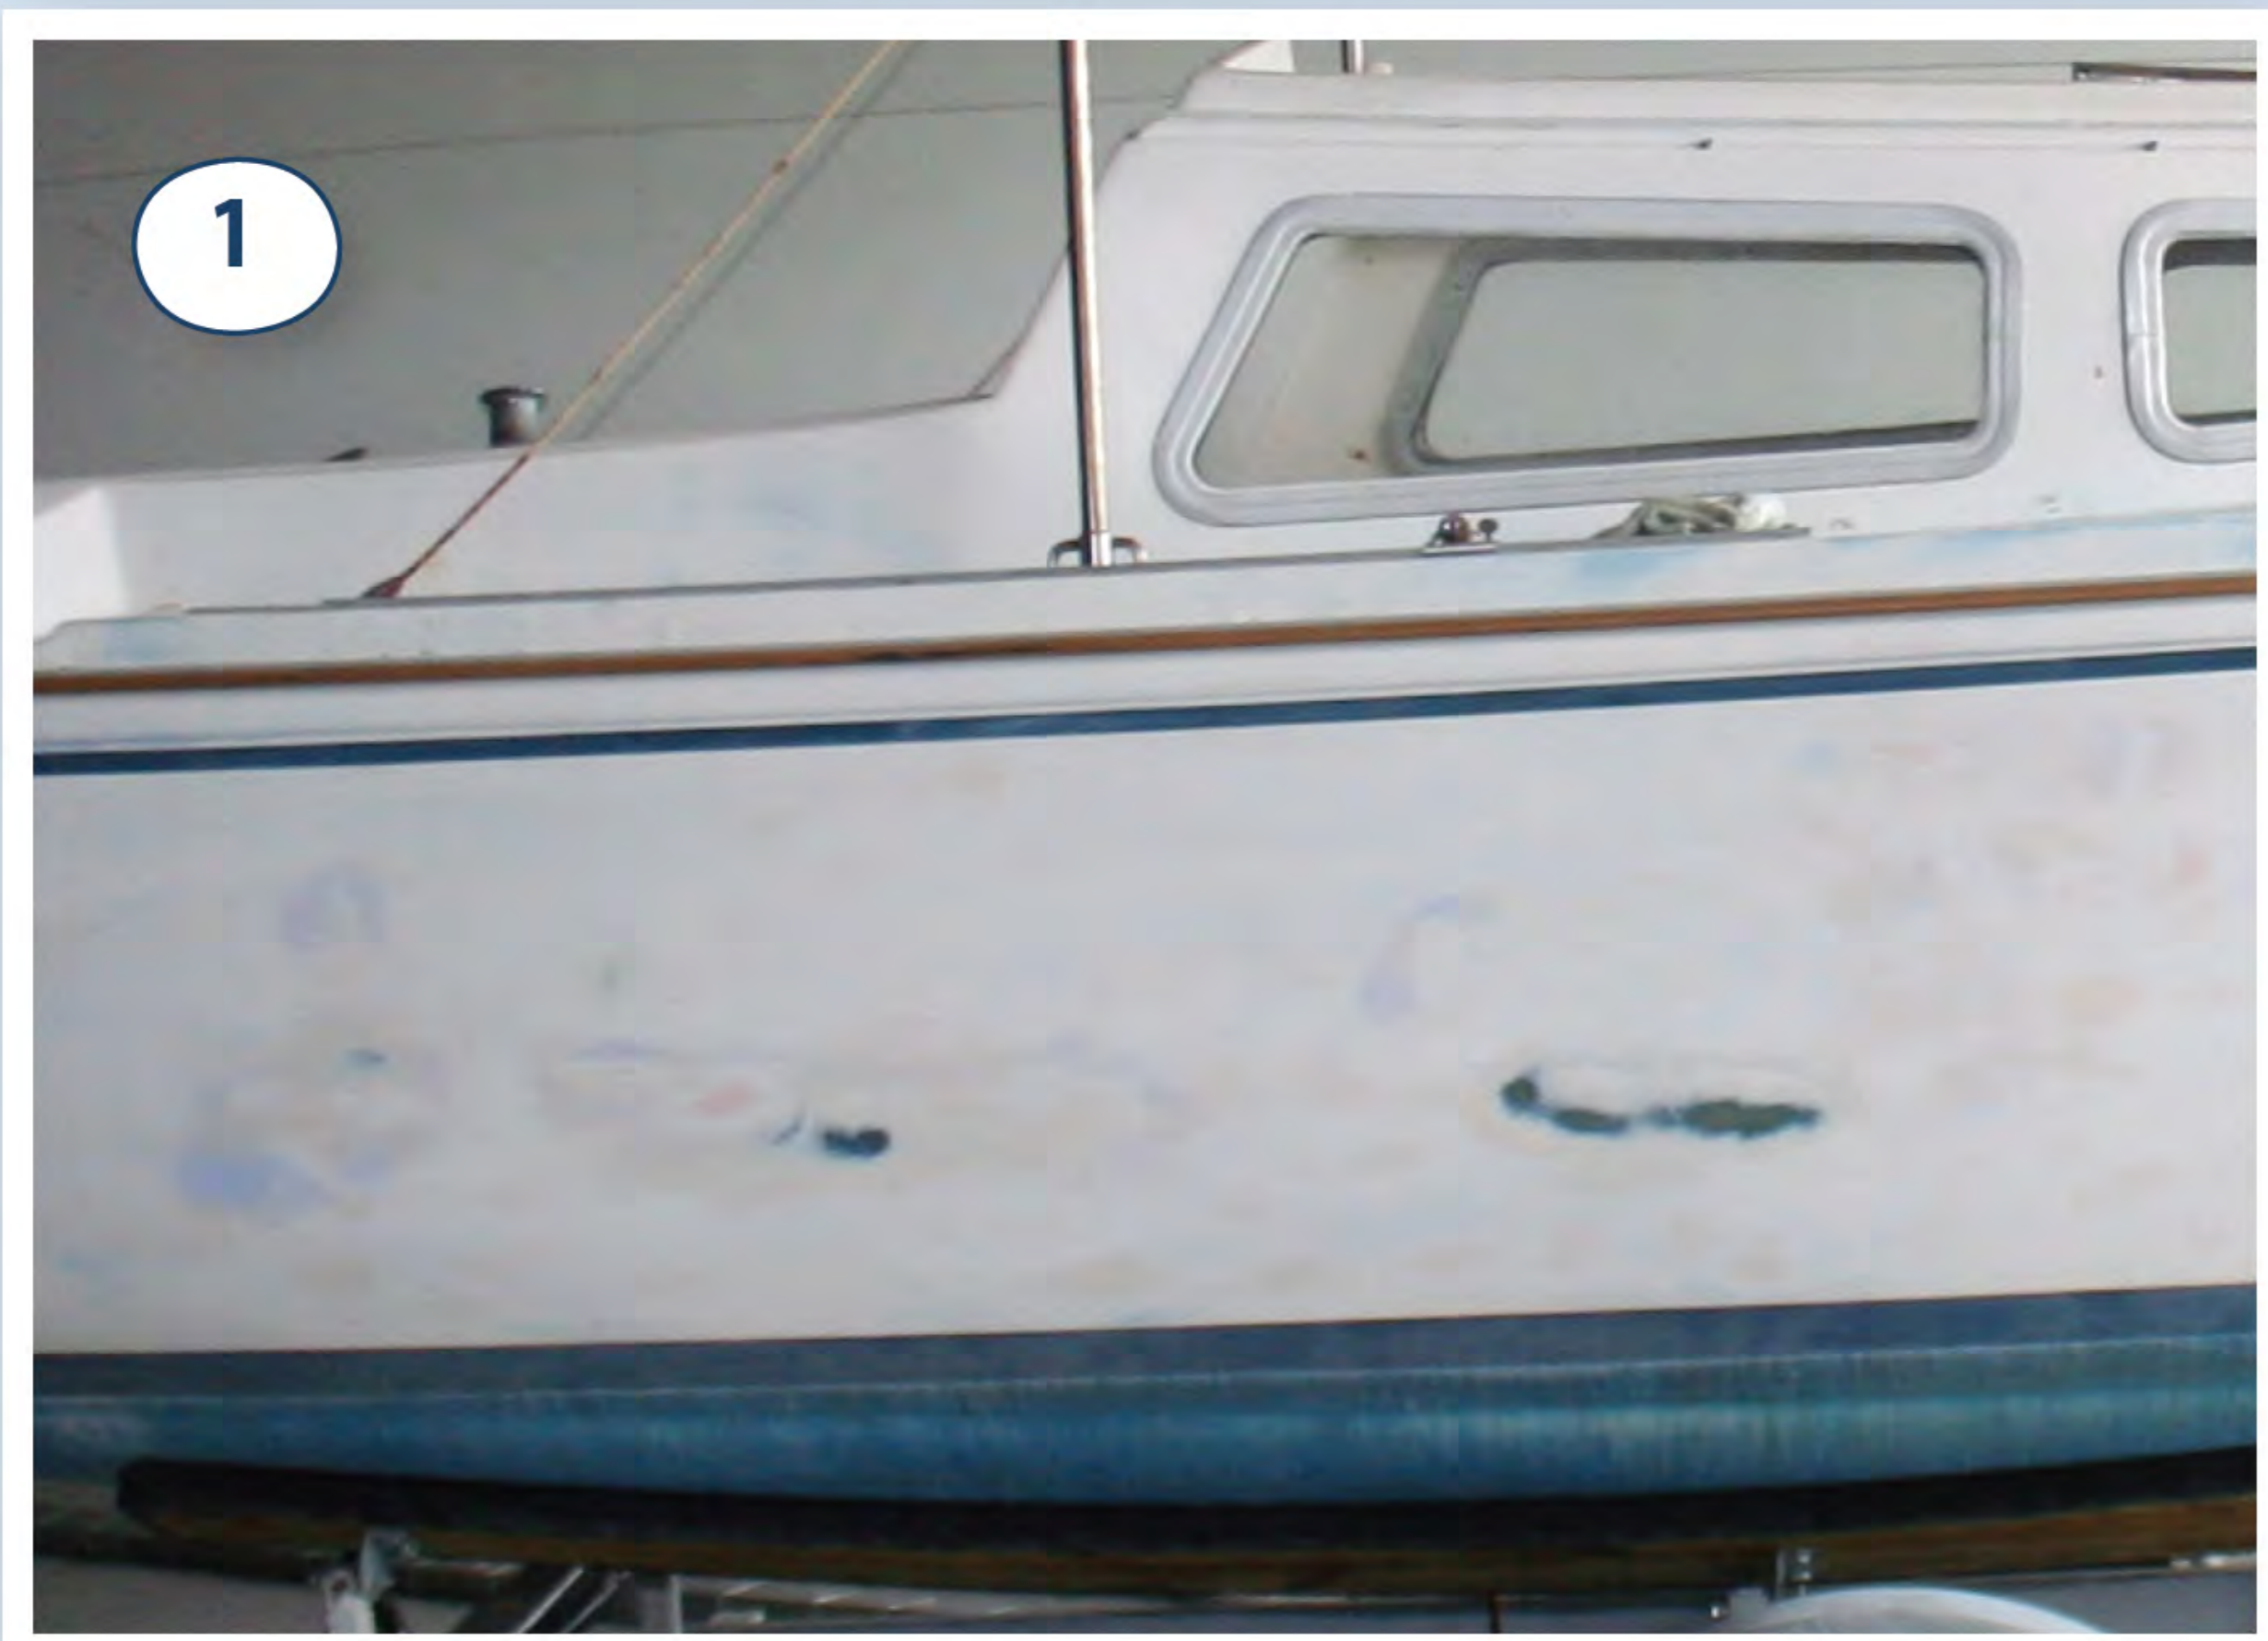
- Testers used 100-grit sandpaper and pneumatic dual-action (DA) sanders to smooth the surface and ready the hull for gelcoat repair. **(Photo 1)** We opted for pneumatic DAs as they leave a smoother finish than electric orbital sanders, even when used with a heavy hand. We hand-sanded at the molded lip below the toerail and the rounded edges of the transom.

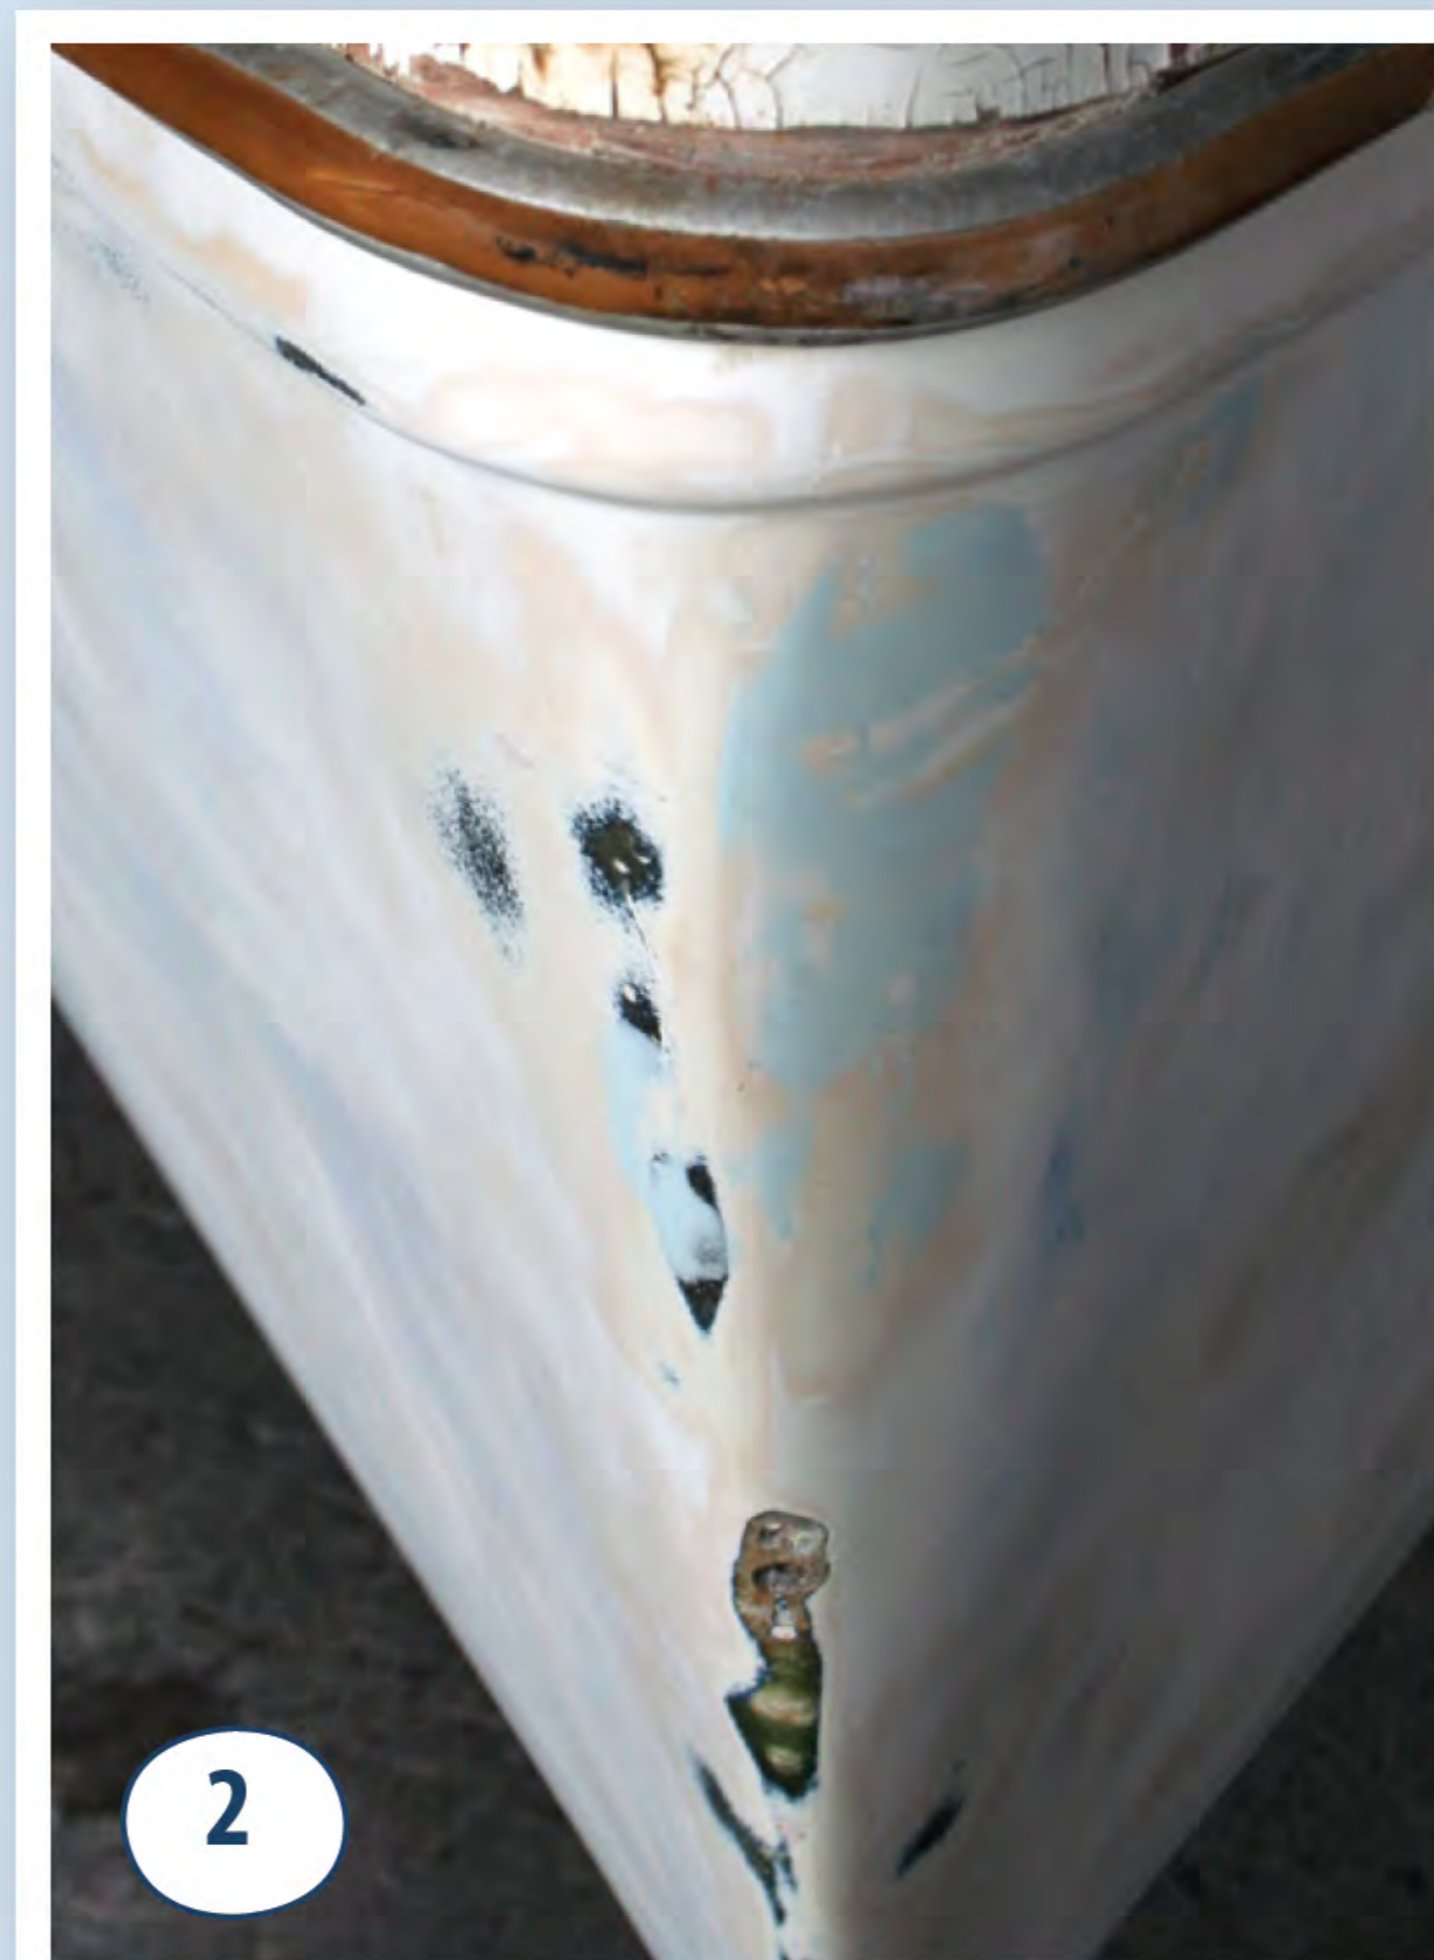
- To fill in gouges (like where the U-bolt had once been at the bow), worn gelcoat areas, and pin holes **(Photo 2)**, testers used fast-curing two-part fillers: the vinylester-based Ad-Tech Plastic Systems No. 17 SMCR (\$17/quart) and the more expensive two-part epoxy-based Interlux Interfill (\$130/gallon). (Not the difference in before and after shots of the bow in **Photo 3**.) Both products were easy to work with, cured quickly, and were easily faired with 150-grit and higher.

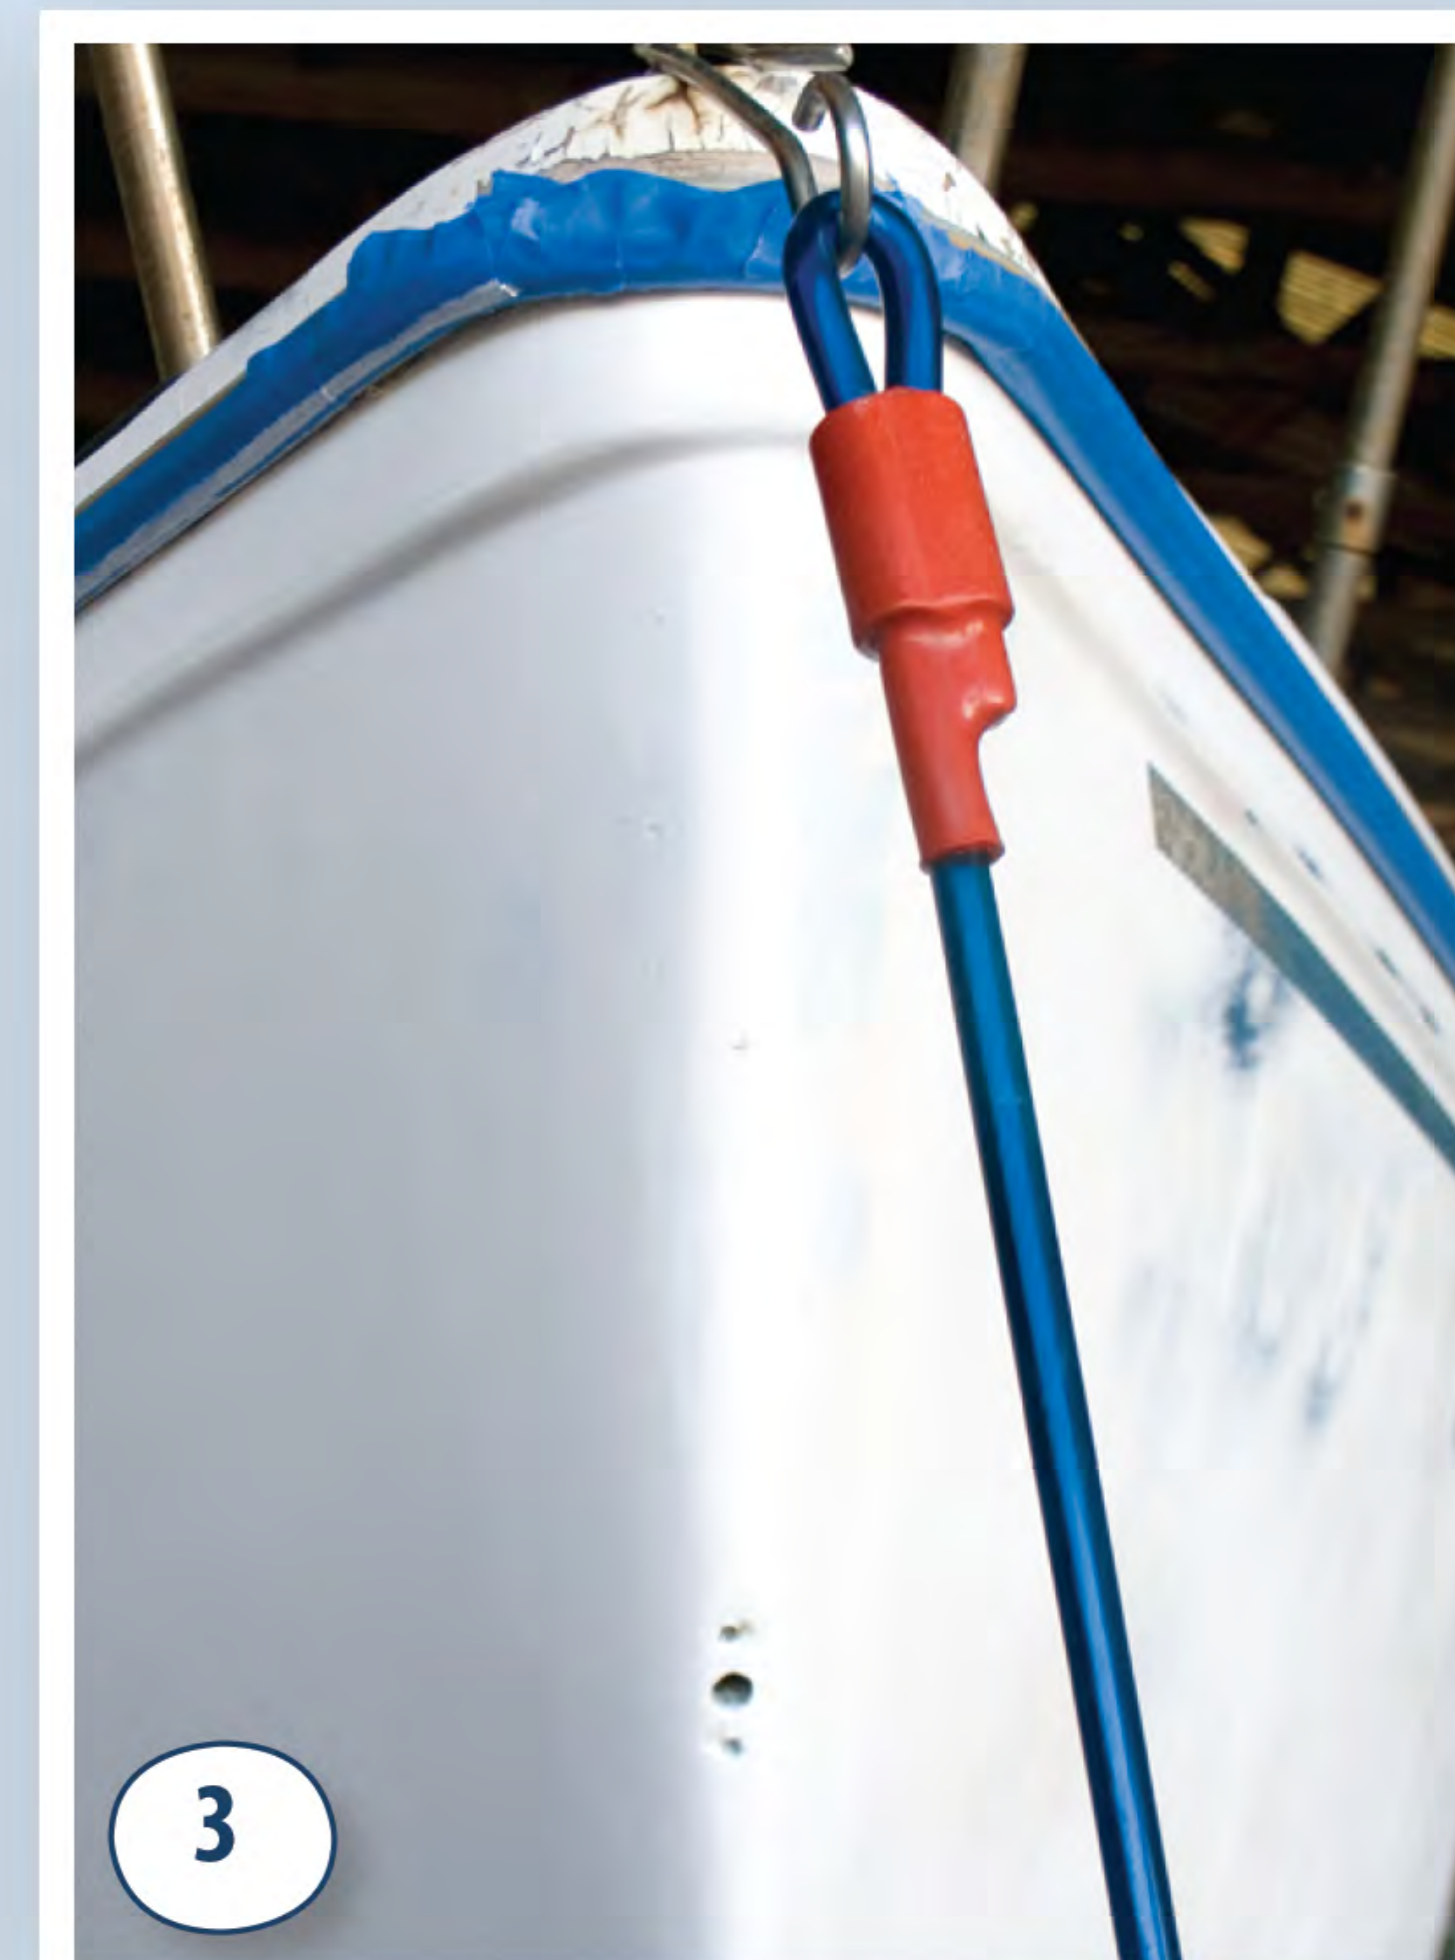
Note the difference already visible after one coat of Primekote (left) and zero coats of Epifanes (right) in **Photo 3**.

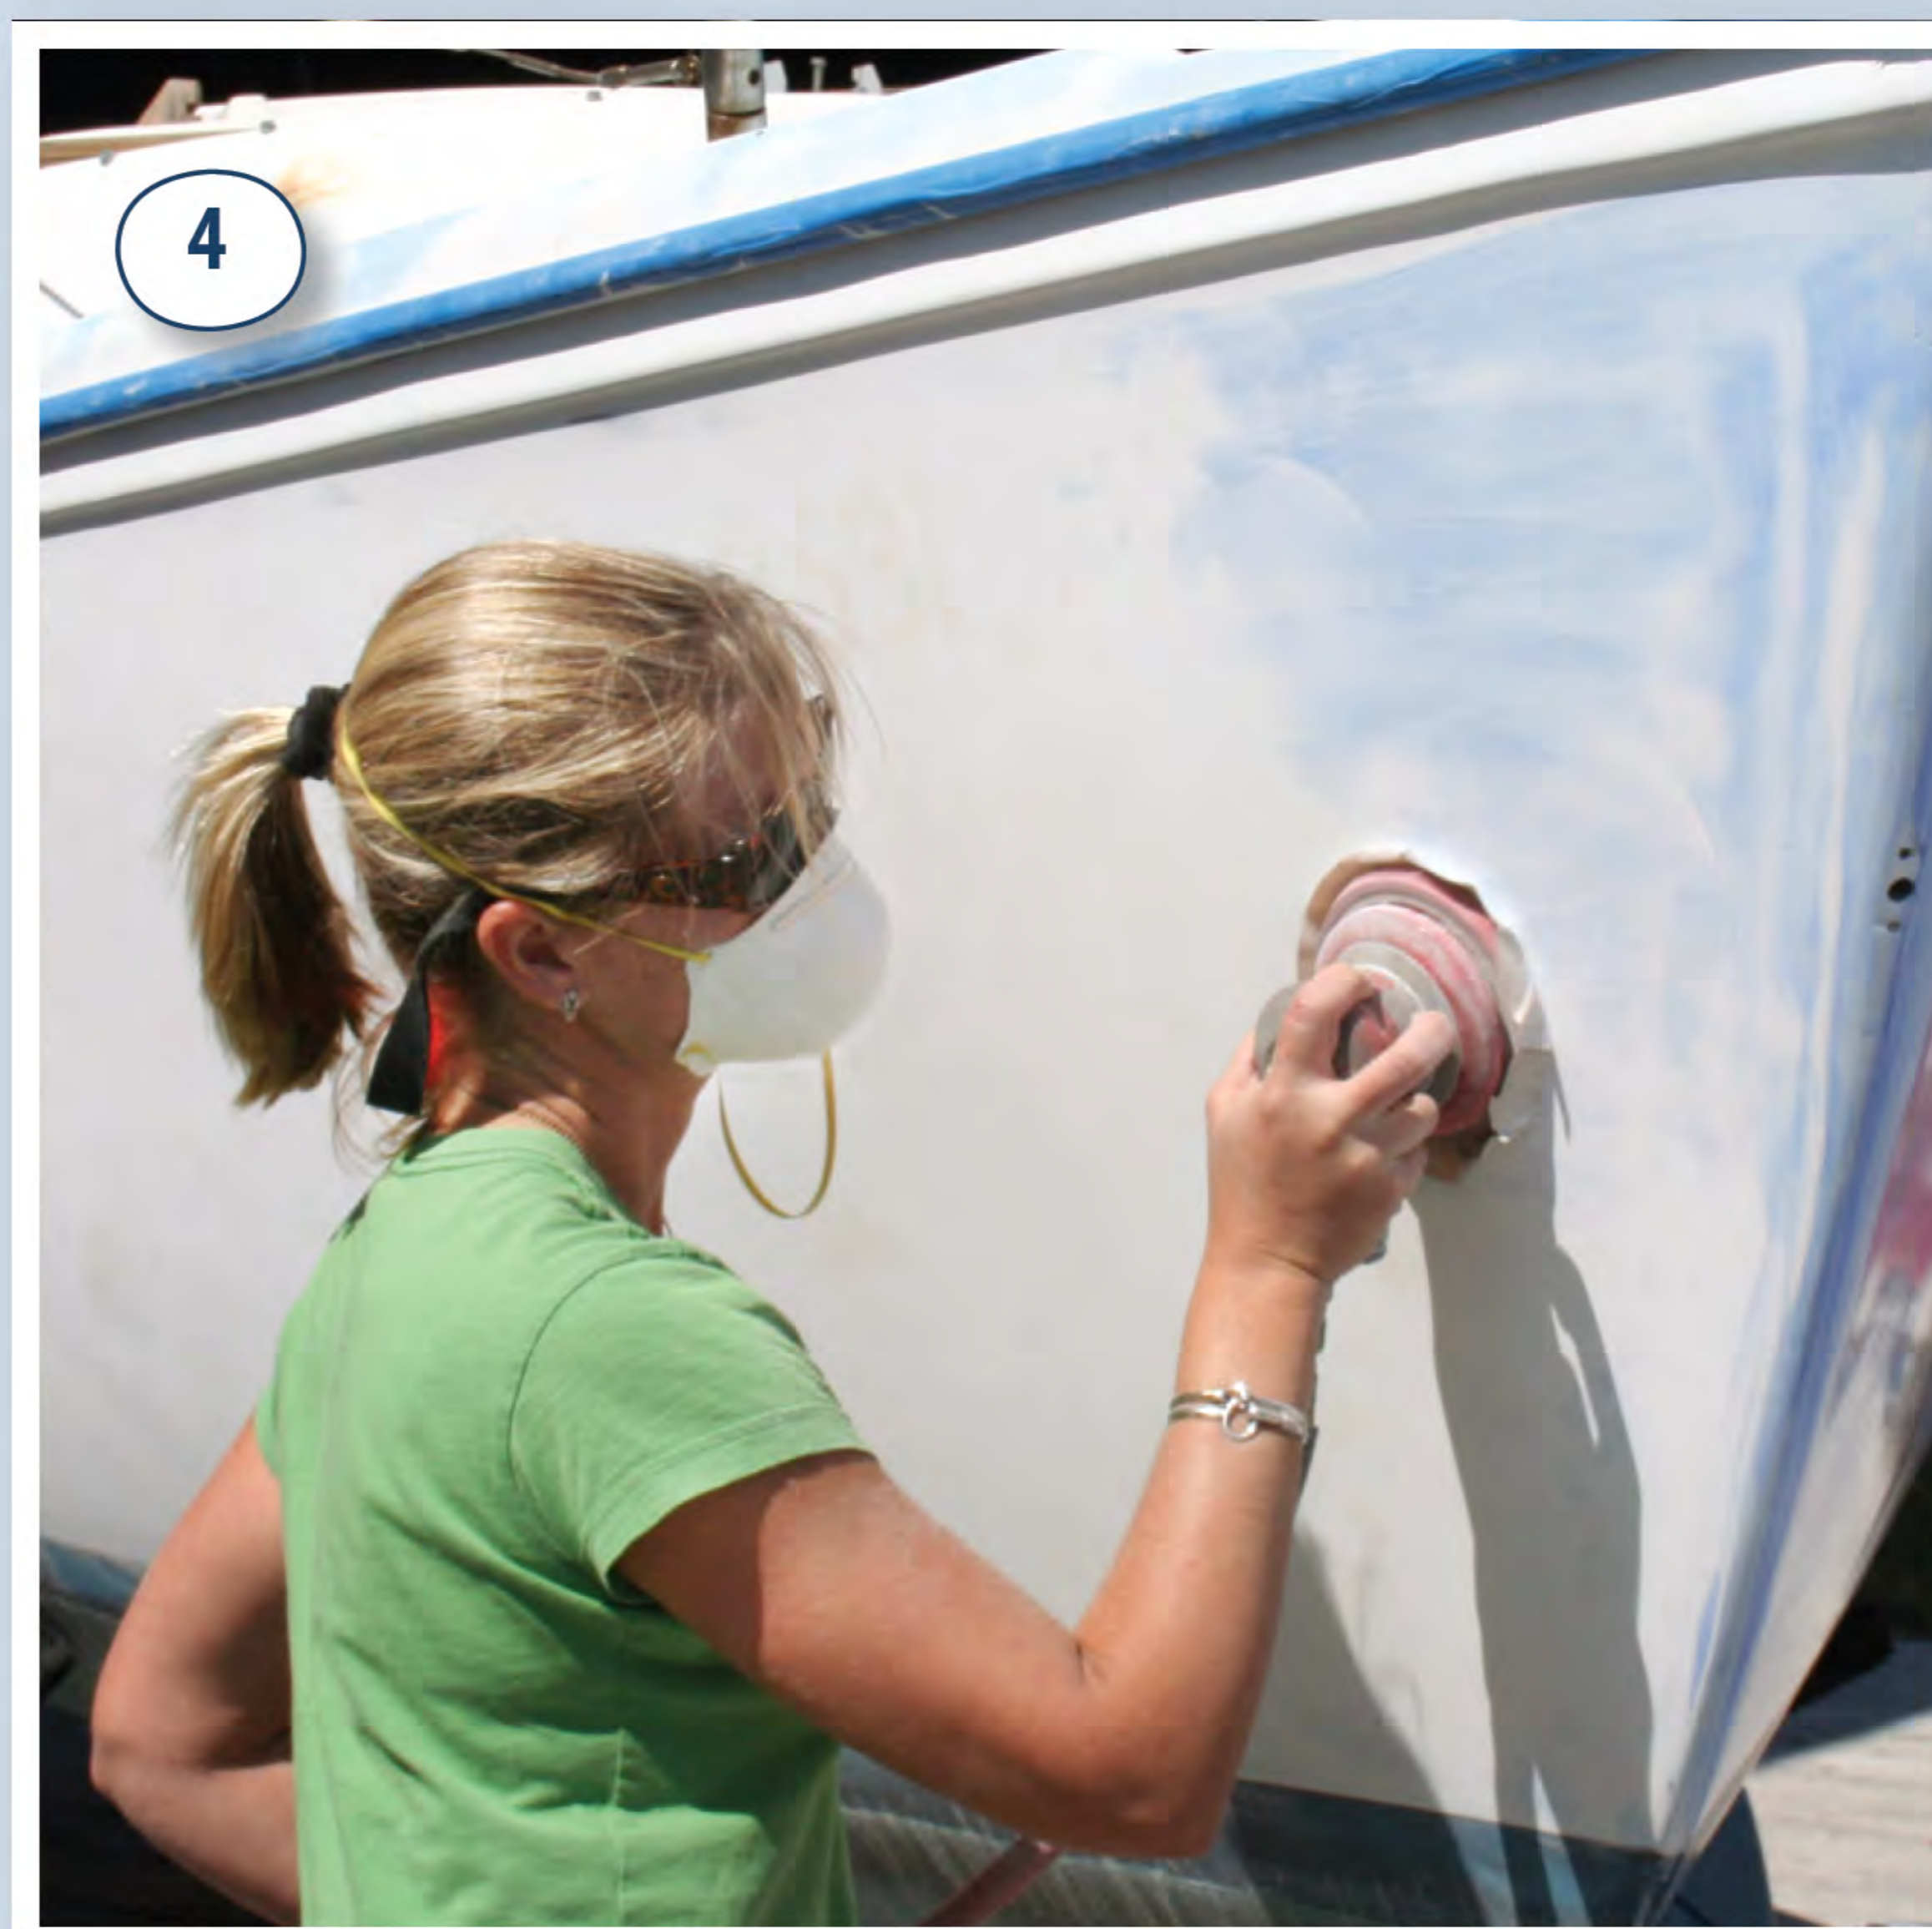
- We then rubbed the hull down with Dykem No. 80660 steel blue layout fluid (\$10/4 ounces), cut 50 percent with acetone. The dye—a welcome crutch to limit the amount of over-sanding that was done—makes it easy to spot which areas need further filling or more sanding. A few more rounds of filling, fairing, sanding, wiping, and taping ensued, and then the final pre-priming once-over with the pneumatic DA and 220-grit sandpaper. **(Photo 4)**

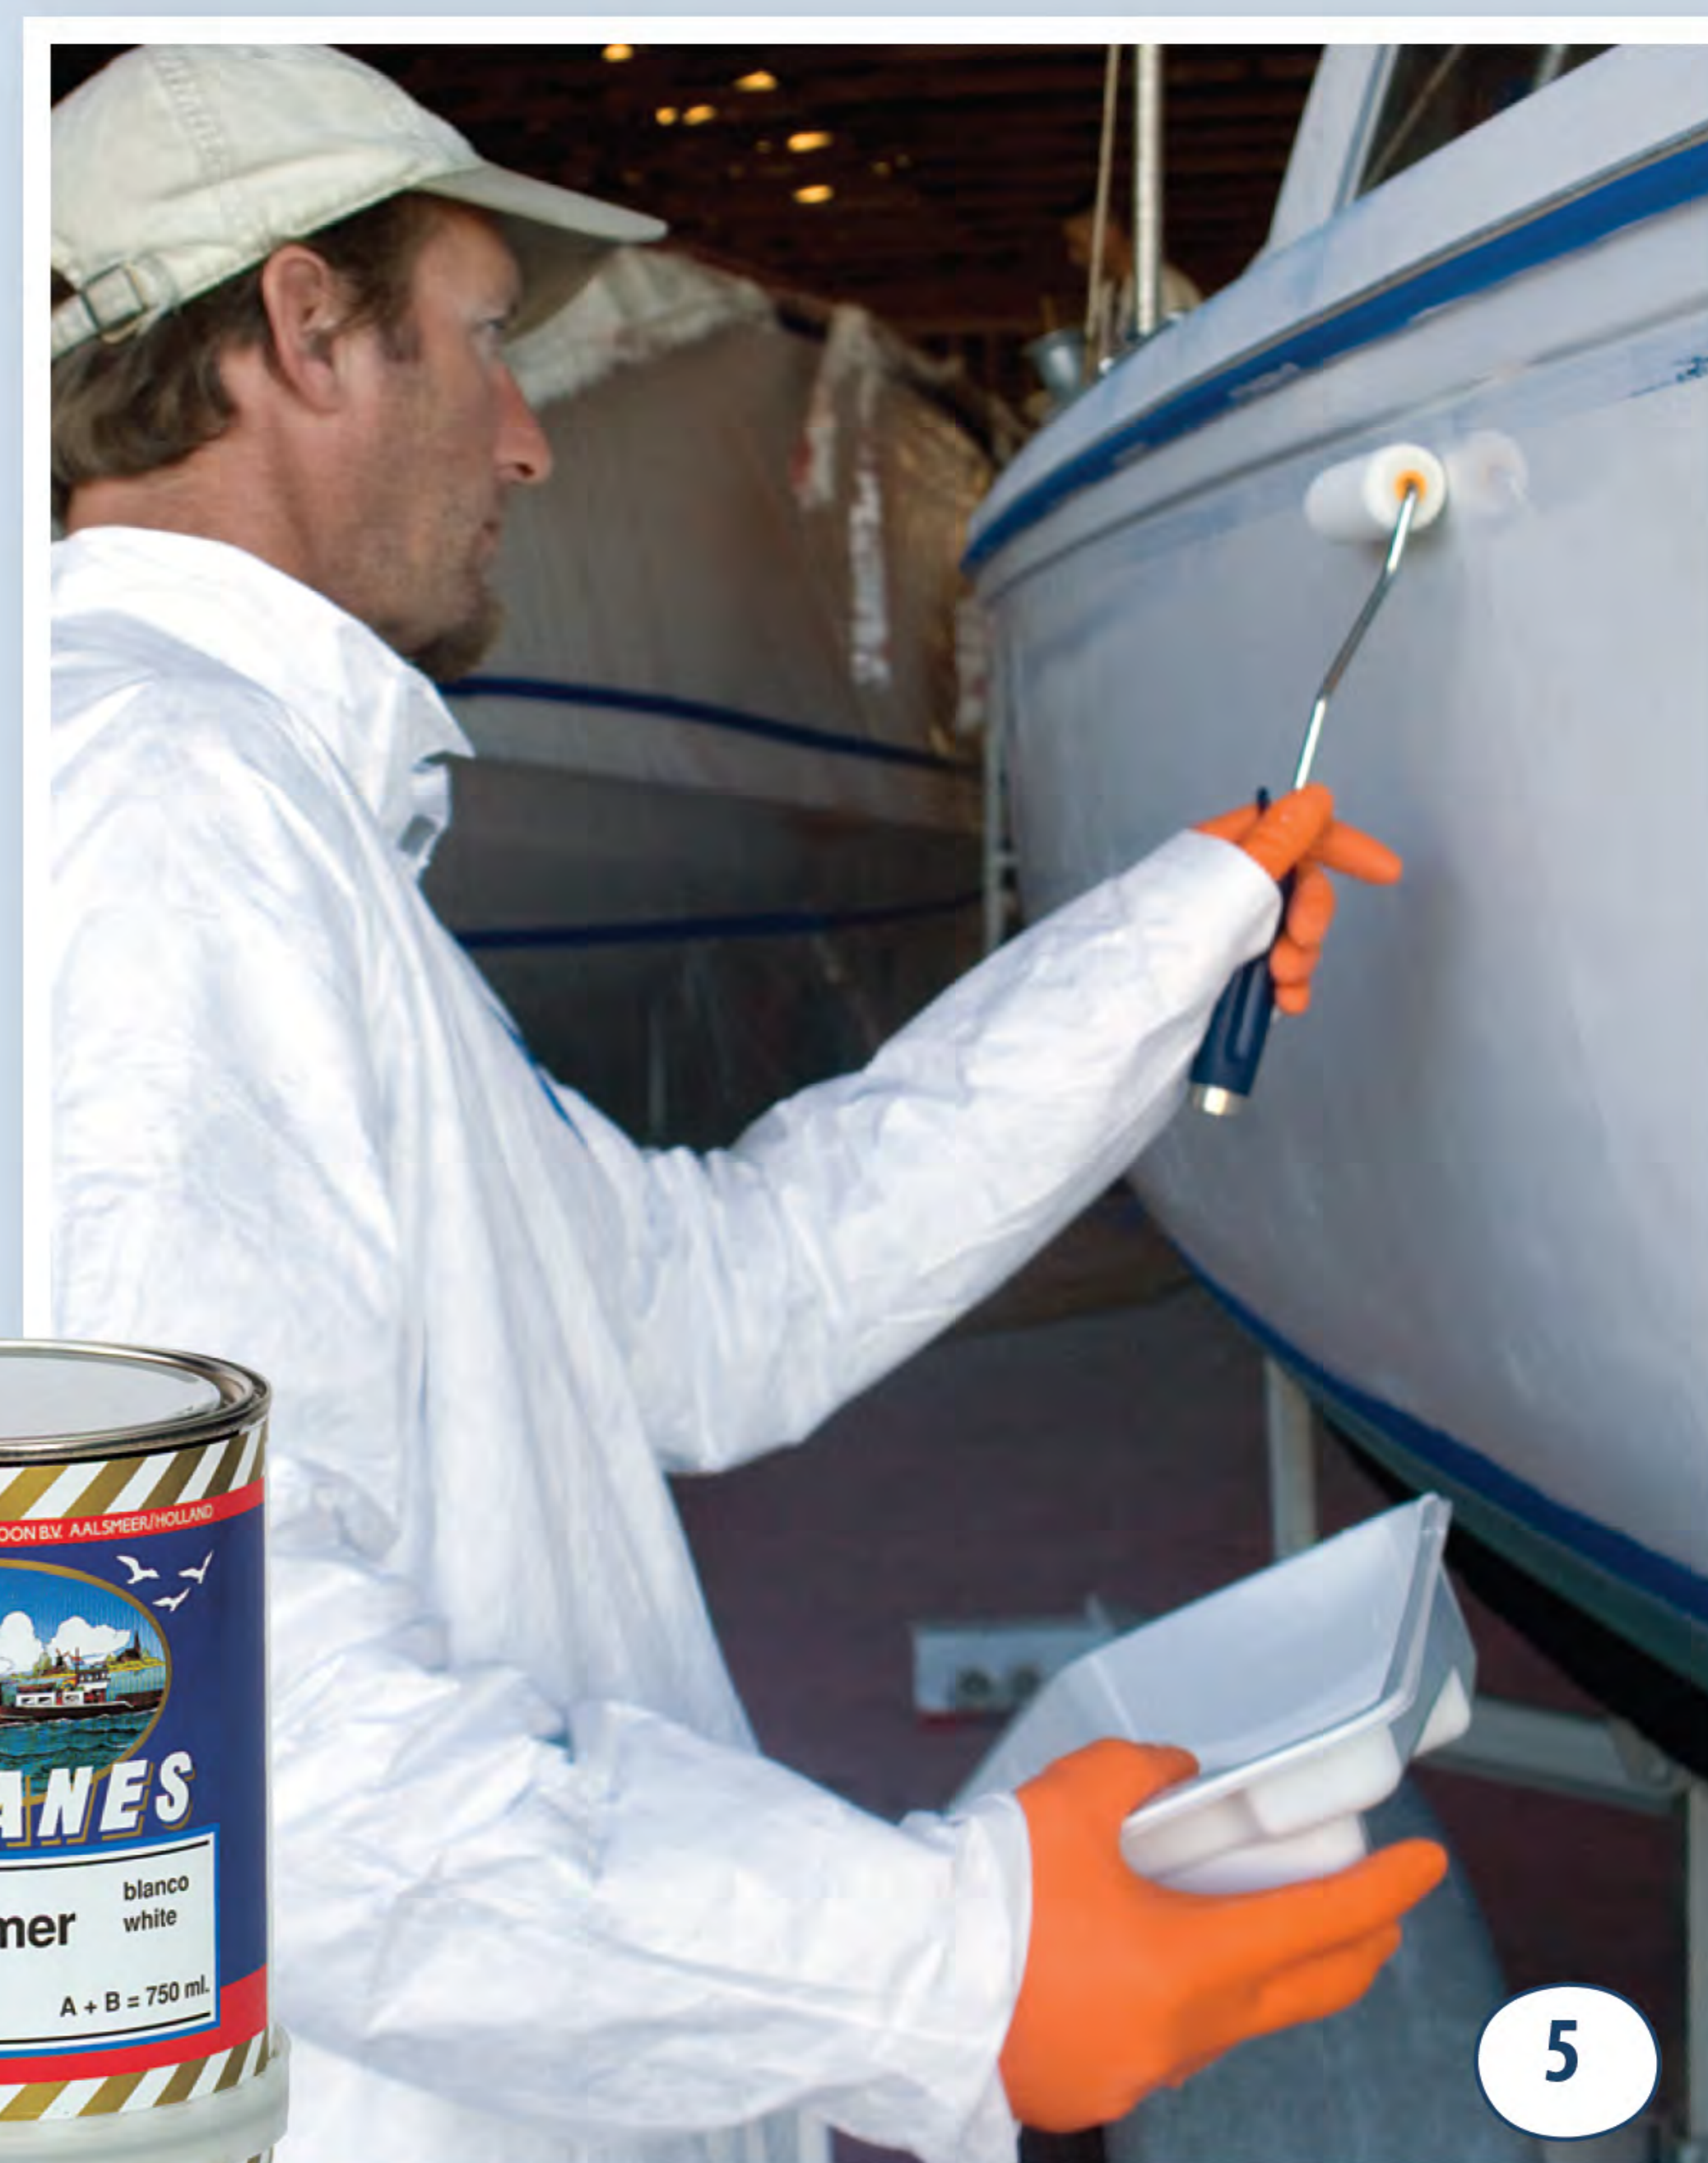
- Using high-density foam sausage rollers, testers applied two coats each of Interlux Epoxy Primekote (starboard) and Epifanes Epoxy Primer (port). **(Photo 5)** Between coats, we hand-sanded with 220 grit.
