A CLOSER LOOK

The Weak Link: Battery Compartments

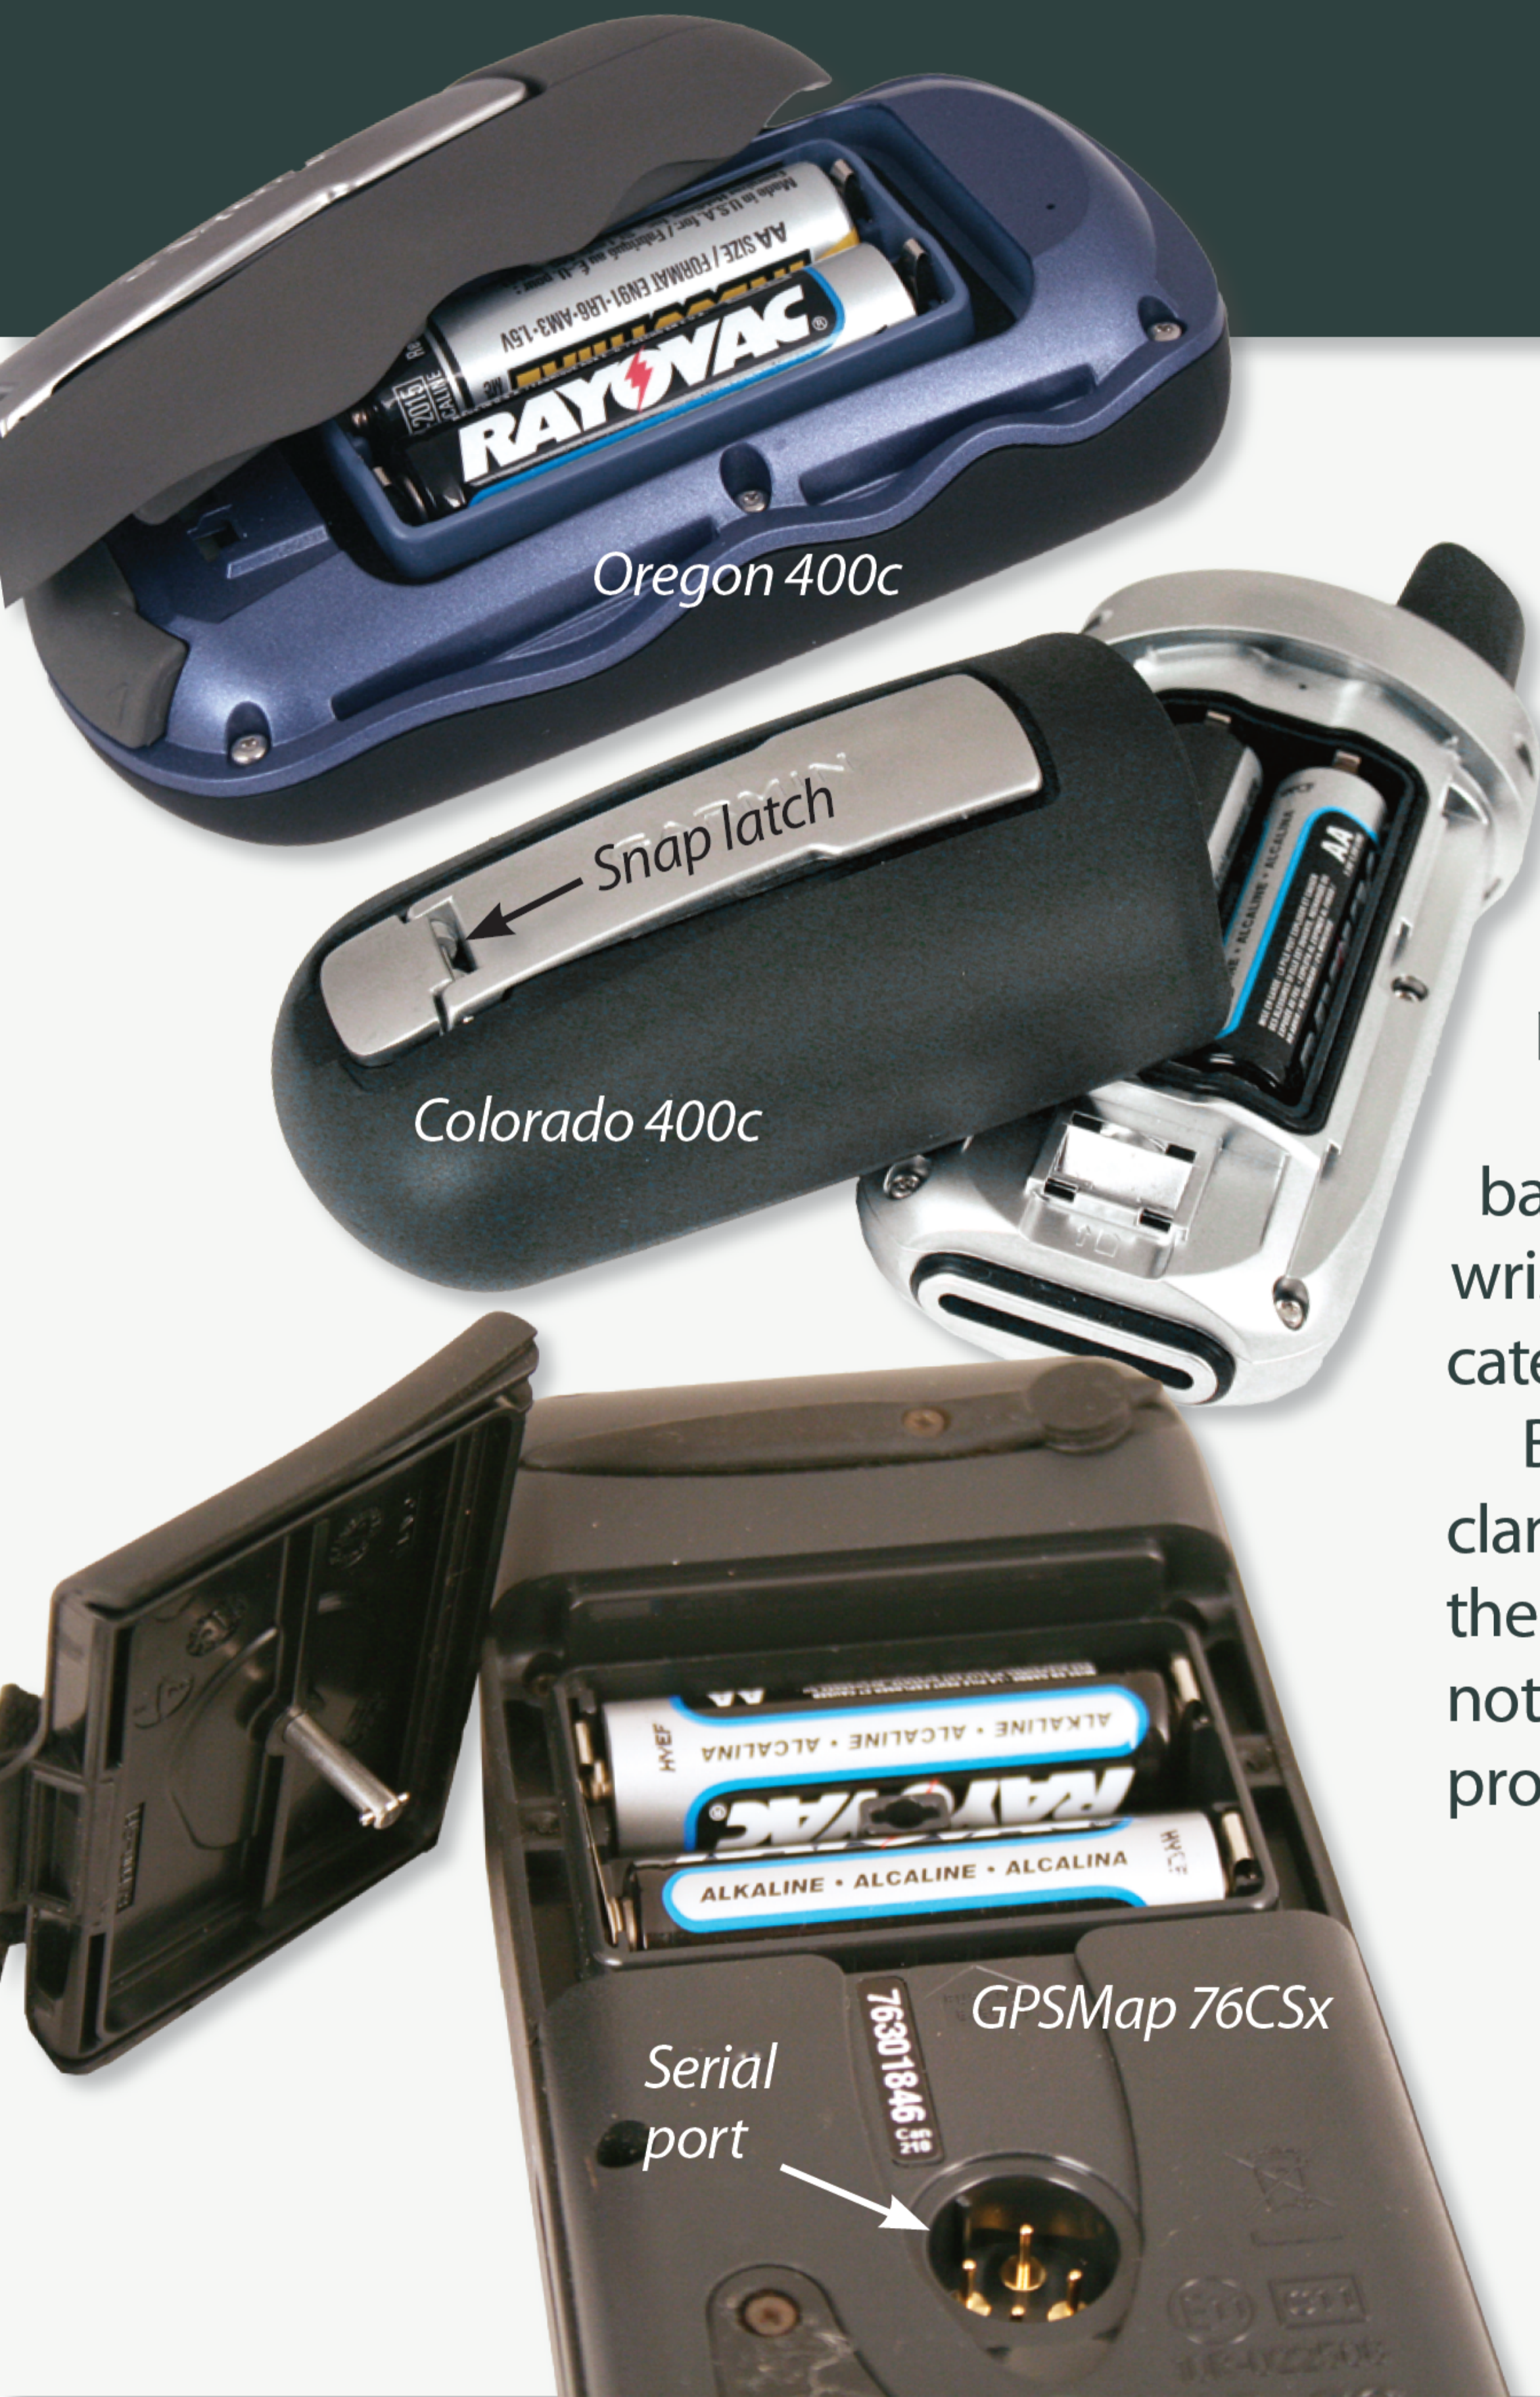
.....
The three test units took three different approaches to protecting the battery compartment, data card slots, and data ports.

The GPSMap 76CSx has a straightforward, metal twist-lock latch that seats the small back cover against its gasket. One potential problem with this arrangement is that the wrist-strap attaches to this latch, preventing it from lying flat in the locked position. A dedicated attachment point for the wrist strap would be a better solution, in our opinion.

Both the Colorado and Oregon series GPS latch with a hard plastic snap-lock that clamps the back covers in place. The Colorado back cover slides in place and snaps tight; the Oregon back cover simply snaps tight. The Colorado fell short here. The cover was not only difficult to fit, but water leaked beneath it, and the snap-lock gave some testers problems. Another concern regarding these products in the marine environment is that

the USB mini-B port is vulnerable to corrosion. Only the GPSMap76CSx still has a serial port interface connection, but that in turn requires a serial-to-USB converter to connect to most modern laptops.
