THE WORLD TURNED UPSIDE DOWN

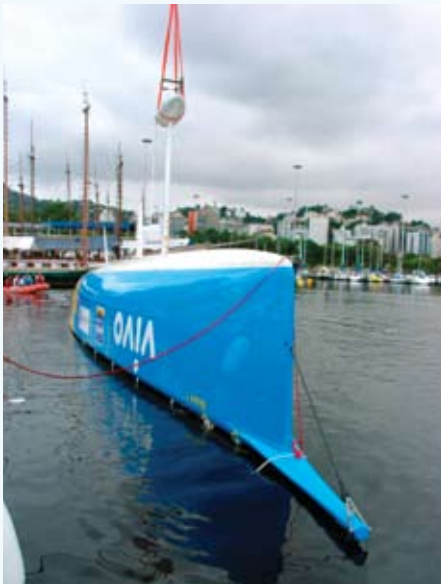
The accompanying photo shows the inversion test of *Brasil One* in Marina da Gloria, Rio, prior to the race. It was a gray, rainy day, and the filthy waters of Rio's harbor were not appealing.

.....
Brasil One, with two of its crew members inside, undergoes the mandatory inversion test that all Volvo Open 70s must face.

The inversion test required of every VO 70 is a daunting process. With the mast removed and at least two members of the crew sealed up inside, the boat is slowly and carefully capsized, using a crane attached to the keel to pull the boat over. The engine, generator, batteries, and all other heavy items remain in place.

Using only the keel's manual canting system, the crew must

right the boat from a full inversion. Experience proved that it was only necessary to move the keel about eight degrees off the centerline before the boat would flip upright in an instant. To minimize the risk of injury to the crew, the crane was left loosely connected to the bulb during the test to slow down the righting of the boat.
