Practical Sailor™

Waterline Stains Revisited

Can clear antifouling paint solve this problem?

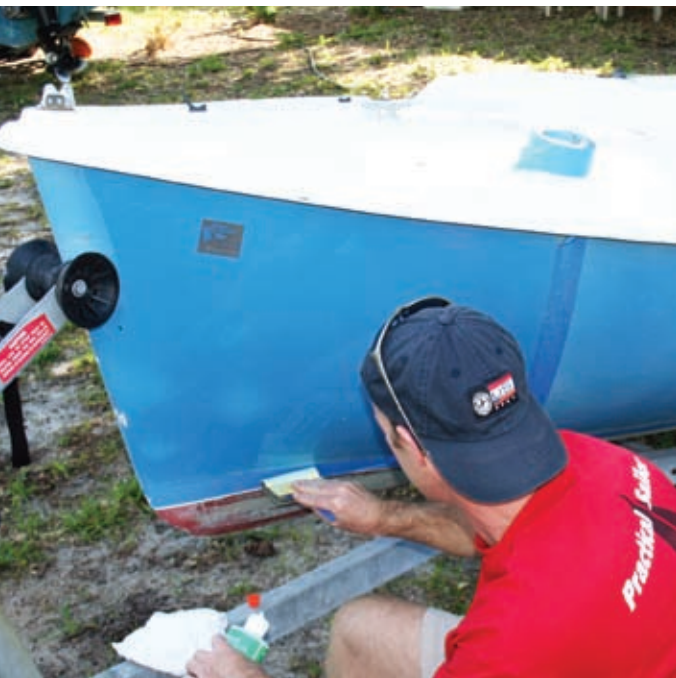
PS readers have reported good results warding off waterline stains with a regular application of PoliGlow acrylic coating. We are currently testing PoliGlow and similar products on a 1974 Javelin (left).
